Blade Inspection Report

WTG

Blade Care Consulting

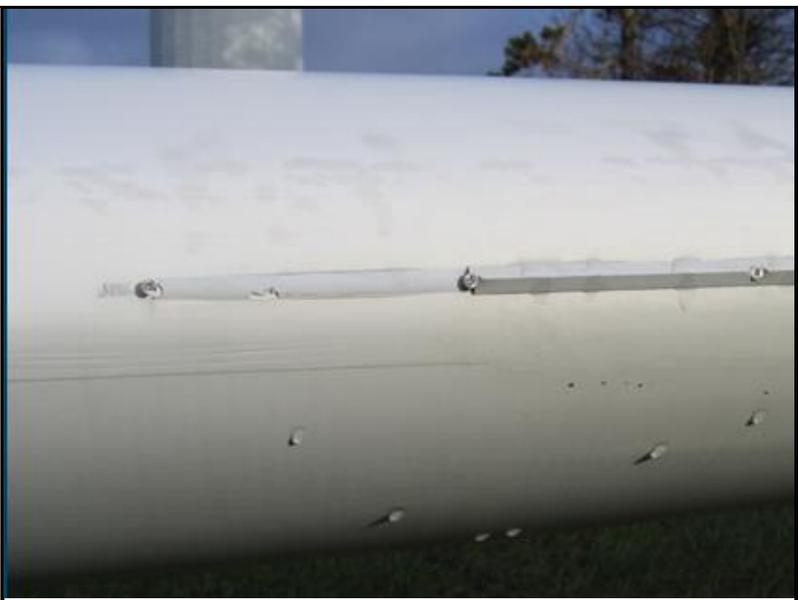
Photo no. JPG_0273

<p>Obs. 1 Stall strip missing</p>

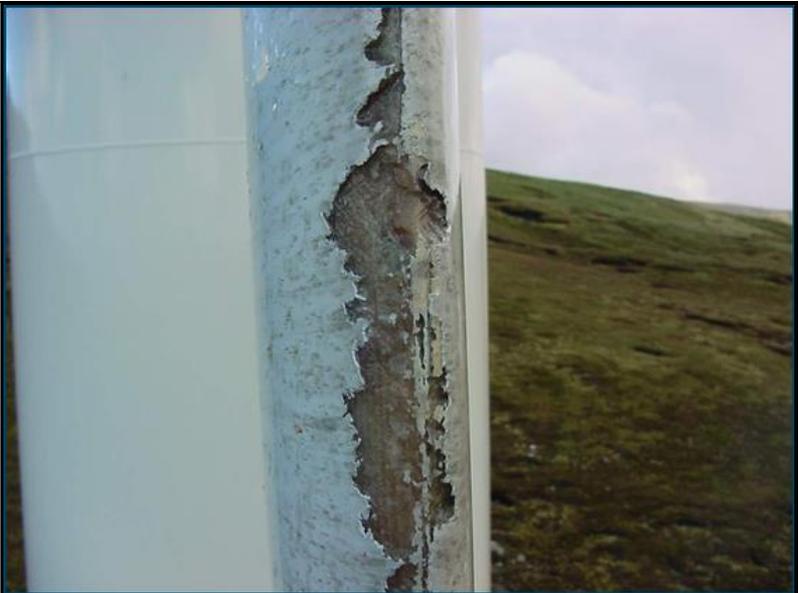
Photo no. jpg_071

Obs. 1
Coating and first layer of laminate worn out

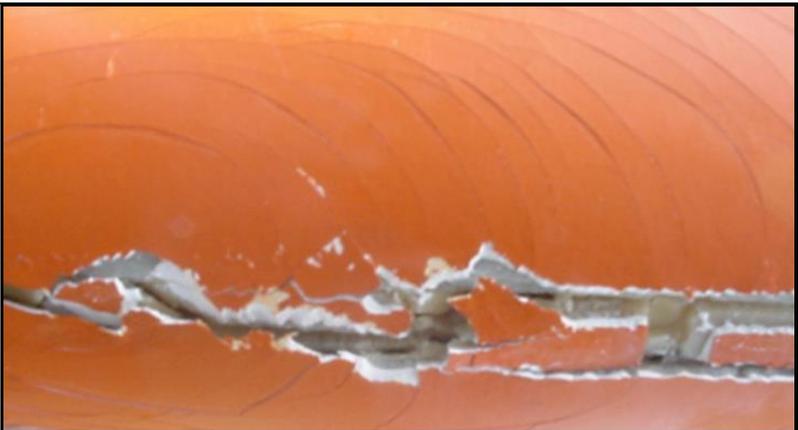
Photo no. JPG_055

Obs. 1
Impact on LE
