Blade Heat System Repair, part II

Greger Nilsson

Blade heat systems

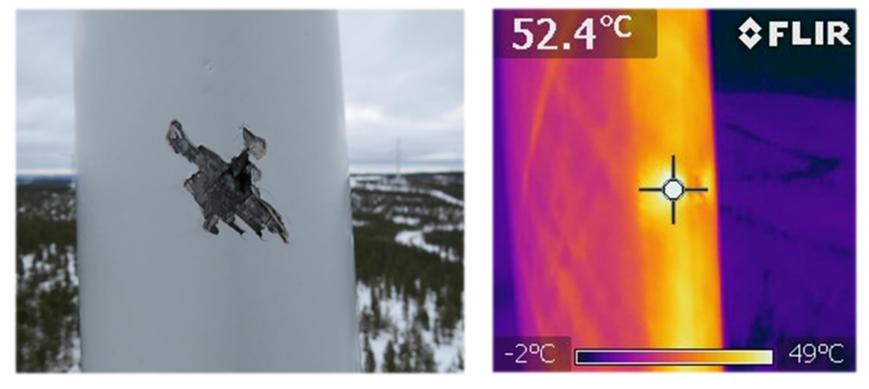
Impact damage

Hotspot

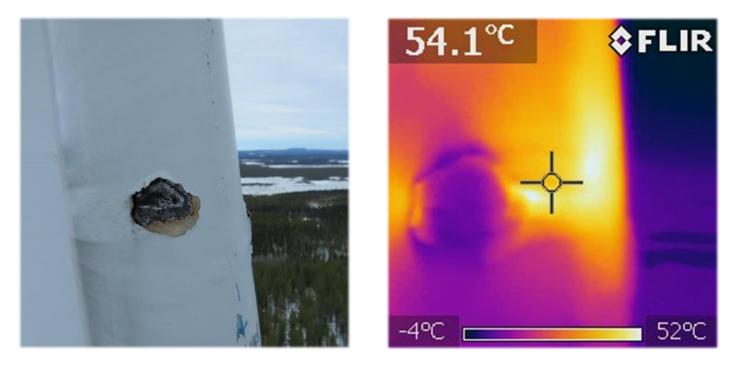
Lightning

Damage on carbon fibre mat Hot Spot 34.5°C **\$FLIR**

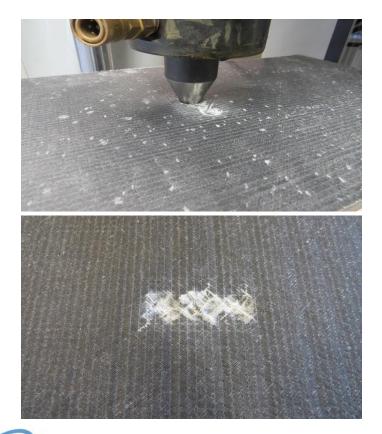
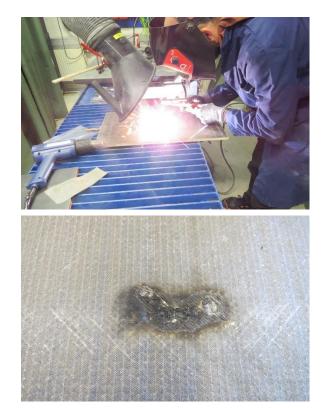
Impact and lightning damage

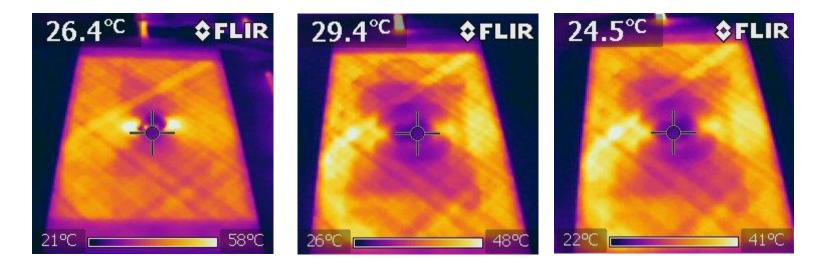
Repair of impact damage

Before repair

After repair

After fatigue testing

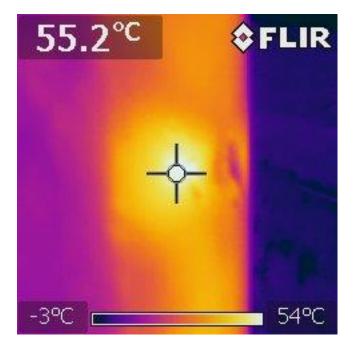
Carbon heat mat repair of a impact damage

Before repair

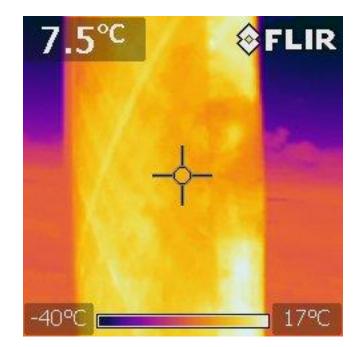
After repair

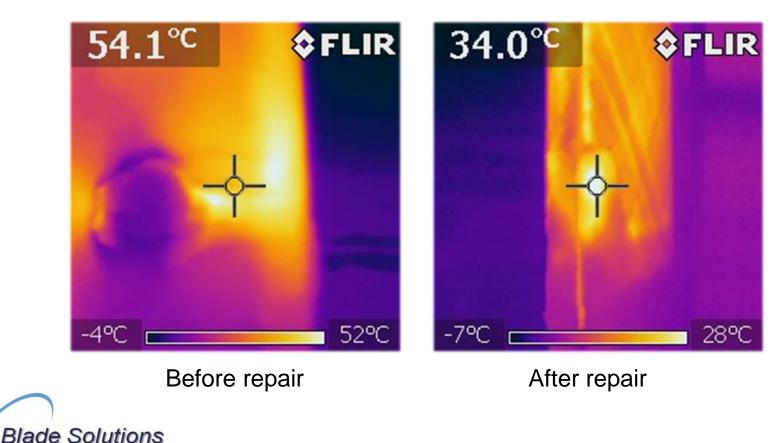
Carbon heat mat repair of a lightning damage

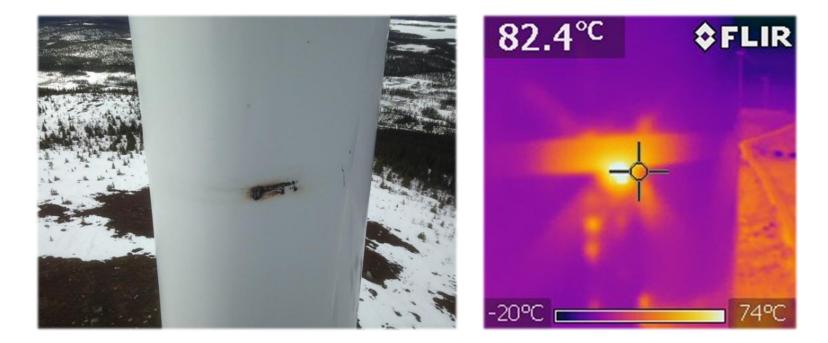
Damage in root blade heat connection

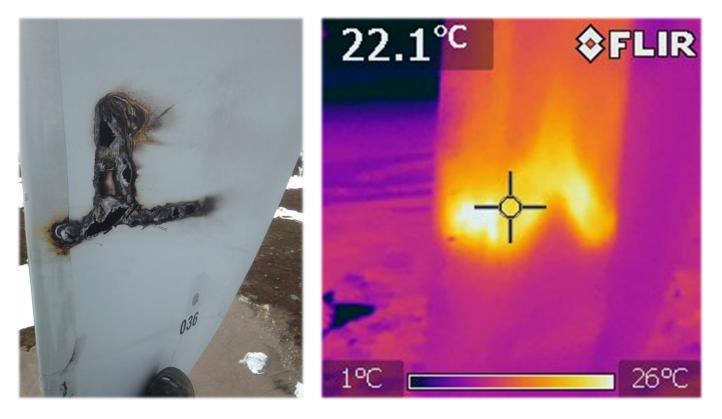
Damage in tip blade heat connection
