Blade repair in artic climate

Greger Nilsson

Blade Solutions

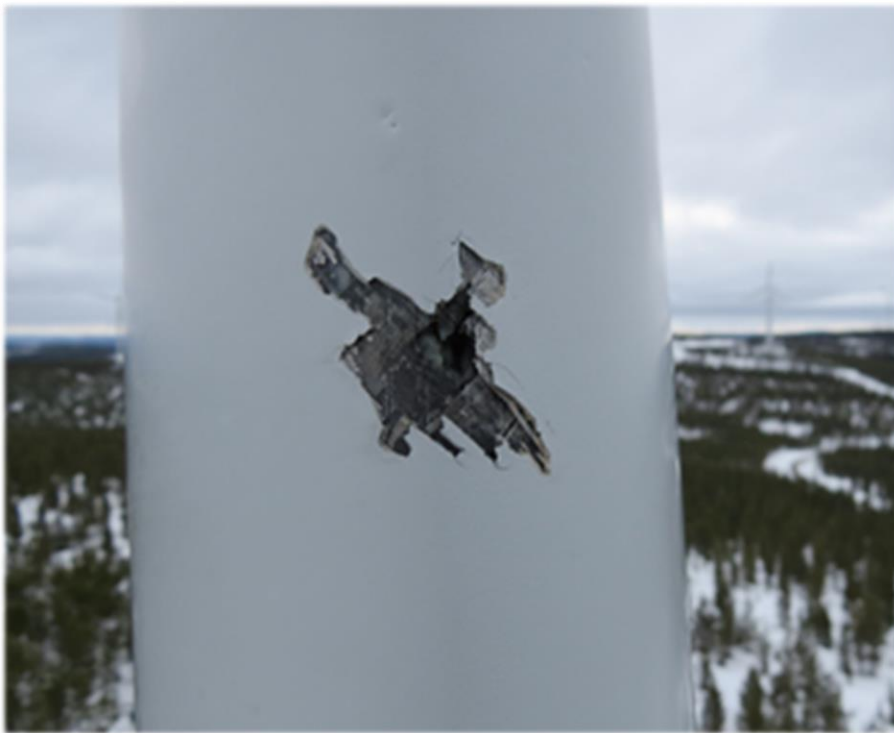
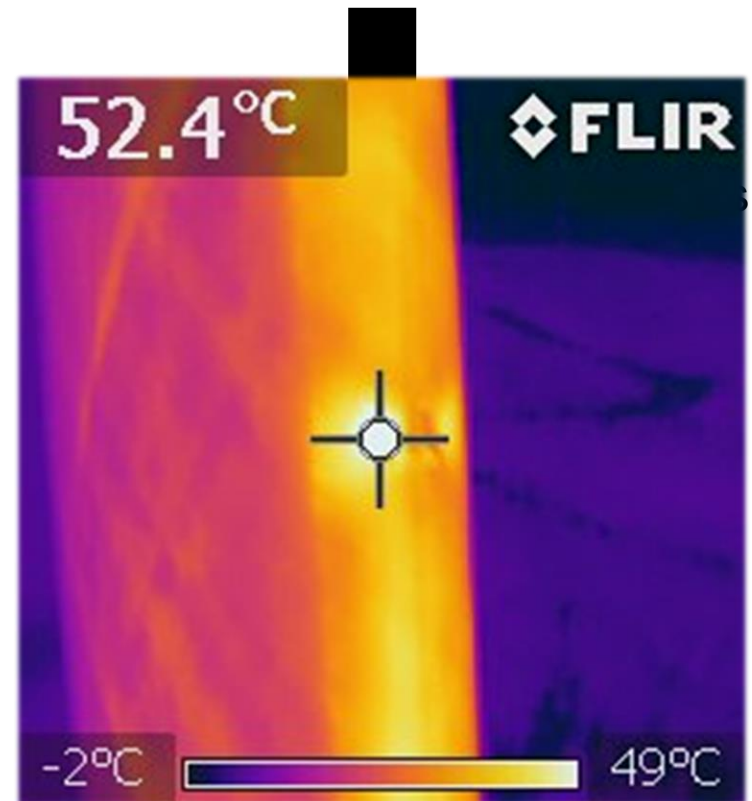
Carbon heat mat damage

Impact

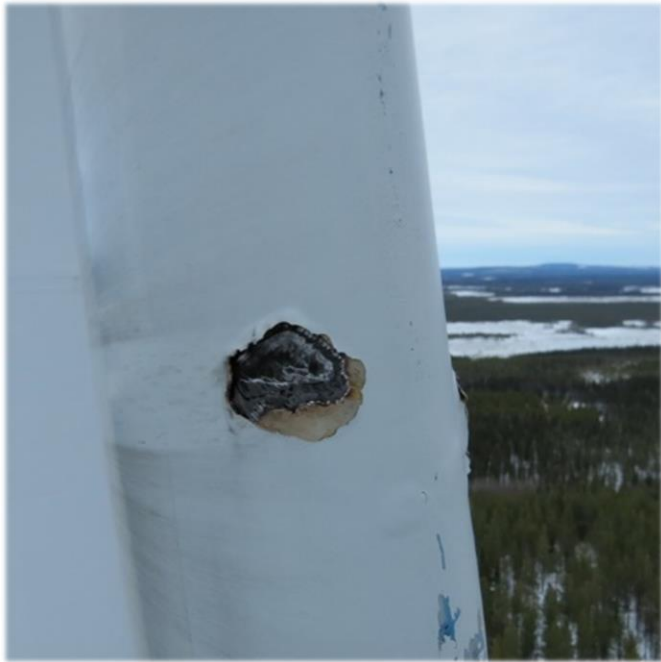
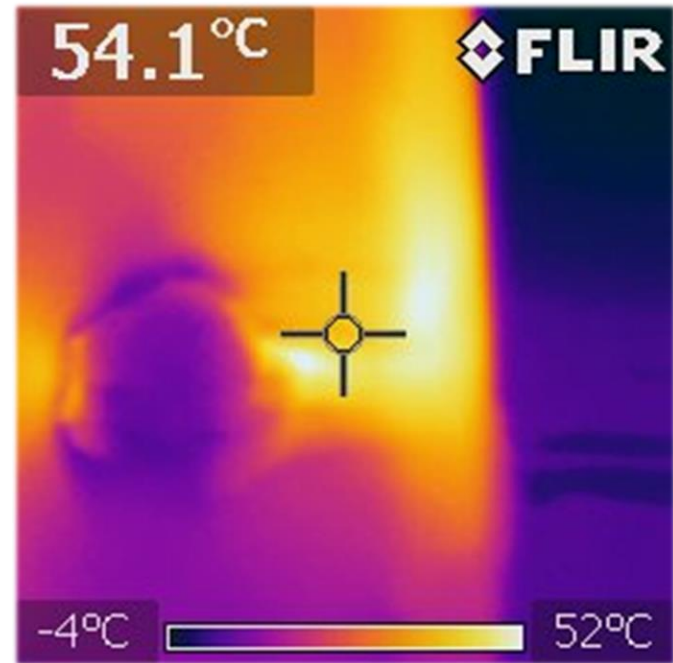
Carbon heat mat damage

Lightning

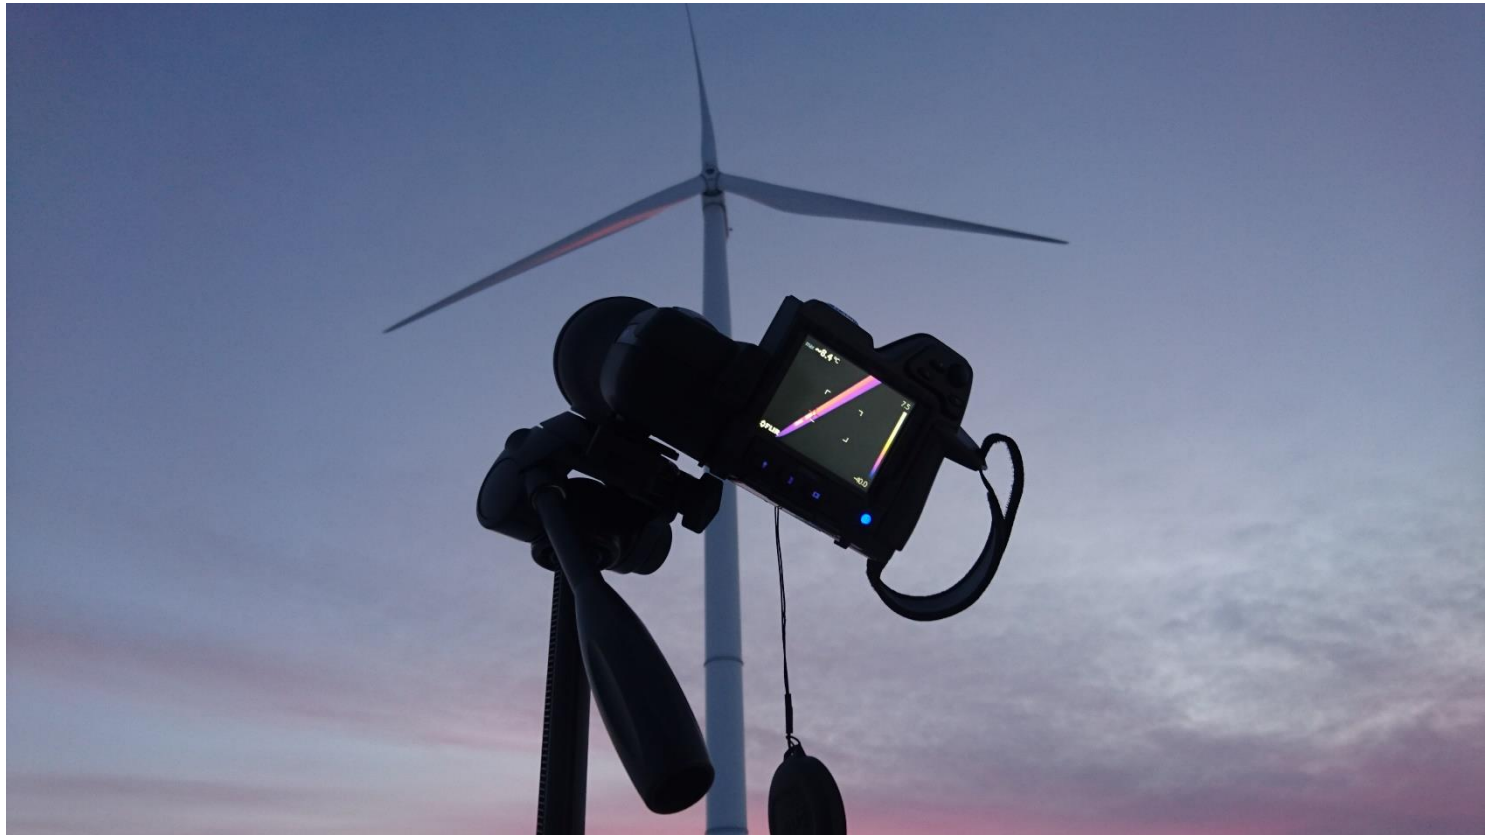
Infrared inspections

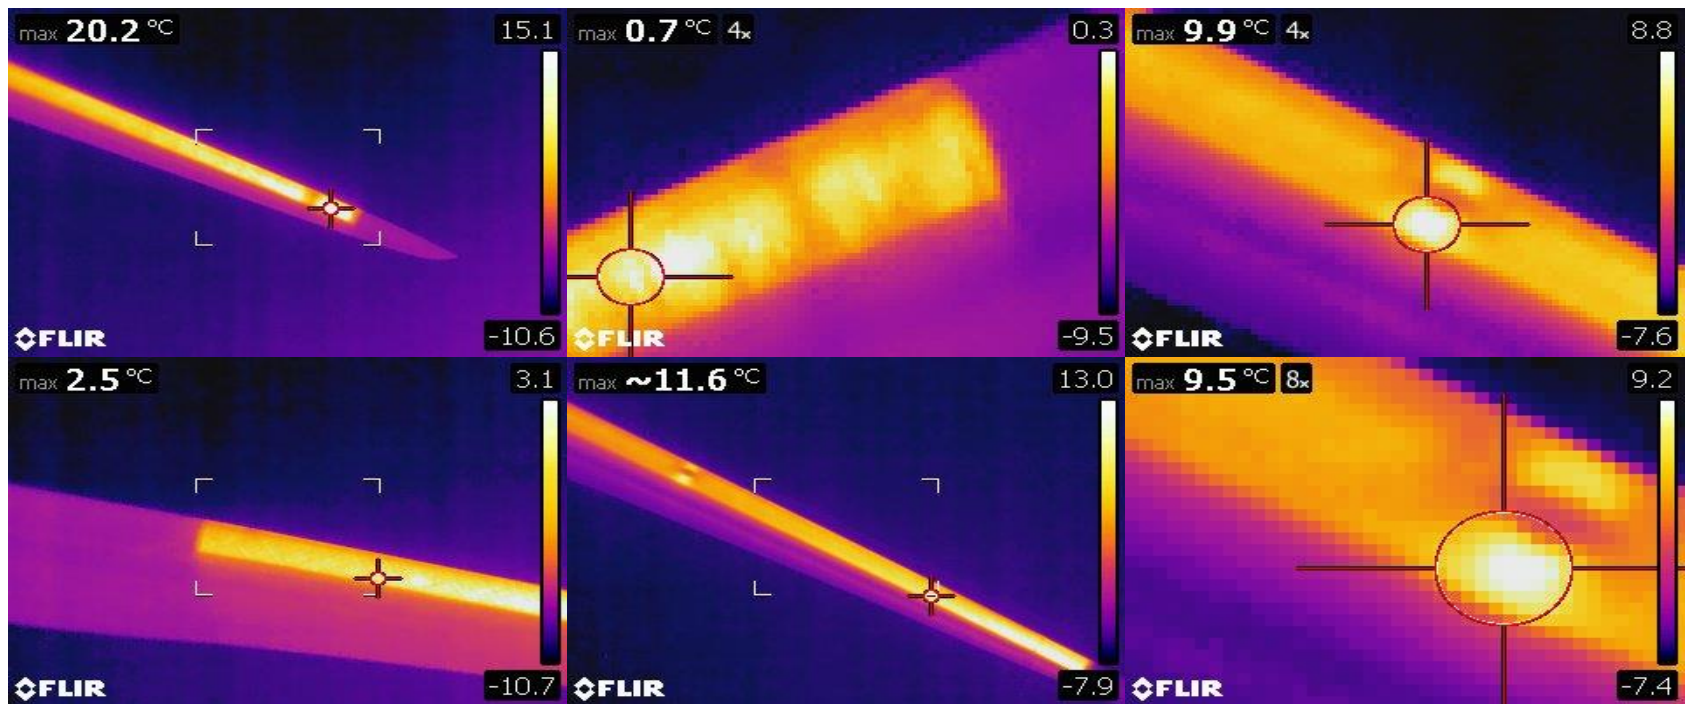
Infrared inspections

Set value at tip, 20 °C

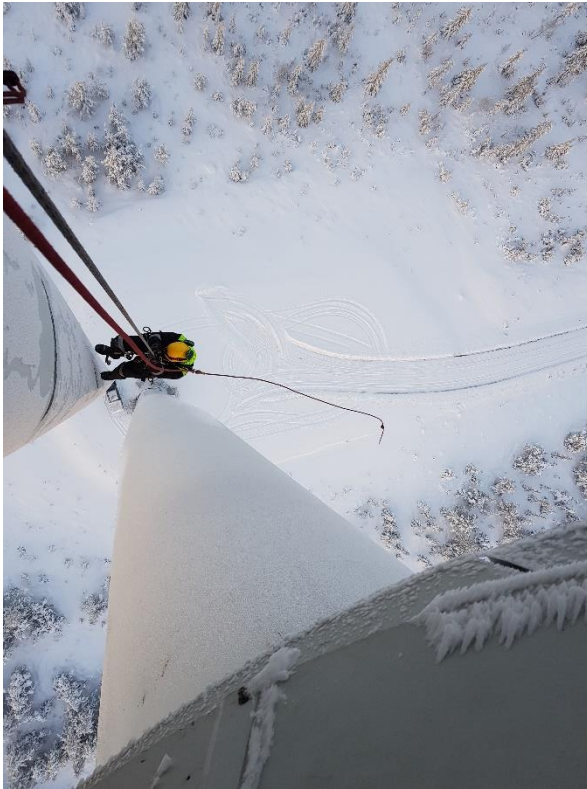
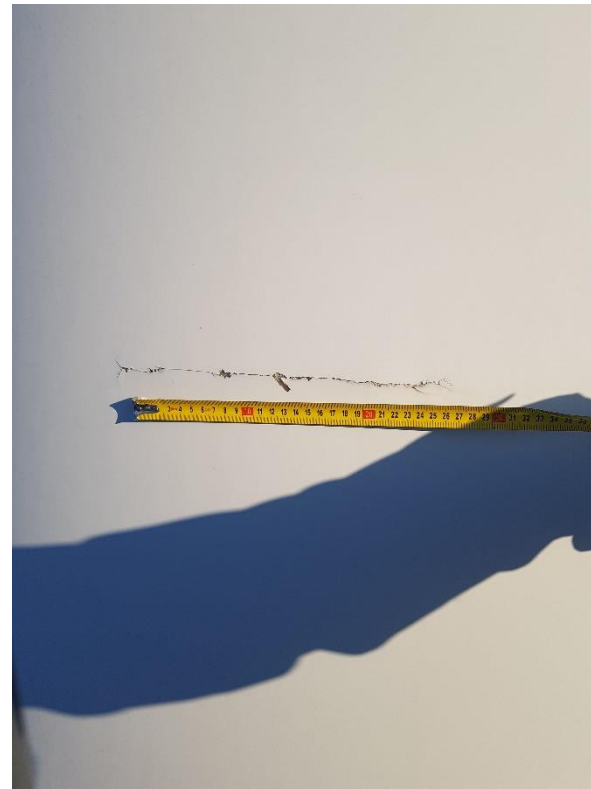
Blade inspection and fibre wrinkle defect

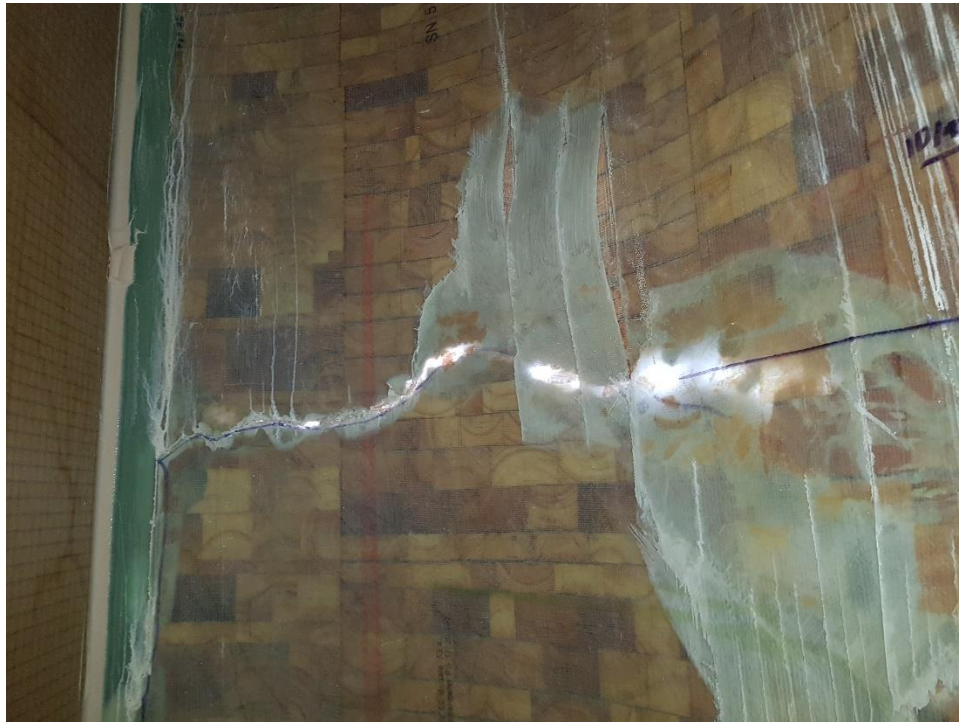
Crack propagation
