# Icing alleviation for wind turbines with no ice-protected blades

Masafumi Yamazaki Kanagawa Inst. of Tech Shigeo Kimura Kanagawa Inst. of Tech Paolo Rossi Anemos Makedonias Evi Stavropoulou Anemos Makedonias Katsuaki Morita Japan Aerospace Exploration Agency

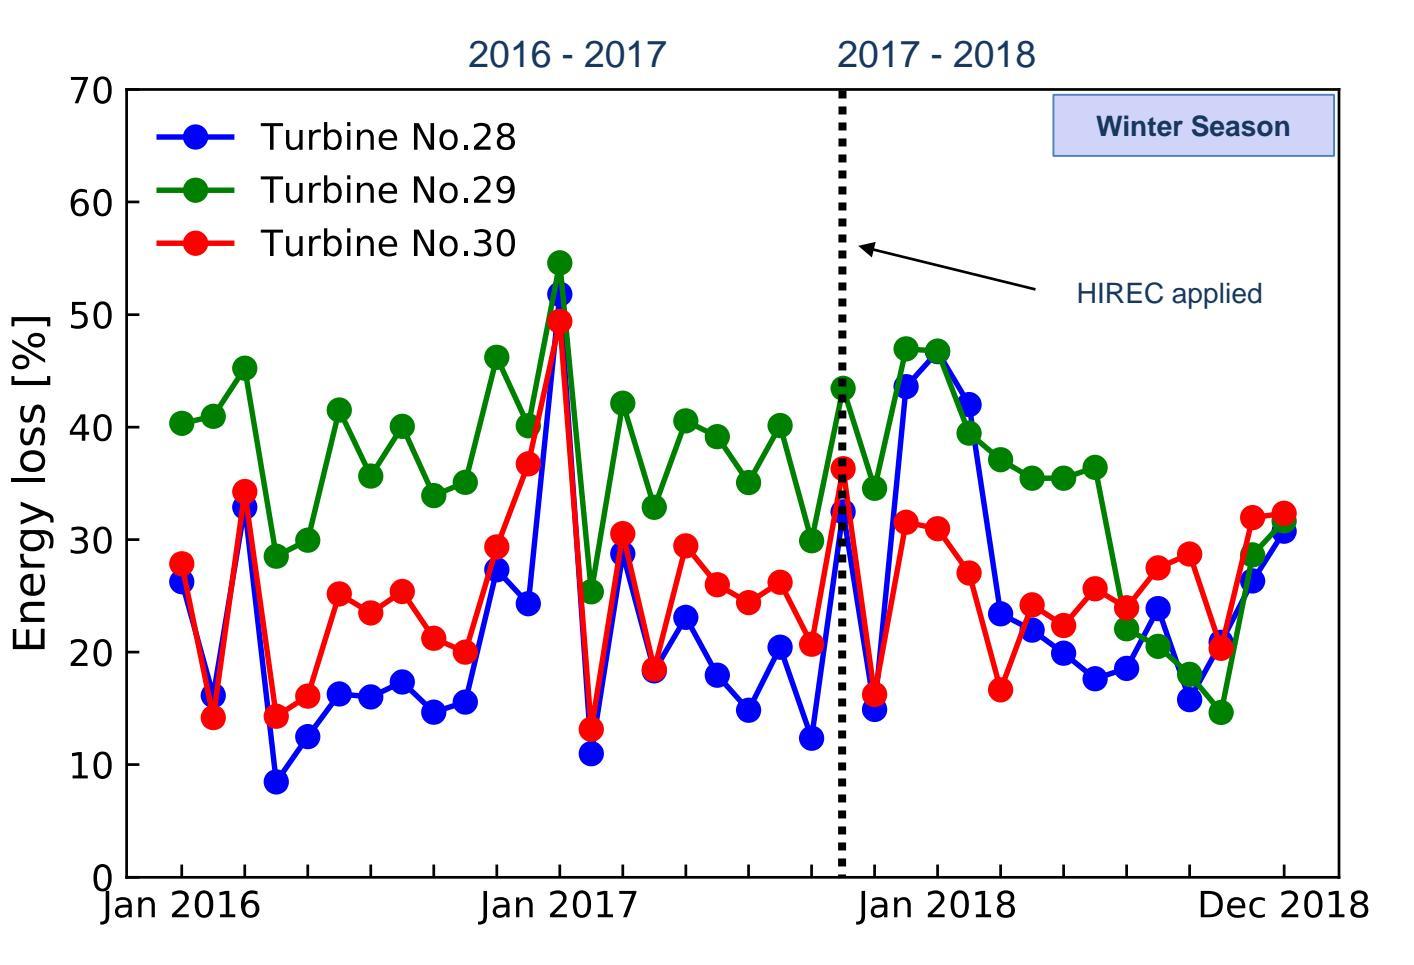
### Energy loss per a month

- Monthly energy loss from Jan 2016 to Dec 2018 are shown
- Black doted-line is when HIREC was applied on blades of No.30
- Winter season (from Nov to Mar) is colored blue
- Energy loss increased in 2016-2017 winter season
- In 2017-2018 winter, No.28 & No.29 showed relatively increased energy loss, while that of No.30 had little rise

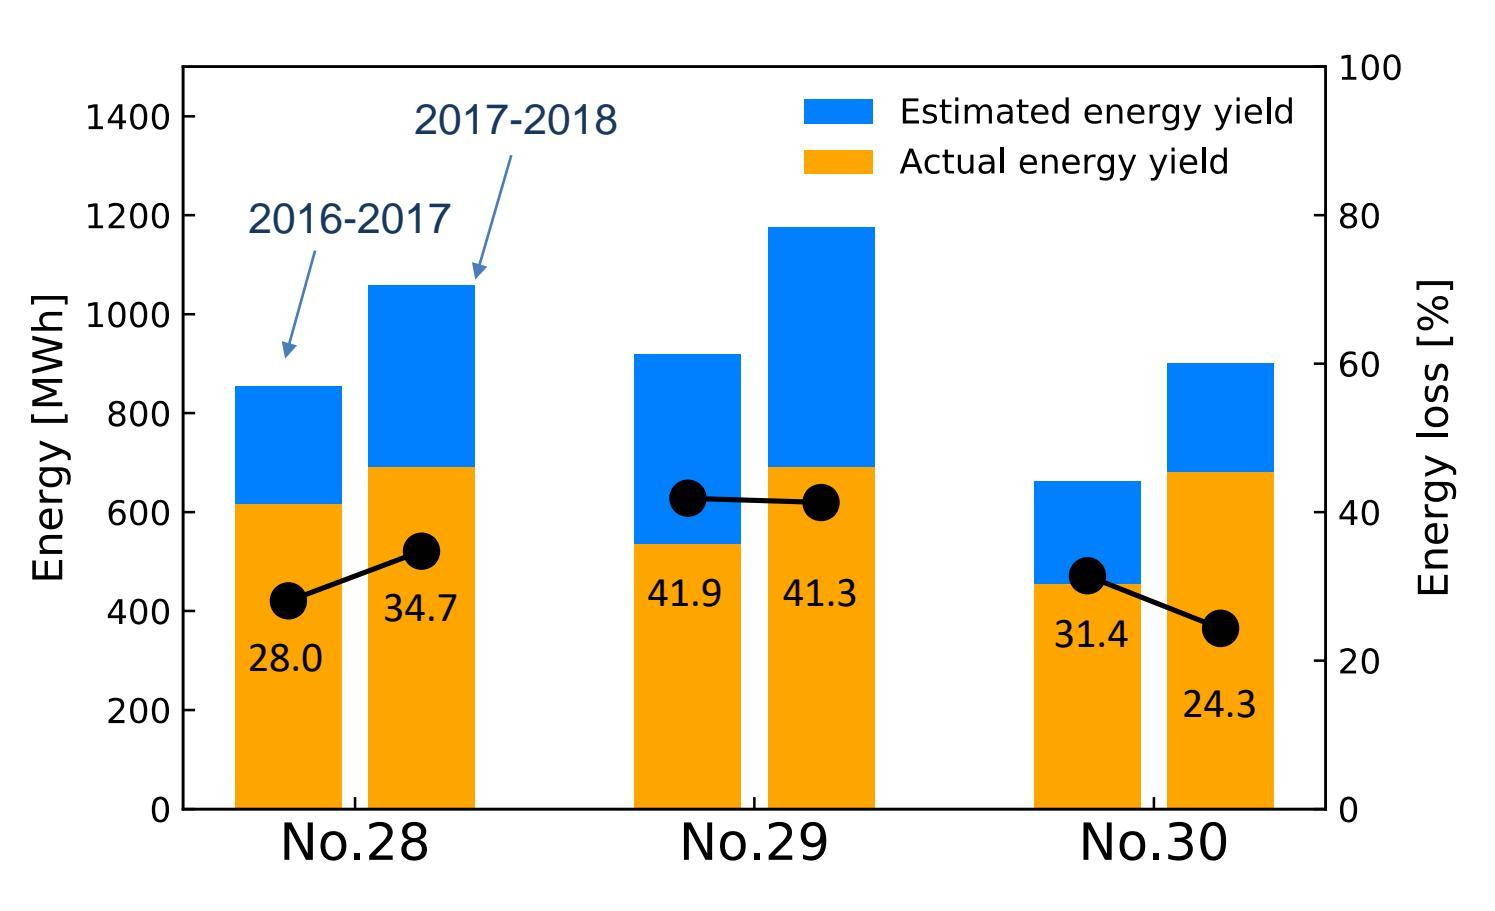
### Estimated & Actual energy yield in winter

- Actual energy yield is shown over the estimated energy as bars

- Left bars are the data obtained during winter "before" HIREC was applied, and right bars are after that.
- Wind speed in the second winter was more favorable
- Although estimated energy yield was increased, actual energy production didn't follow in No.28 and 29
- HIREC led the lower energy loss in No.30

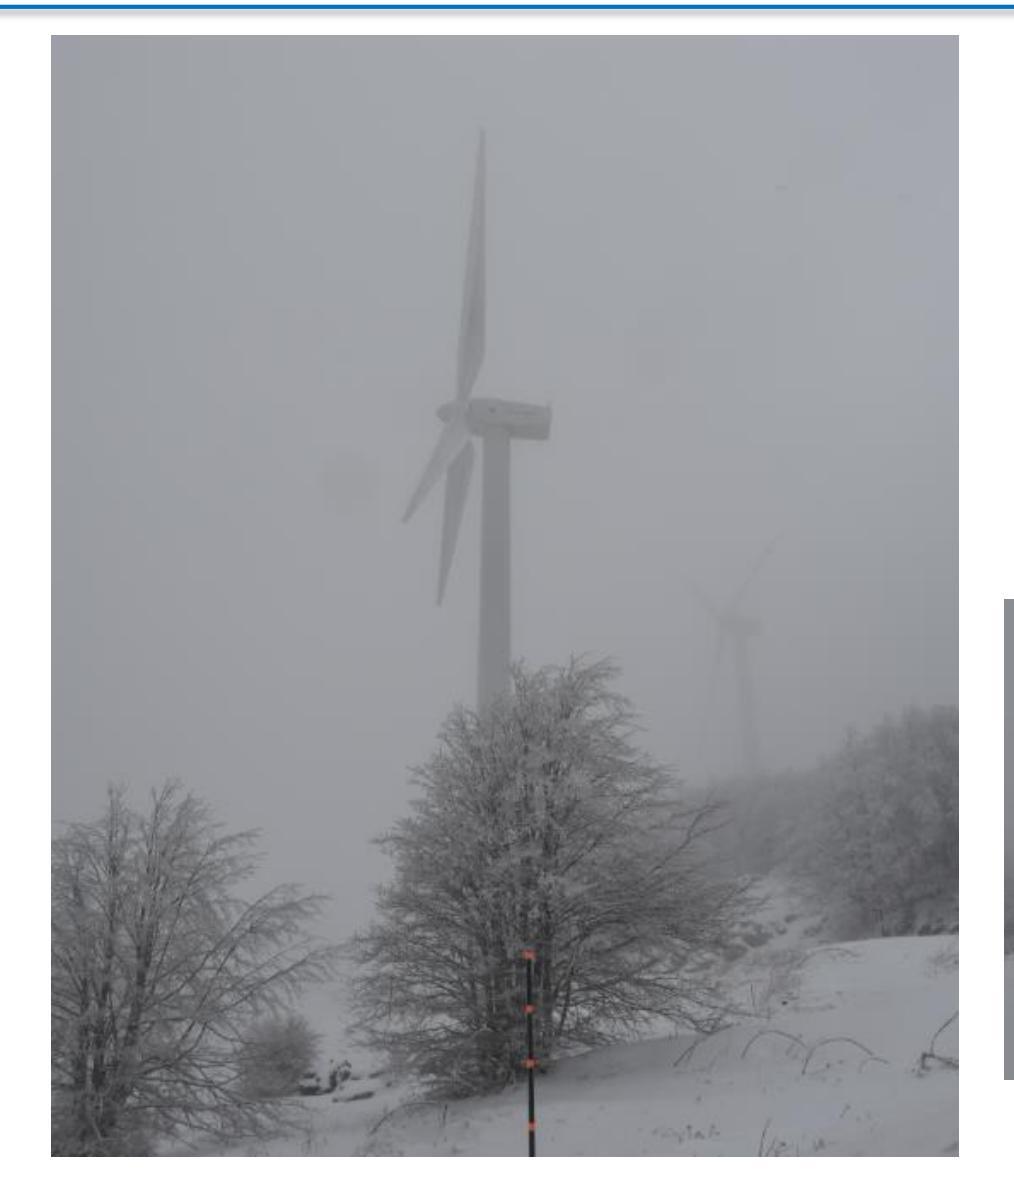
#### Ice fragments flown from coated blades

Taking pictures and collection of flown ice fragments: Mar.2018
