INVESTIGATION OF USING ICEPHOBIC COATINGS ON A CABLE STAYED BRIDGE

Ahmed Abdelaal, Clinton Mirto, Douglas Nims, Tsun-Ming Ng - University of Toledo –
University Transportation Center

Outline

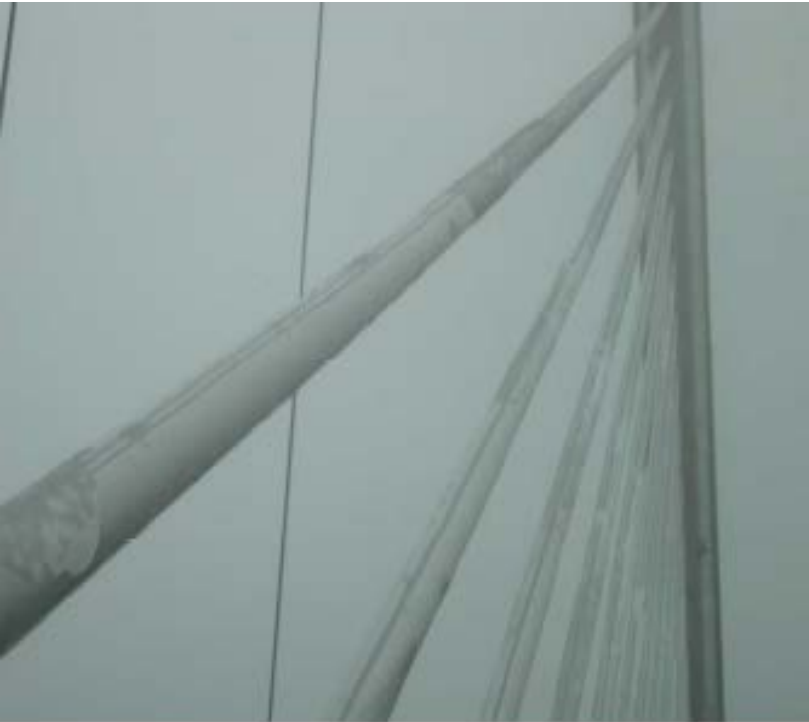
Ice accumulation pattern on VGCS stays

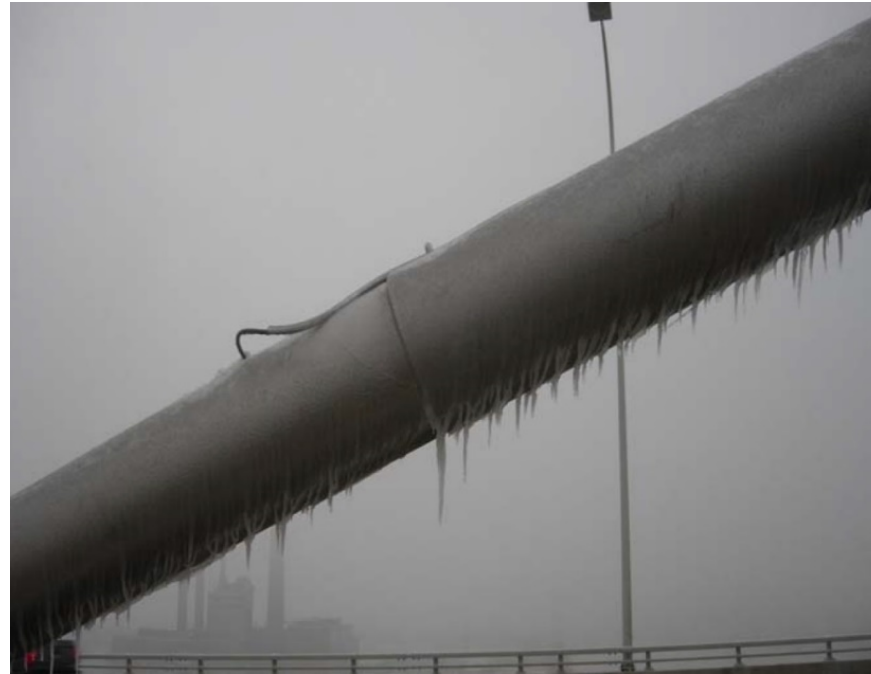
Ice accumulation on the east side of VGCS

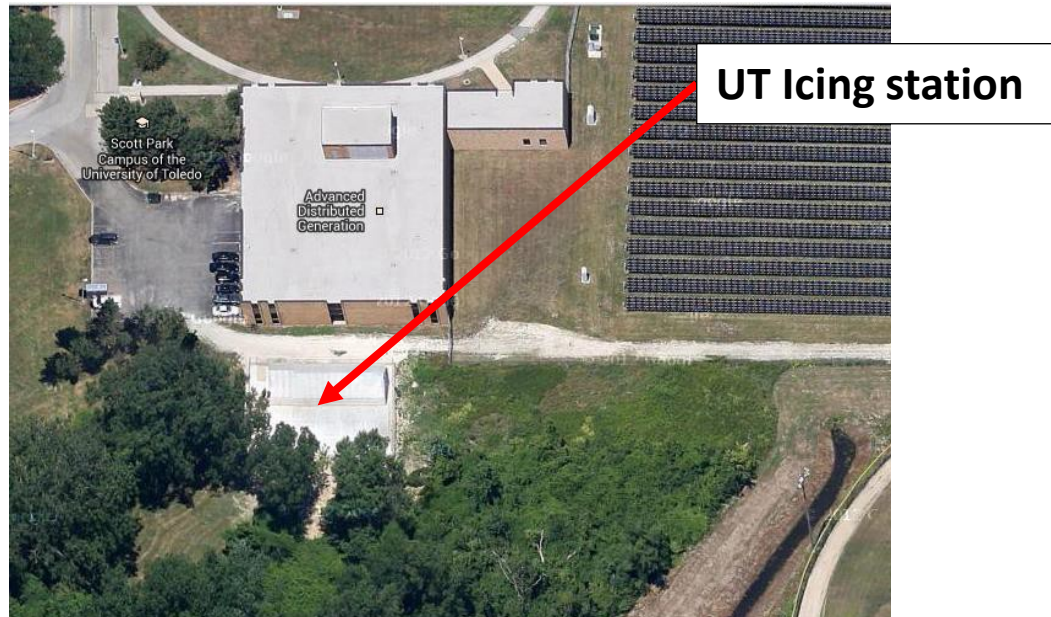
UT Icing experiment station

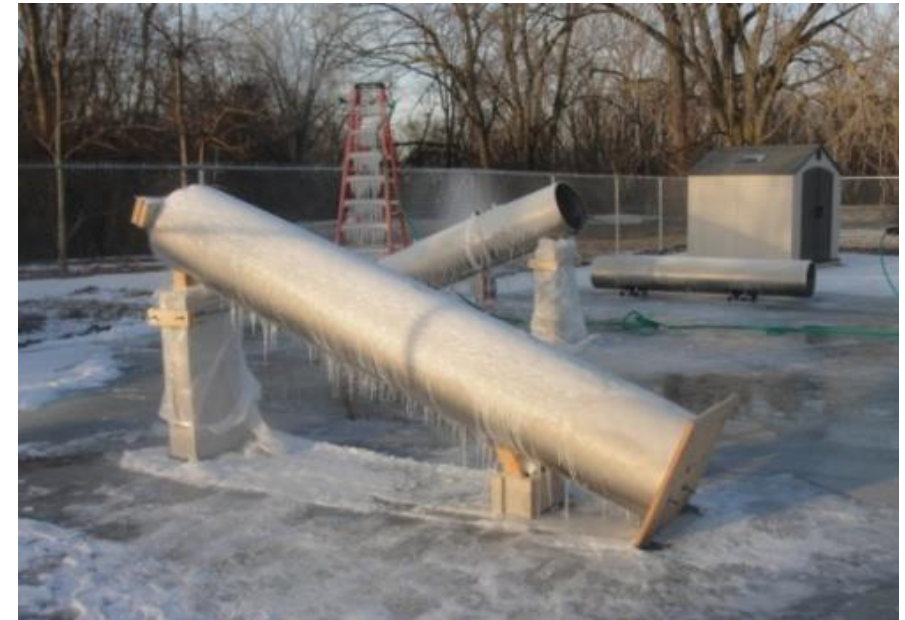
Three specimens with different orientations

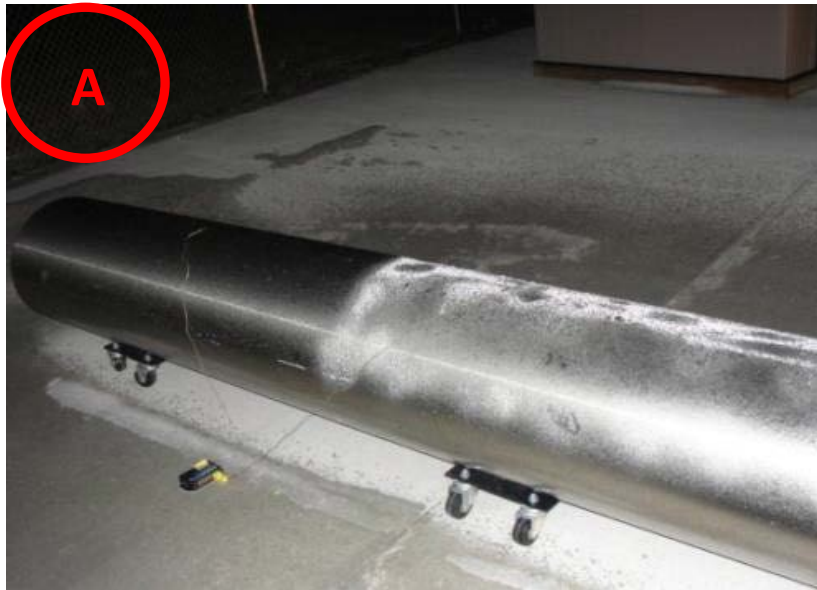
**Aliphatic petroleum distillates
with proprietary additives sprayed
on half of the specimen**

Aliphatic petroleum distillates with proprietary additives was selected

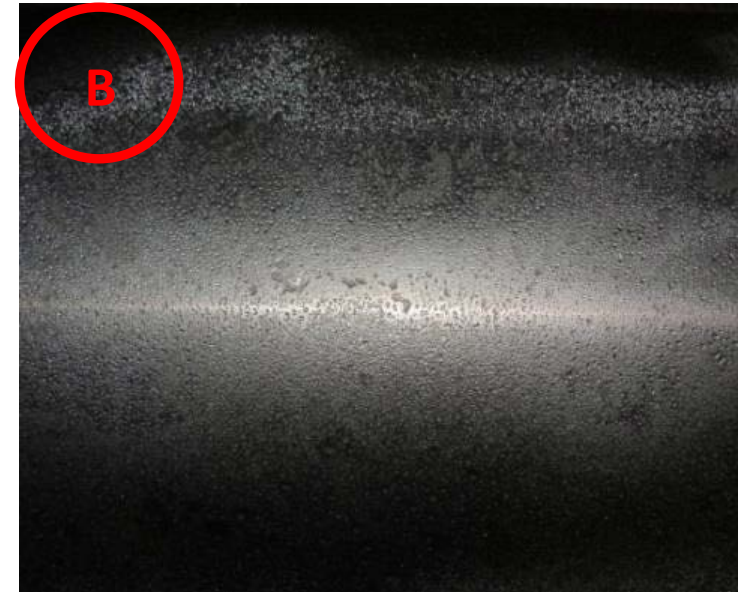
**Water droplets due to
icephobic coating**

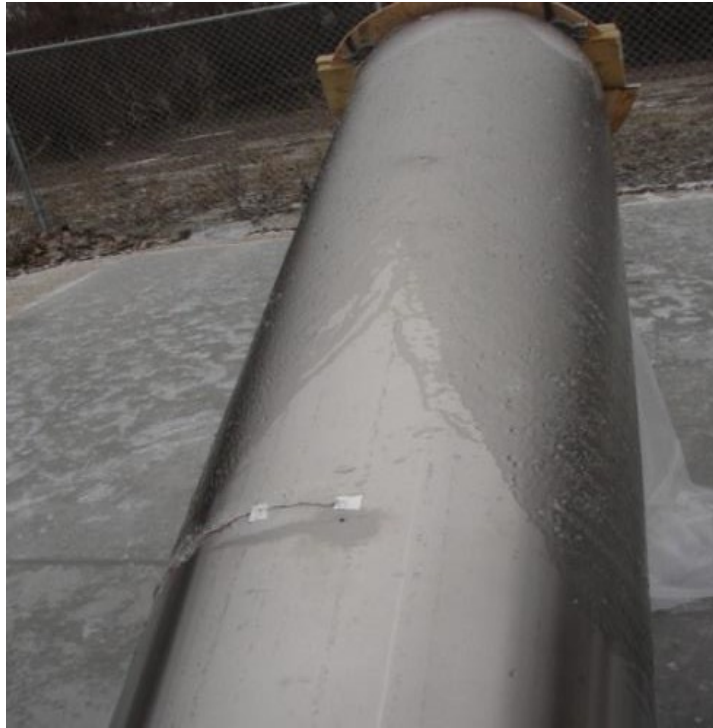
De-icing pattern in thermal test

- VGCS stays are hollow with the structural elements occupying 50% of the internal volume
- Internal heating experiments were conducted with 70,000 BTU forced air as a heat source
- Tried as de-icing and as anti-icing technique

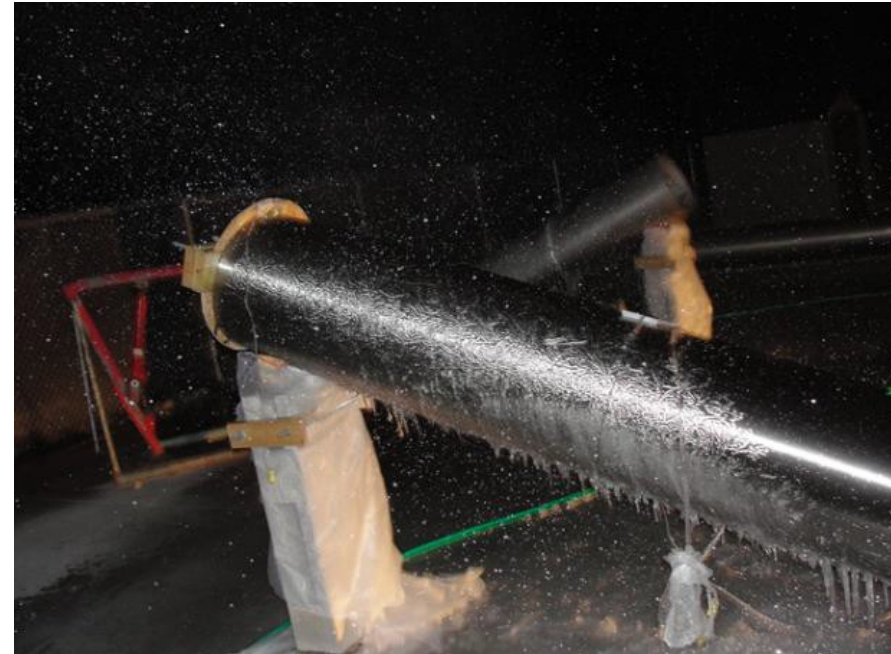
Accumulated ice in anti-icing thermal test

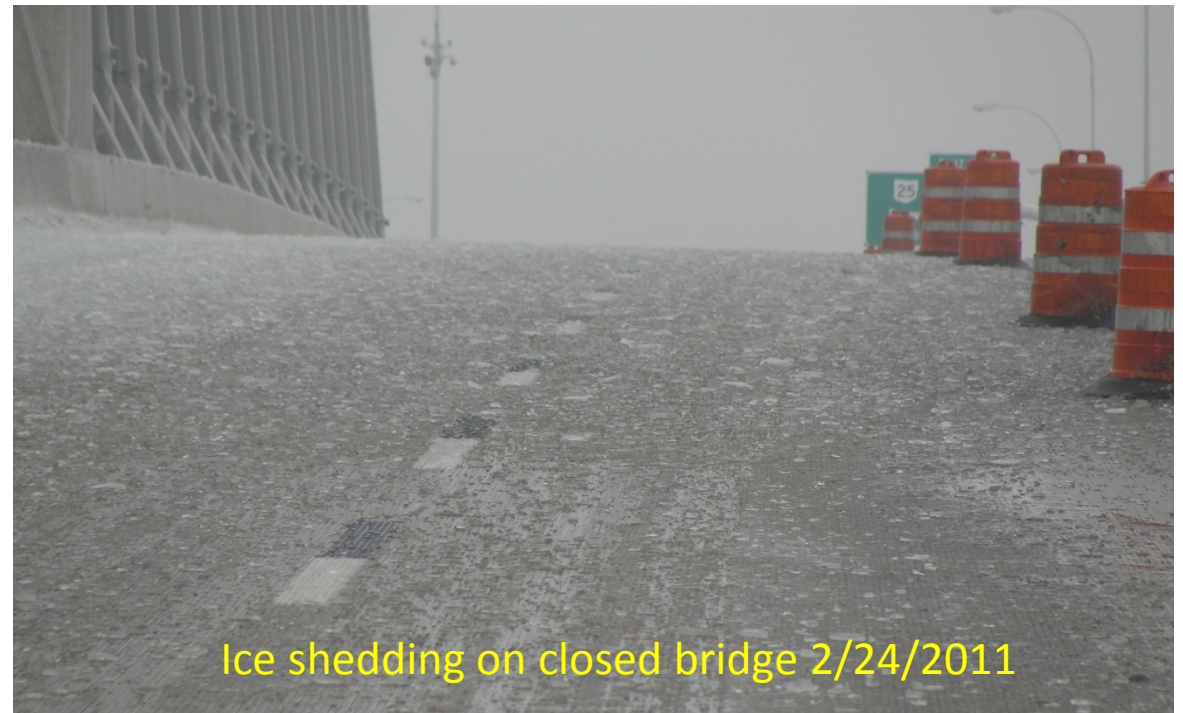
Ice shedding on closed bridge 2/24/2011
