WINDFARM MOSCHKOGEL IN THE AUSTRIAN ALPS

Andreas Krenn/ energiewerkstatt°

CURRENT STATE OF WIND POWER IN AUSTRIA TECHNICAL DATA OF WIND FARM MOSCHKOGEL ENERCON BLADE HEATING SYSTEM

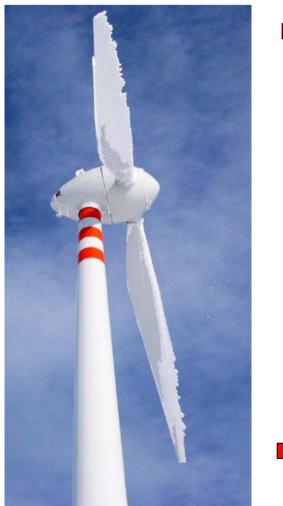
Ice or no Ice?

Enercon Ice Detection System

Power Curve Method

Based on the sensitivity of rotor blade profiles against change in contour and roughness.

The resulting significant change in a WEC's operating performance is used to detect ice build-up (interrelation of wind / rotational speed / power / blade angle).
