ROTOR BLADE REPAIRS IN WINTER CONDITIONS

BLADEFENCE OY - VILLE KARKKOLAINEN

WINTERWIND 2015

CASE STUDY

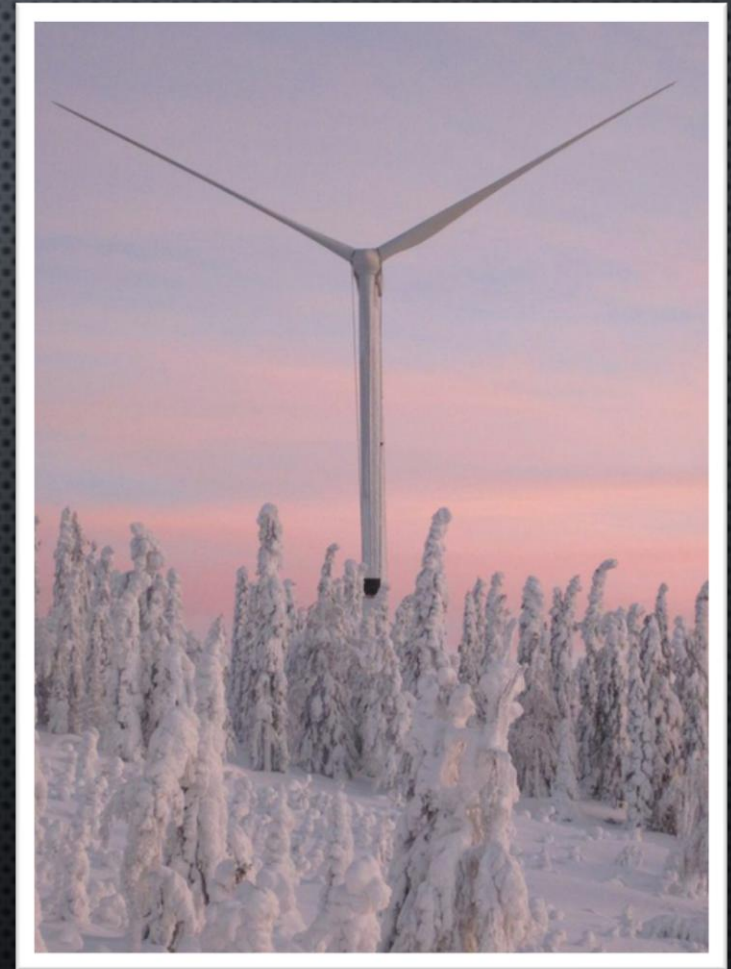
- CUSTOMER: JÄMTKRAFT
- SITE: HORNBERGET
- TURBINE: VESTAS V90
- TIME: JANUARY 2014
- AVERAGE TEMPERATURE: -10 TO -25
- TYPE: SIGNIFICANT DELAMINATION OF APPROX. 2000MM * 300MM IN SIZE
- THE REPAIR ENABLED THE TURBINE TO RETURN FULL PRODUCTION MONTHS EARLIER THAN WHAT WOULD HAVE BEEN POSSIBLE OTHERWISE.

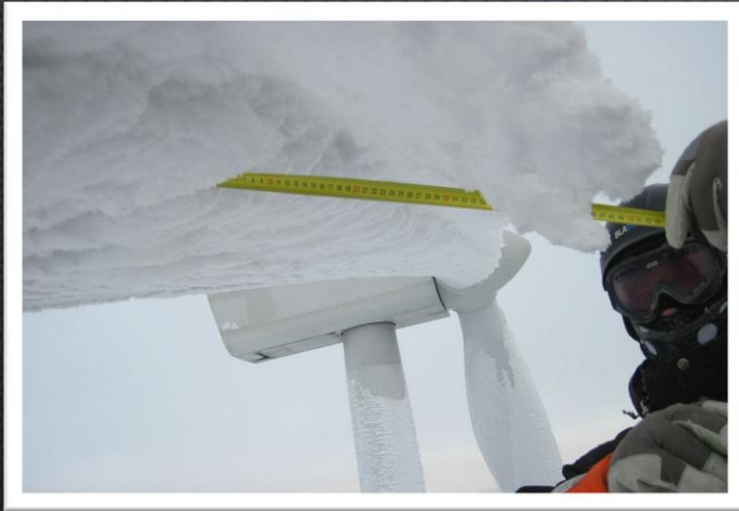
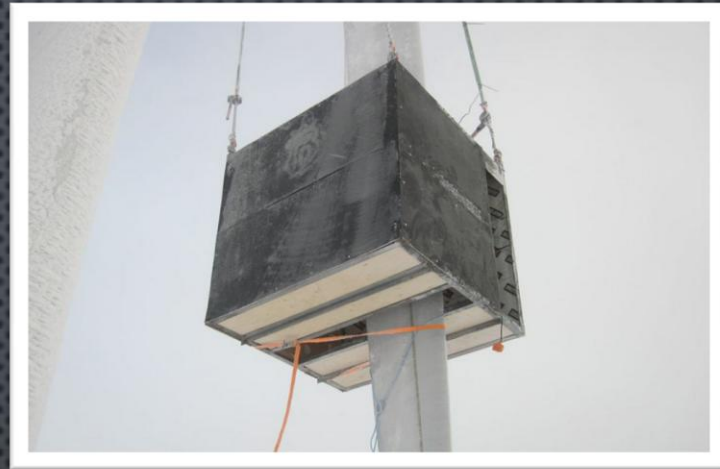
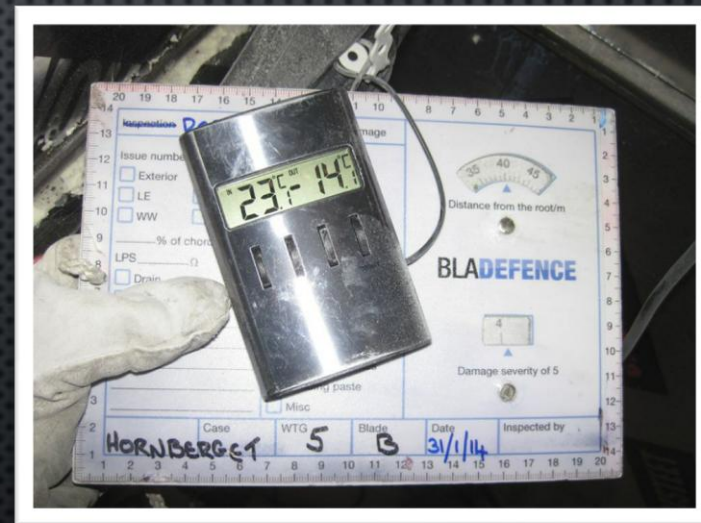
CREATING SUITABLE WORK ENVIRONMENT WITH BLADE
REPAIR MODULE

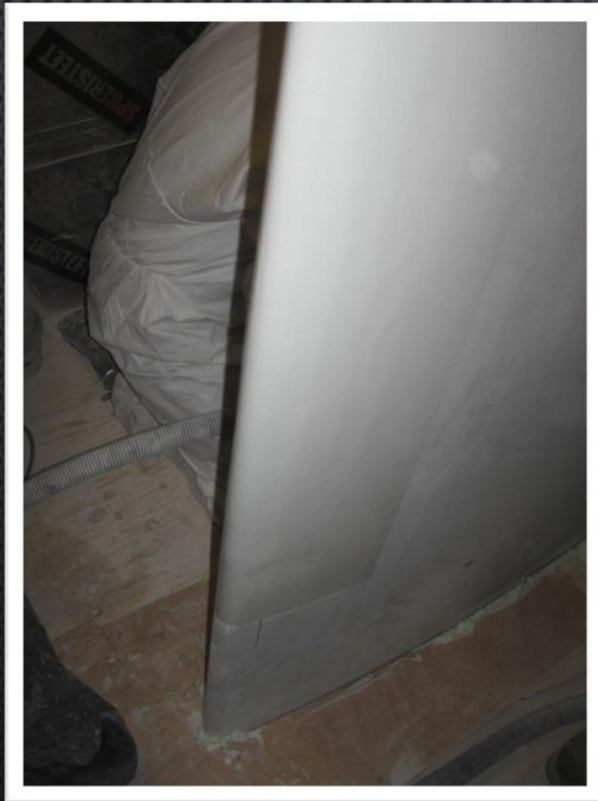
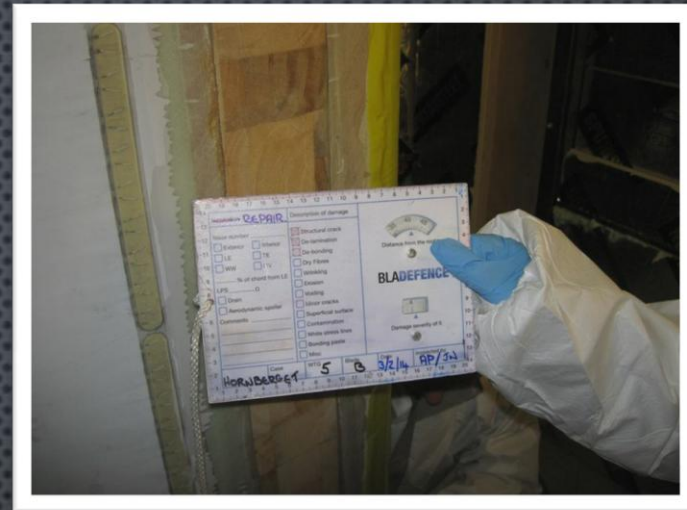
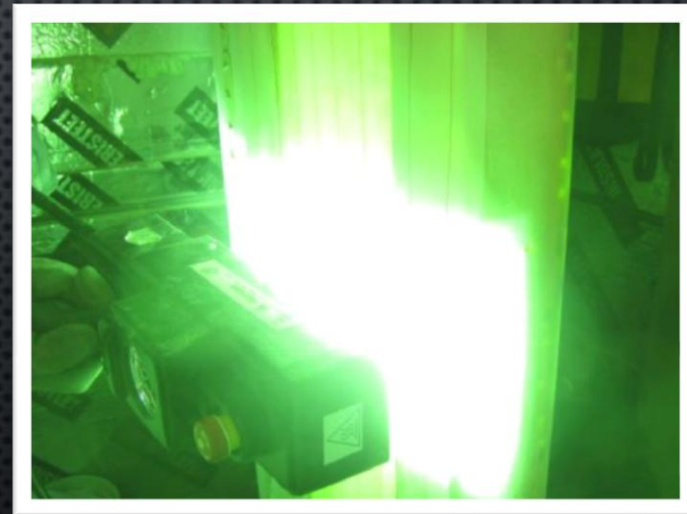
REPAIRING THE DAMAGE IN NEAR FACTORY CONDITIONS
