> Nordex Anti-Icing System on N131

Konrad Sachse
7th February 2017

- 1 Anti-Icing System - Features
- 2 Development of N131 with AIS
- 3 Validation of design and functionality
- 4 Field experience and yield improvement

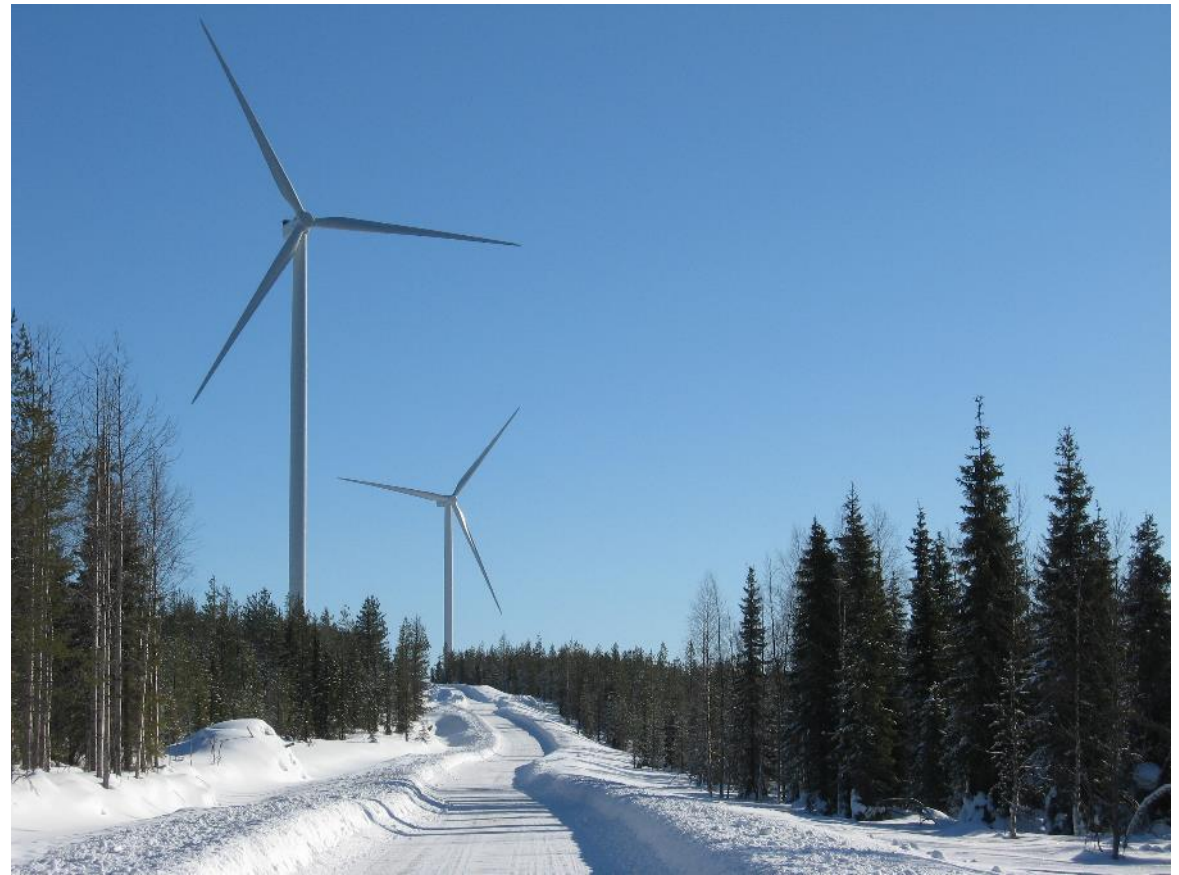
Key features of the Nordex Anti-Icing System (AIS)

Heating element:

- Electrical resistance heater
- Carbon fiber reinforced plastics
- Aerodynamically relevant surfaces

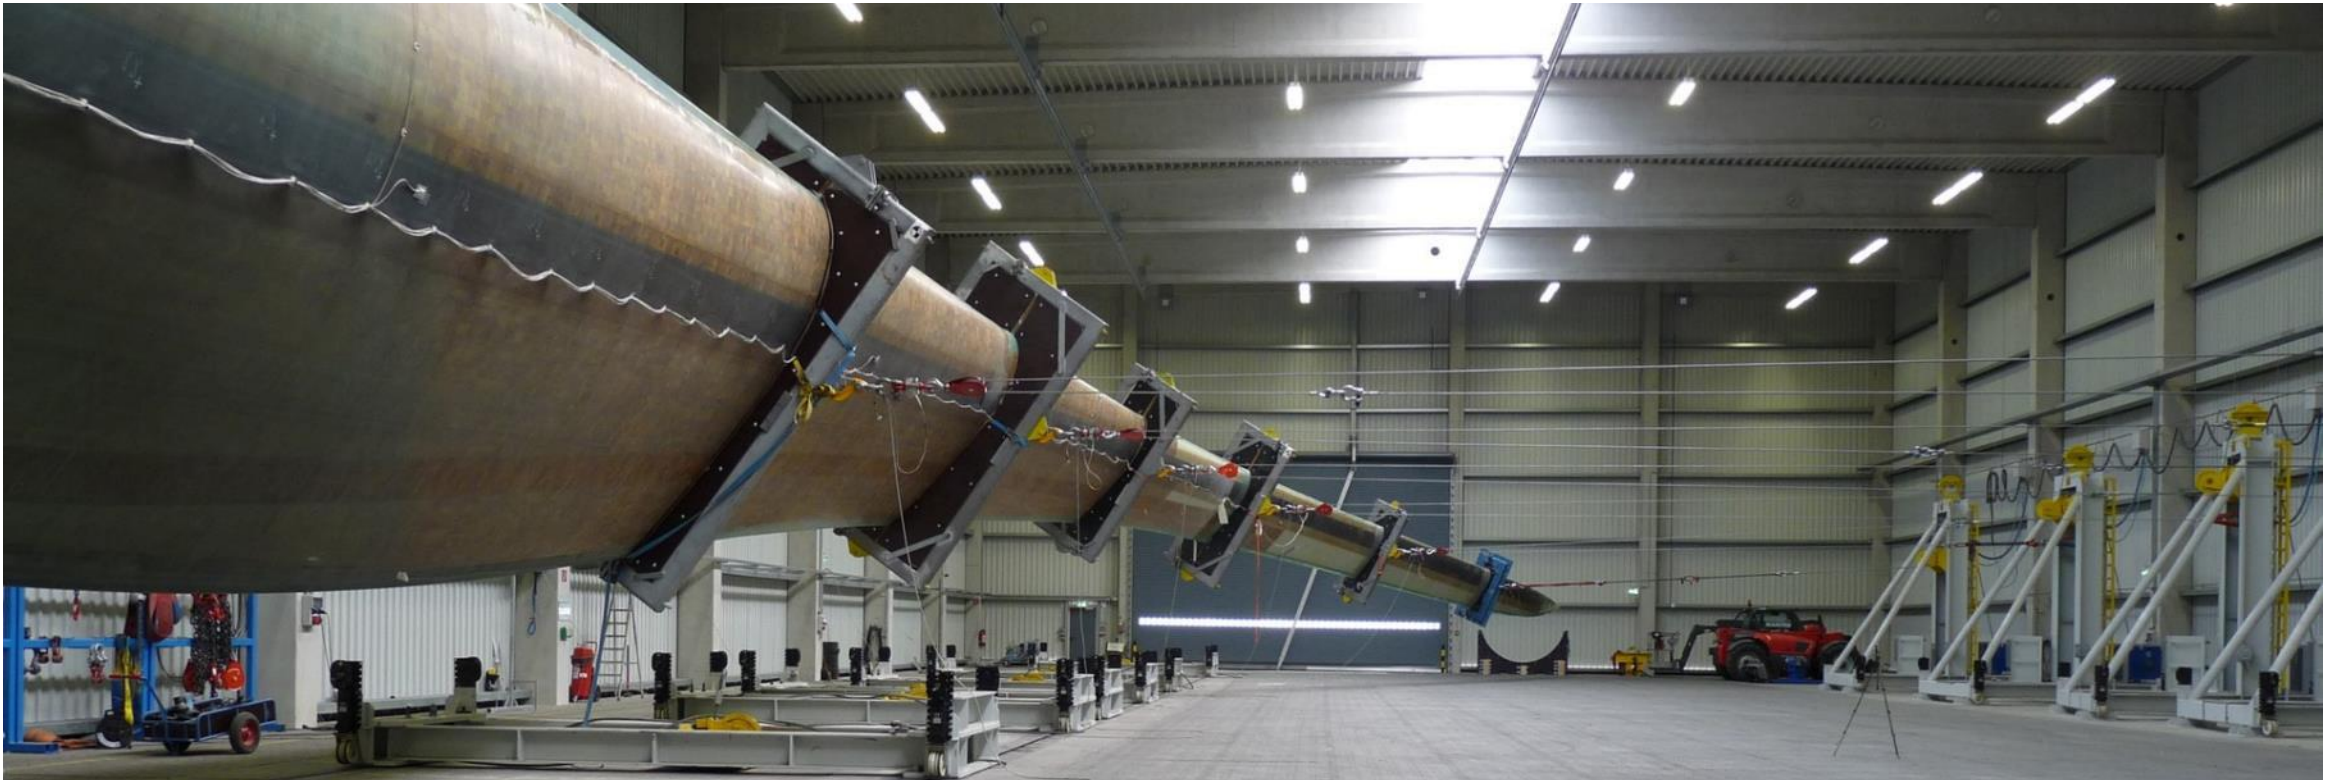
Validation – Structural design

NR65.5 blade is fully tested in static and dynamic tests applying all additional loads for the AIS

- Dynamic flapwise: 2.5 million cycles ✓
- Dynamic edgewise: 7.5 million cycles ✓
- Static ✓
- Heating element ✓

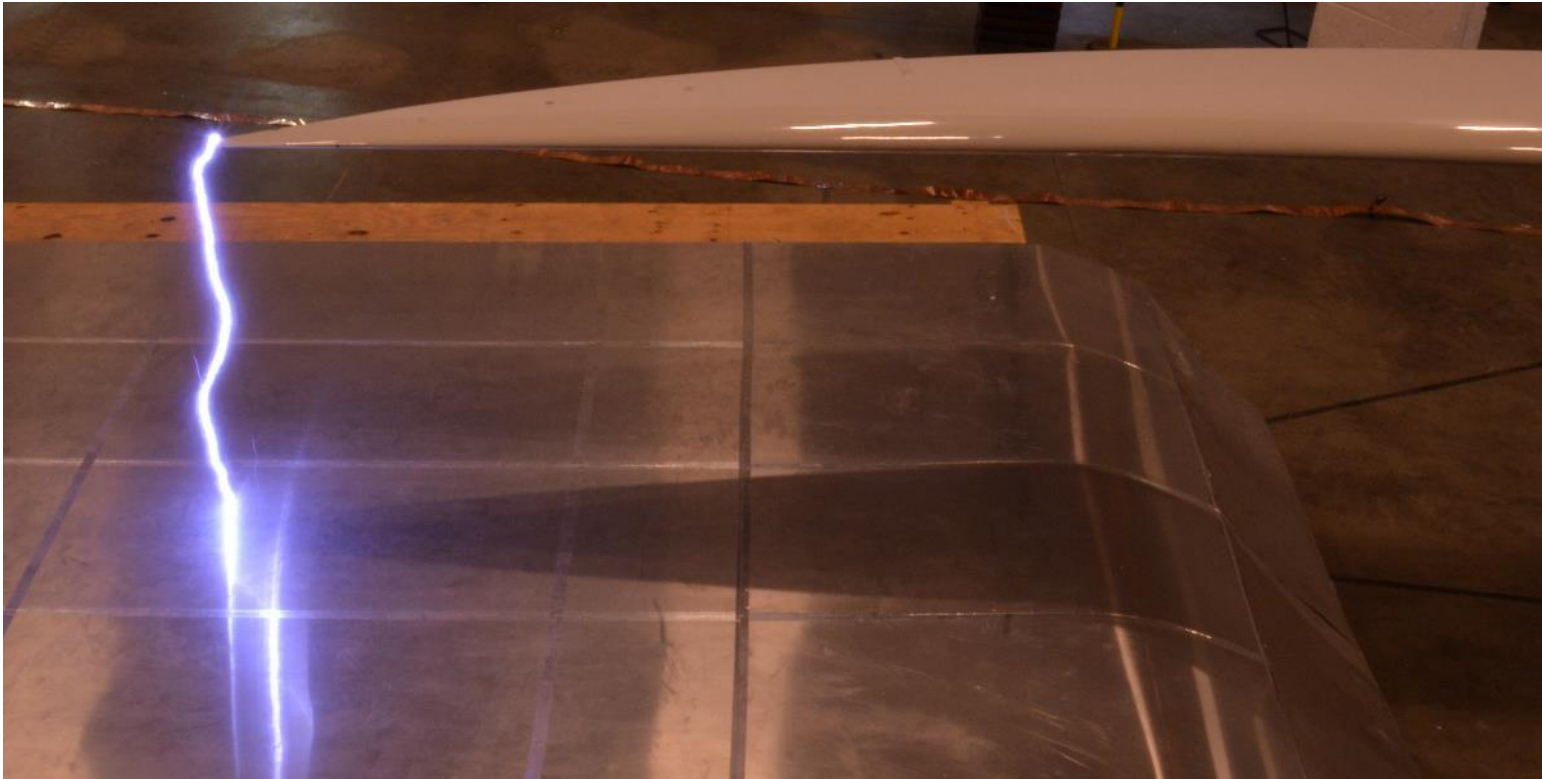
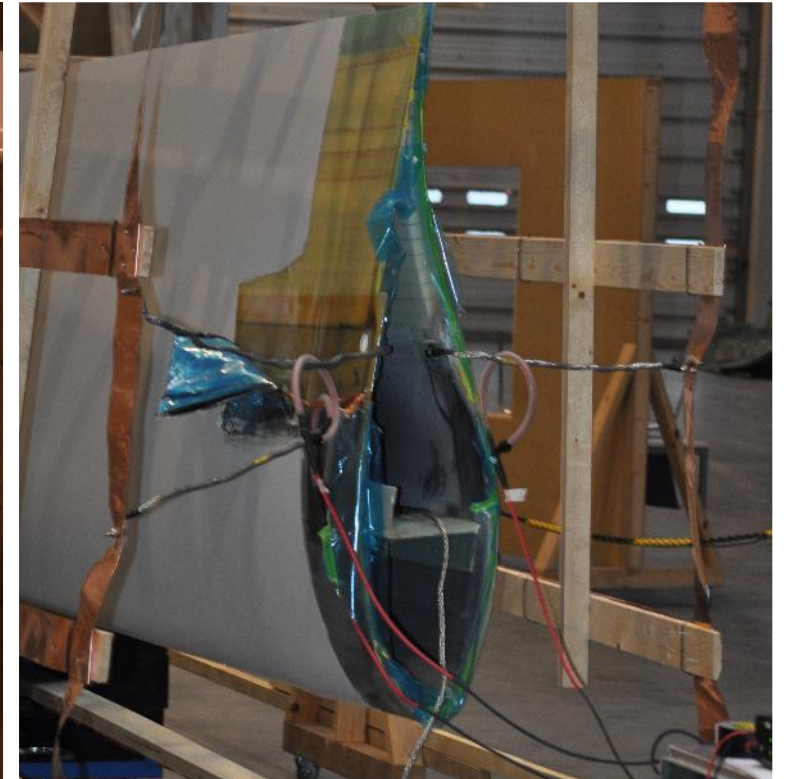
> Validation – Lightning protection system

NR65.5 lightning protection system is fully tested by third party

- Initial leader attachment test ✓
- High current coupon tests ✓

- Current distribution test ✓

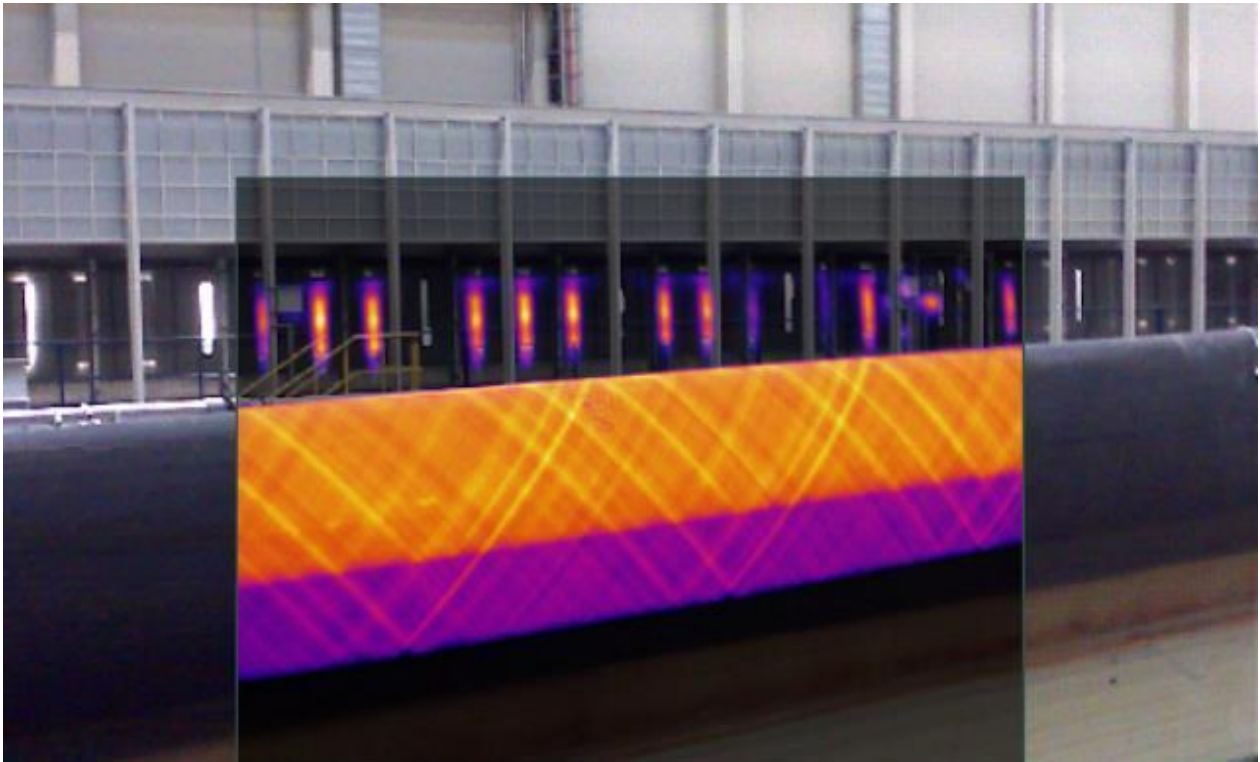
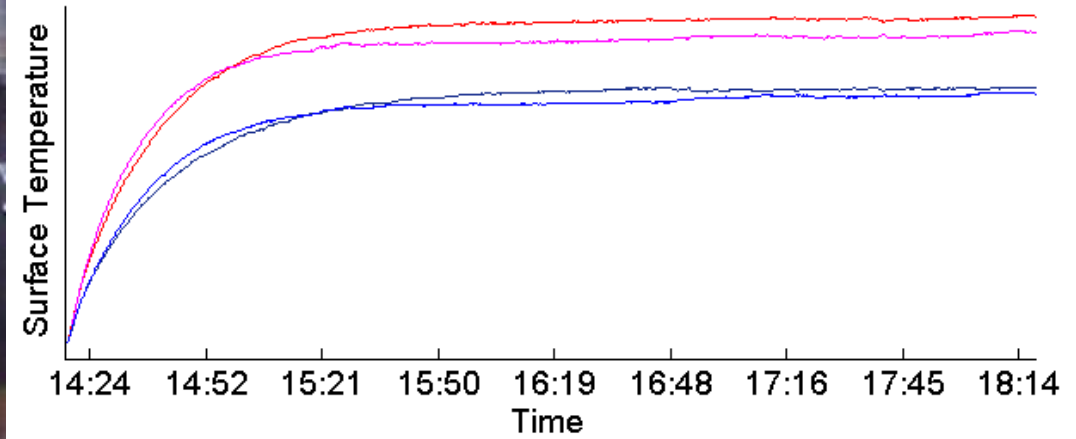
Validation – Anti-Icing System (AIS)

Every single blade of NR65.5 Anti-Icing System is fully tested inhouse

- Resistance and insulation test ✓
- Heating cycles ✓
- Final acceptance test ✓
- Inspection for Hot Spots ✓
- Overheat protection test ✓
- Long time heating test ✓

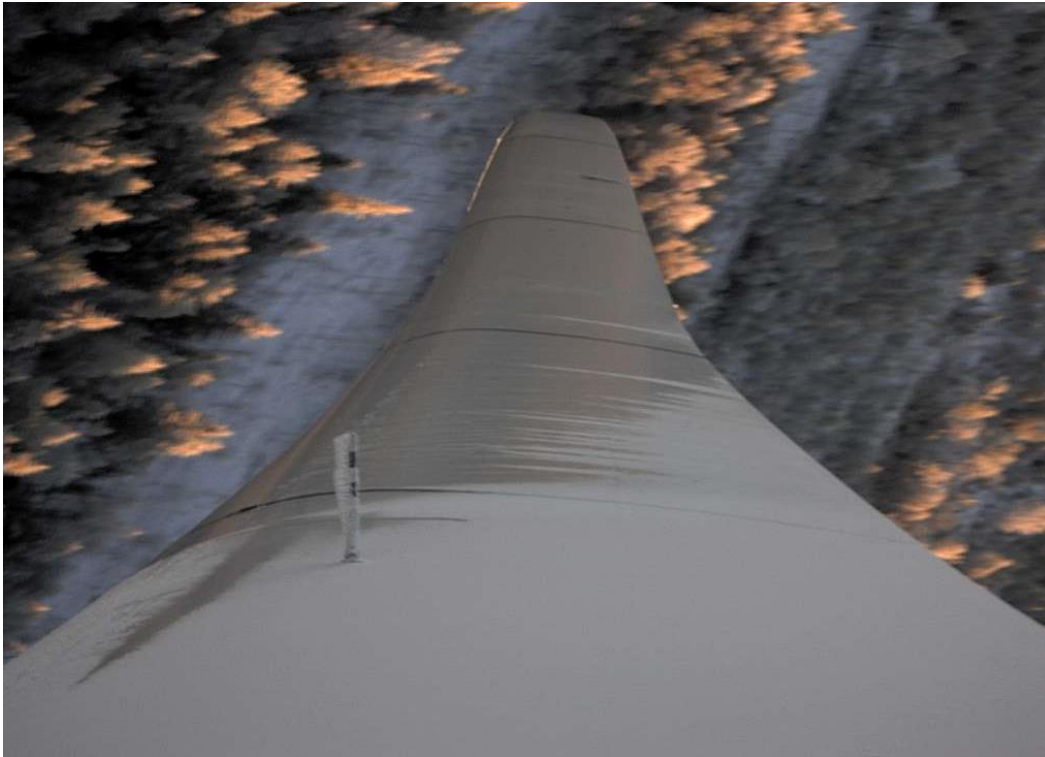
Field validation – NR65.5 Anti-Icing System (AIS)

Specially equipped prototype turbines in Finland

- Cameras on blades
- Ice thickness measurement device
- Additional ice detectors

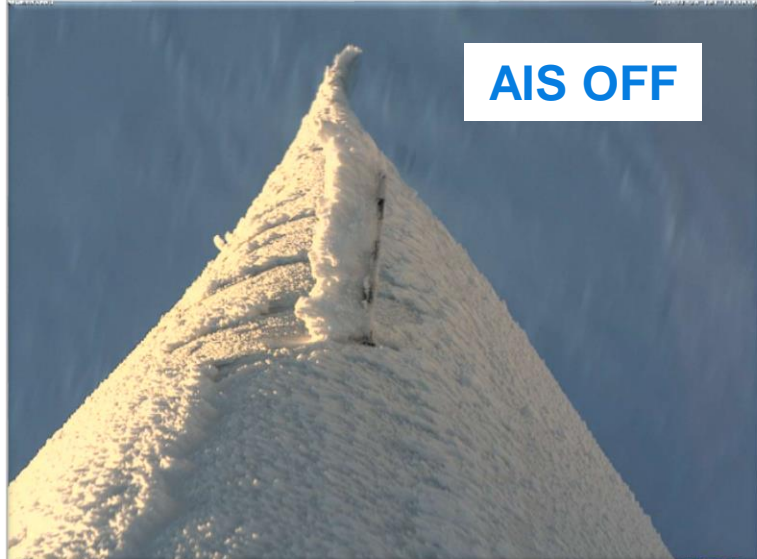
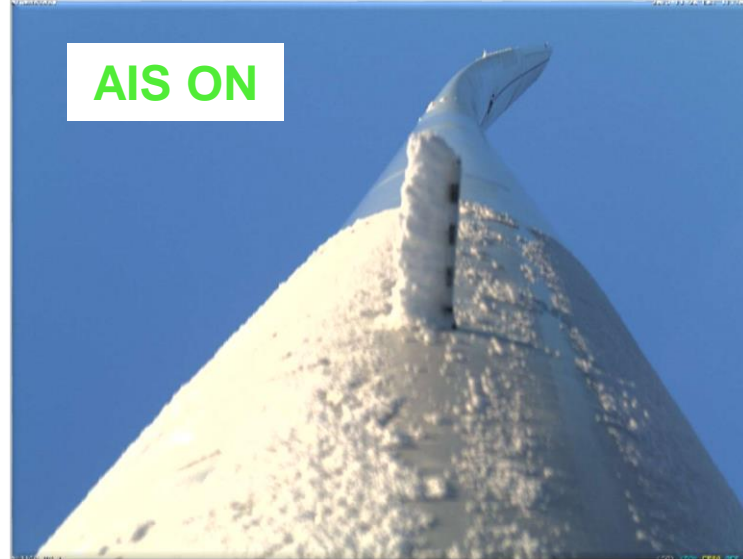
Field validation – Example of production gain in Lapland

- Winter 2015/2016
- N117, Sweden

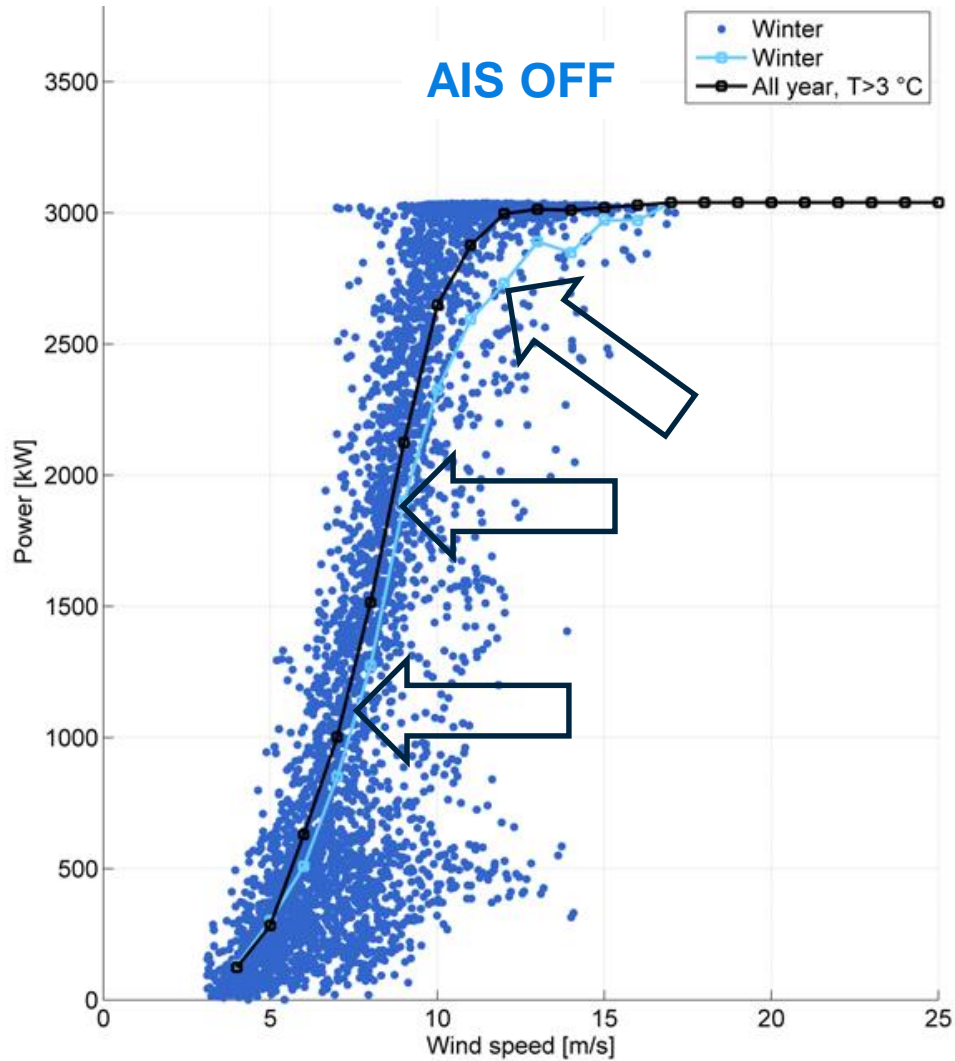
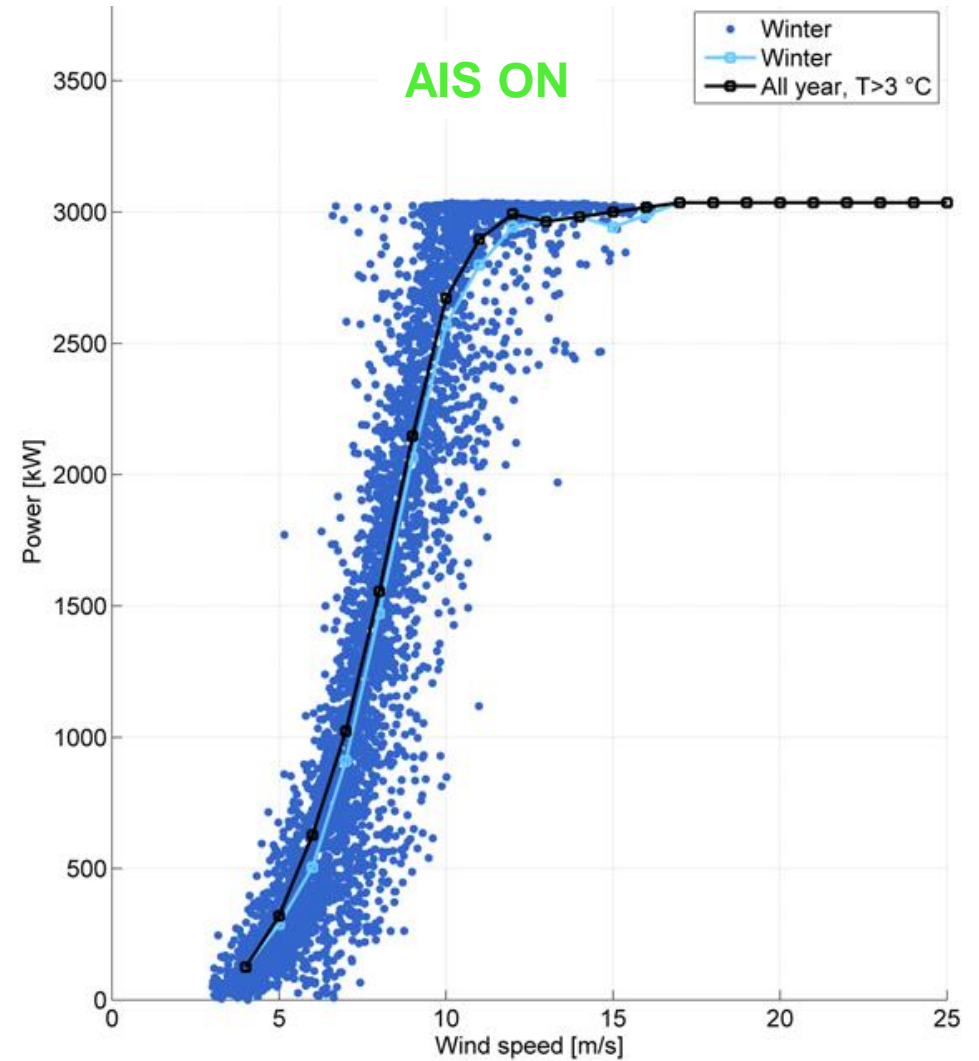
Power curves reflect the yield improvement due to Anti-Icing System (AIS)

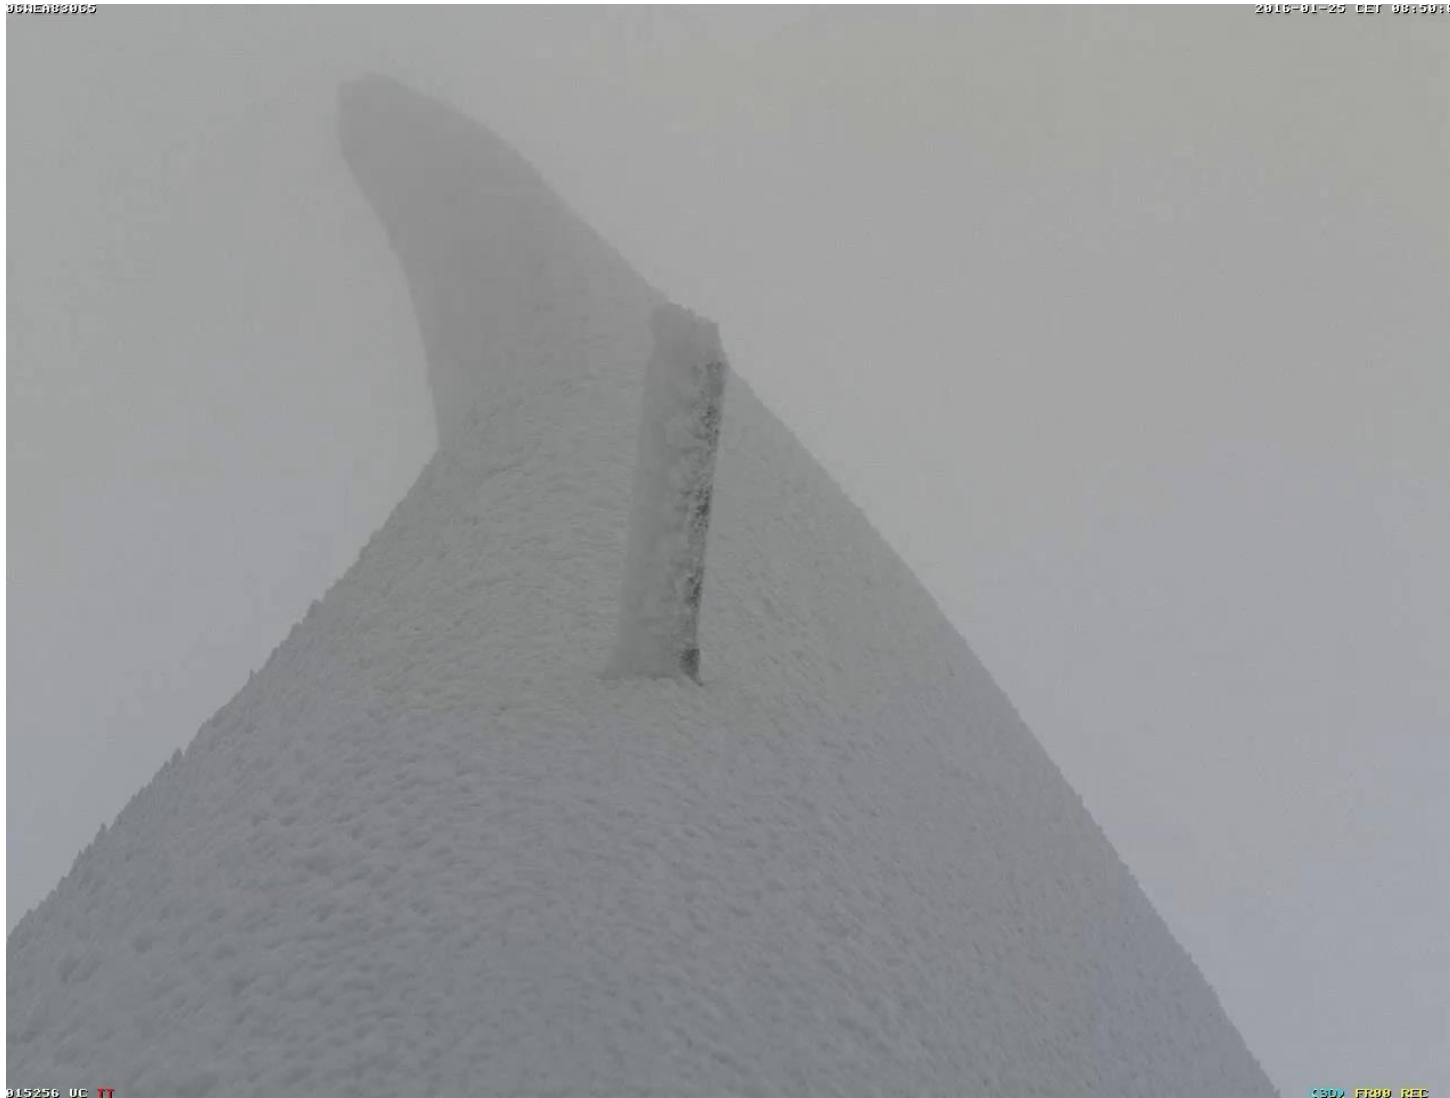
Field validation – De-Icing

Nordex Anti-Icing System (AIS) can also do De-Icing

- AIS switched off intentionally
- Turbine stopped due to icing
- Very fast De-Icing of the leading edge (\approx 20 min.)
- Turbine back in operation

- Winter 2015/2016
- N117, Sweden
- Temperature: -8 °C
- Wind speed: 6 m/s
