RETROFITTING THE WICETEC ICE PROTECTION SYSTEM : OUR EXPERIENCE

February 2018
Winterwind

Retrofitting Wicetec solution

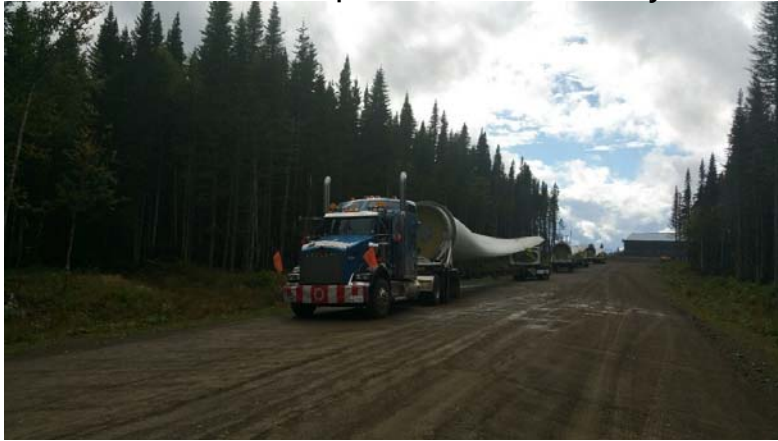
Lift down and transportation to facility

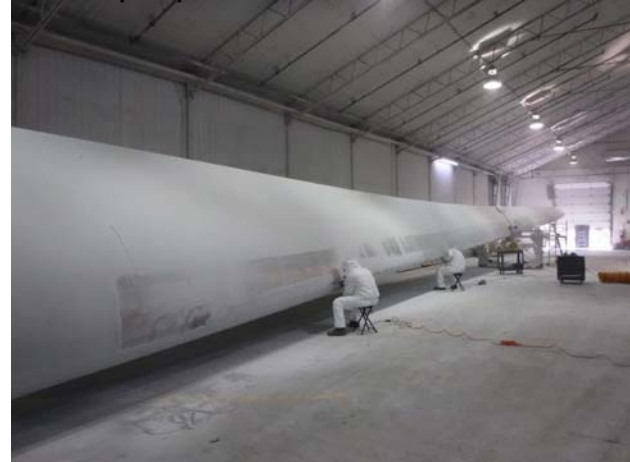
Blade preparation

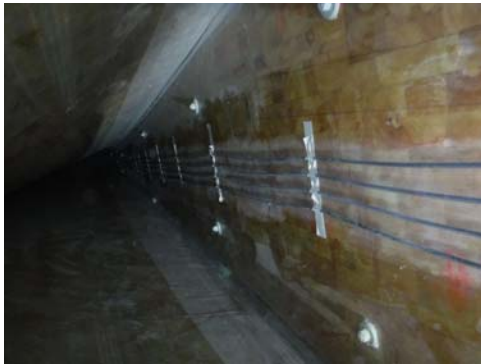
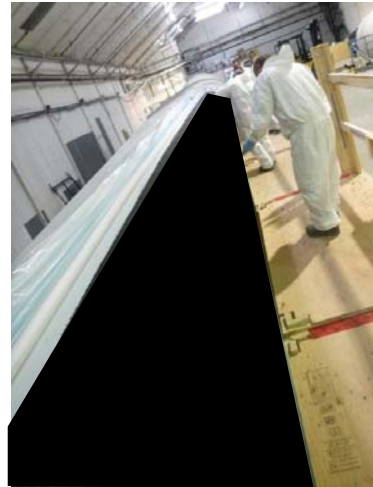
Cables and heating mat installation

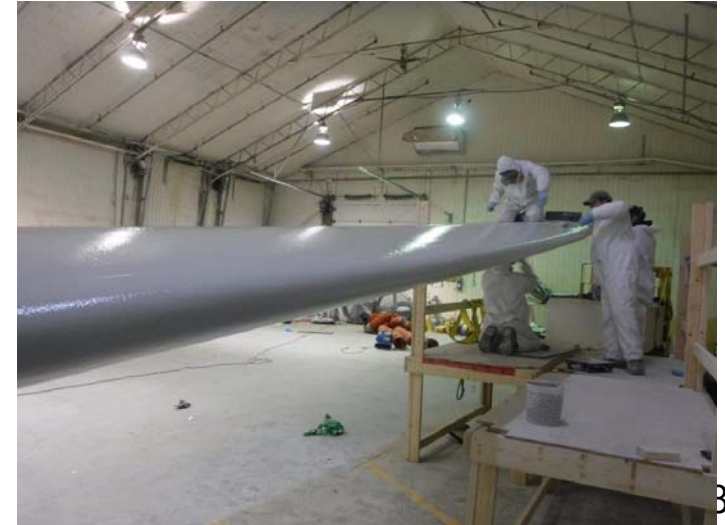
Refinish the blades

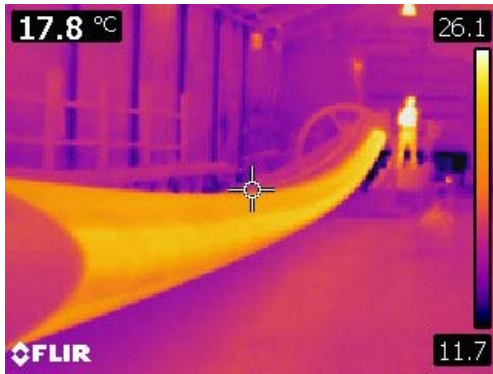
Test the system at the plant

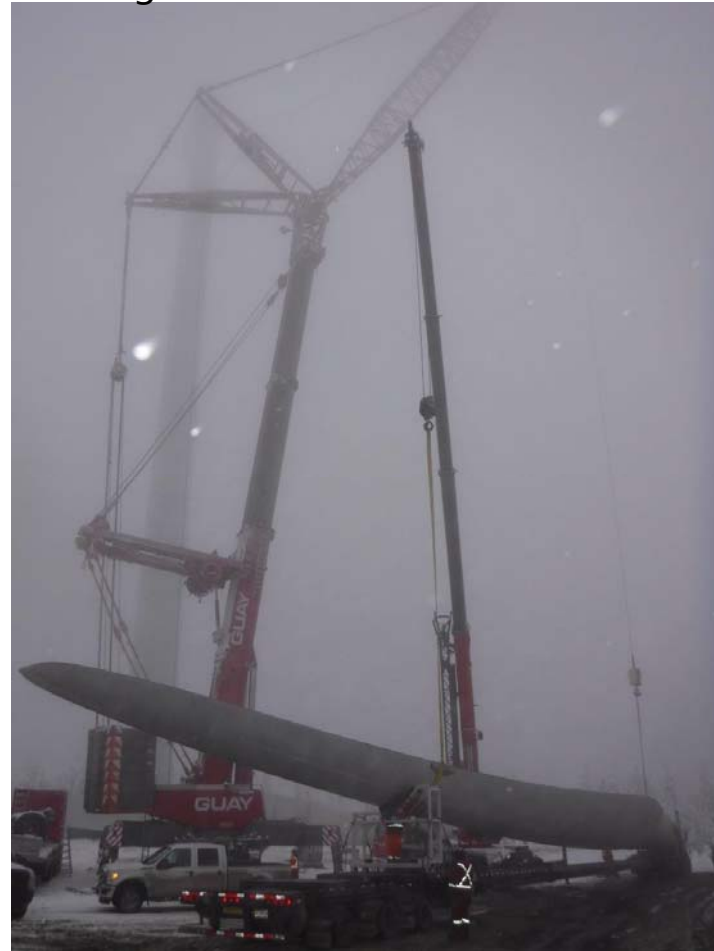
Relifting the blades

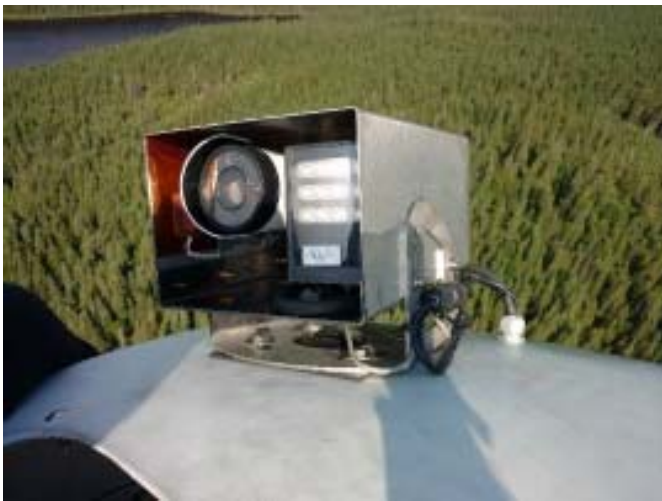
Sensors and cameras
