Borealis Wind

Hot Air Blade De-icing Retrofit – Field Test Results

Winterwind 2019

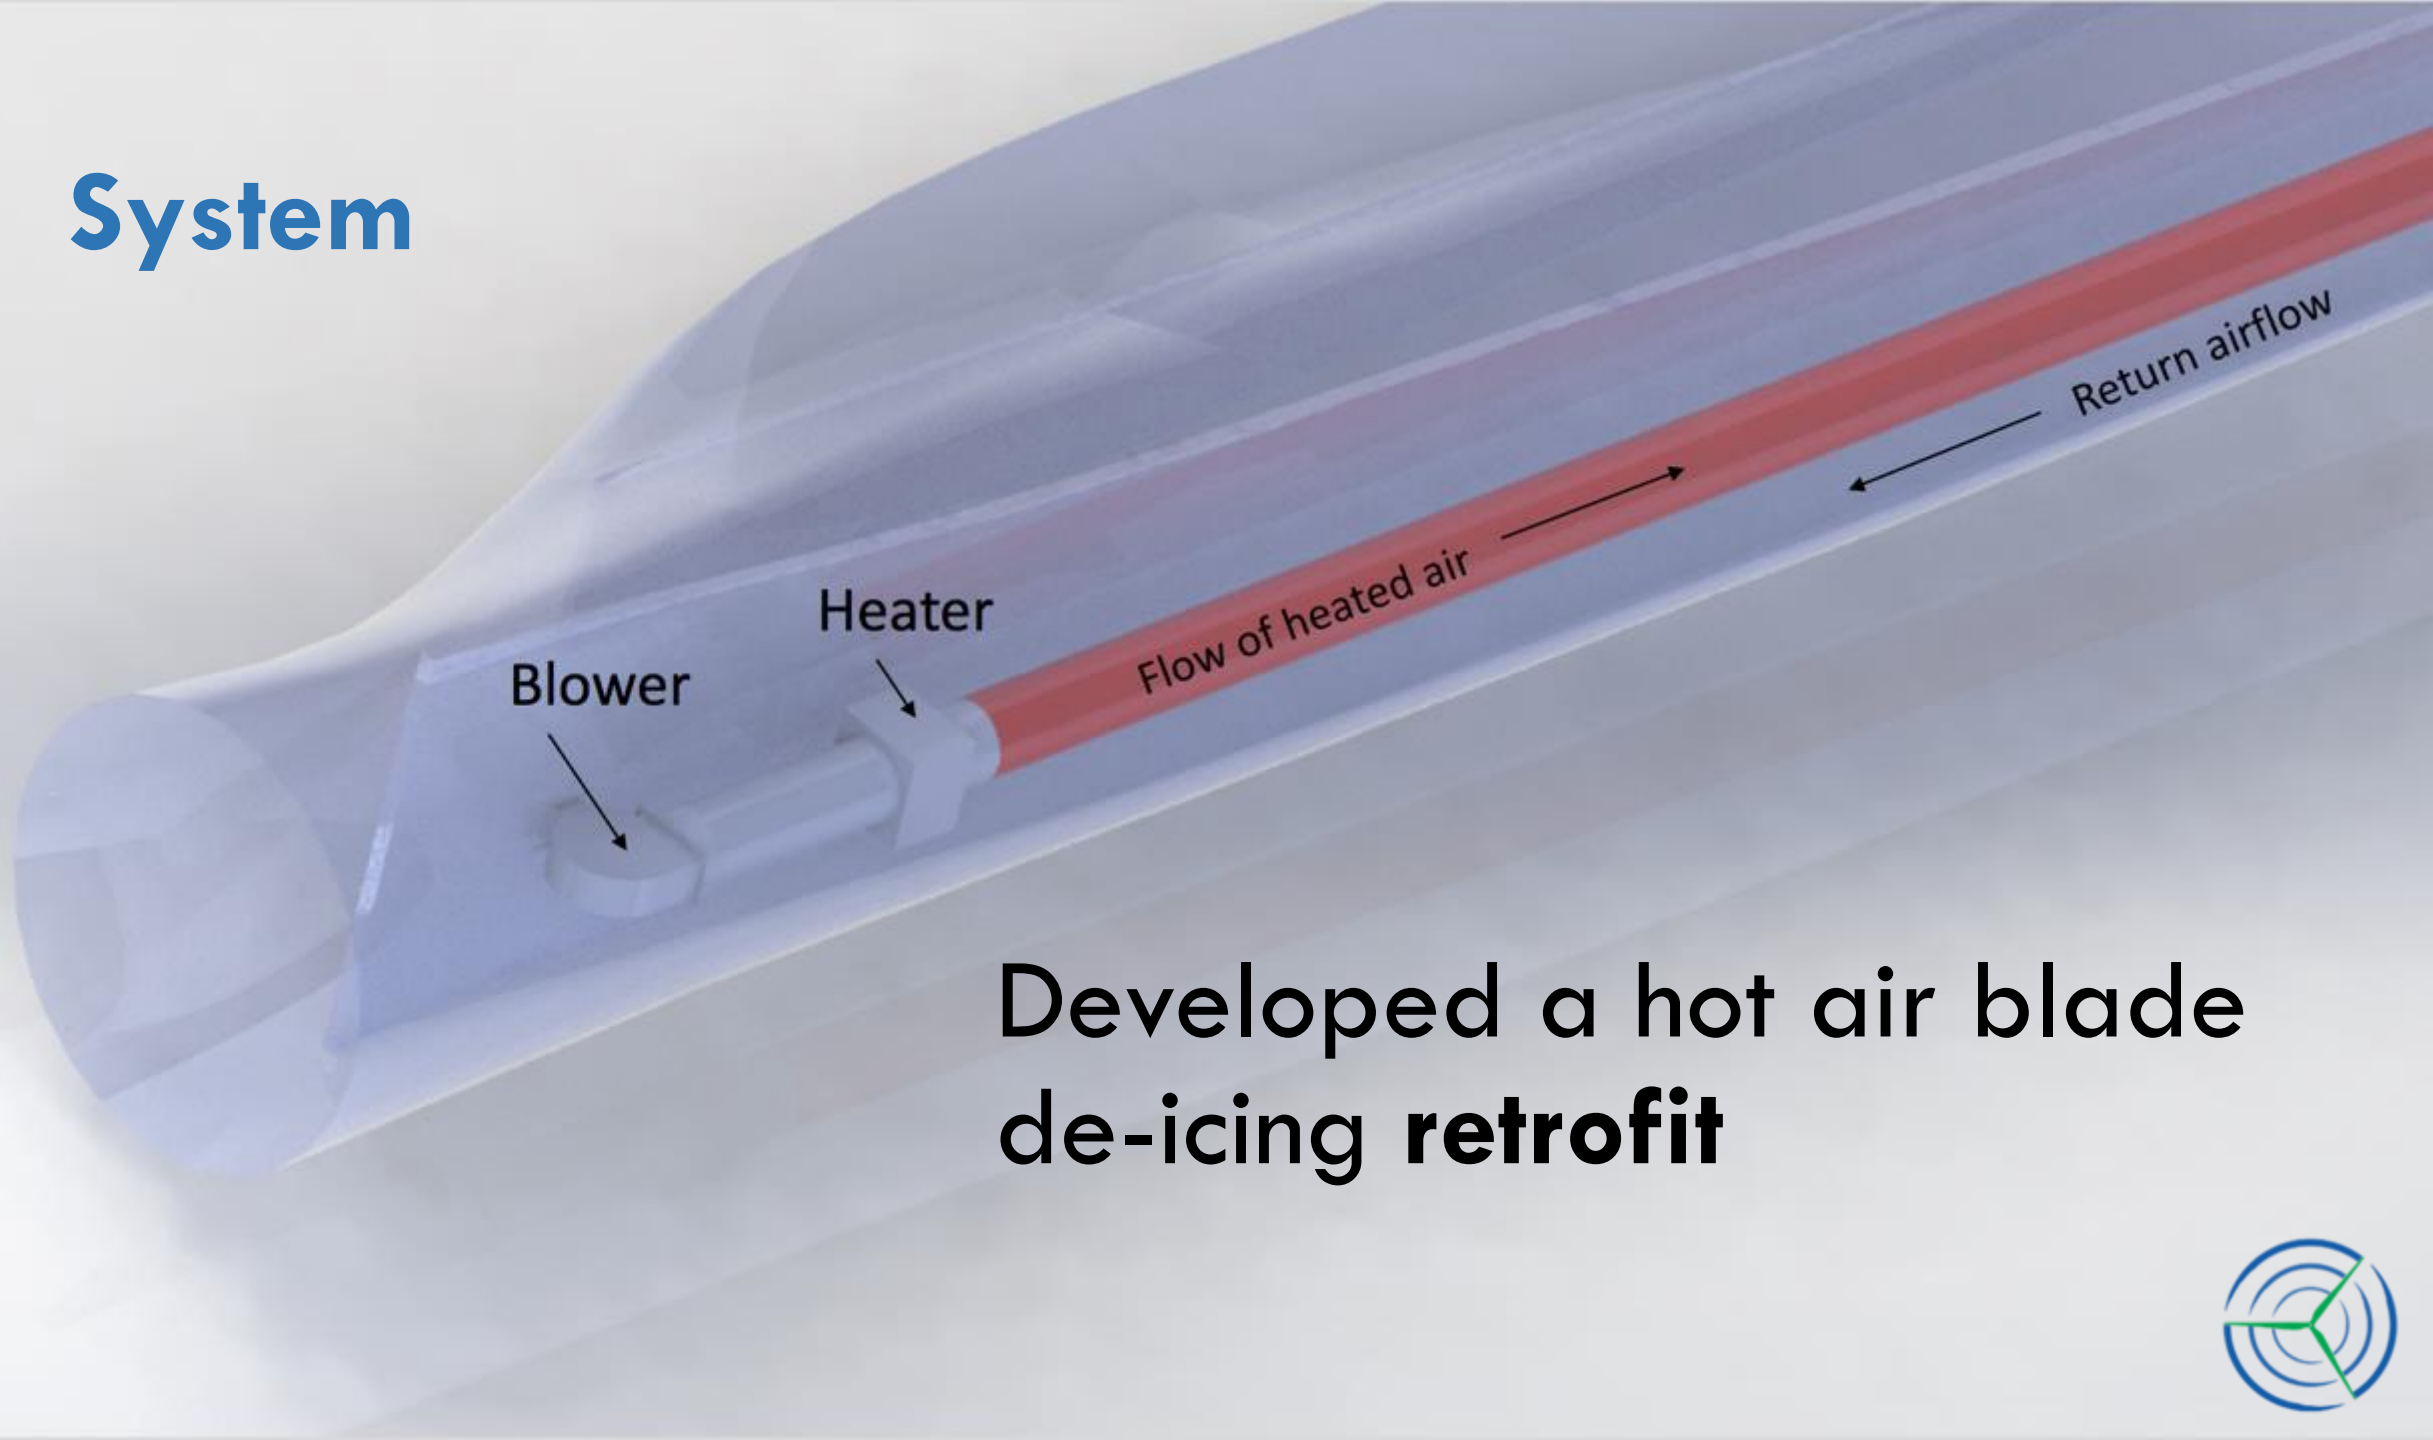
System

Developed a hot air blade de-icing **retrofit**

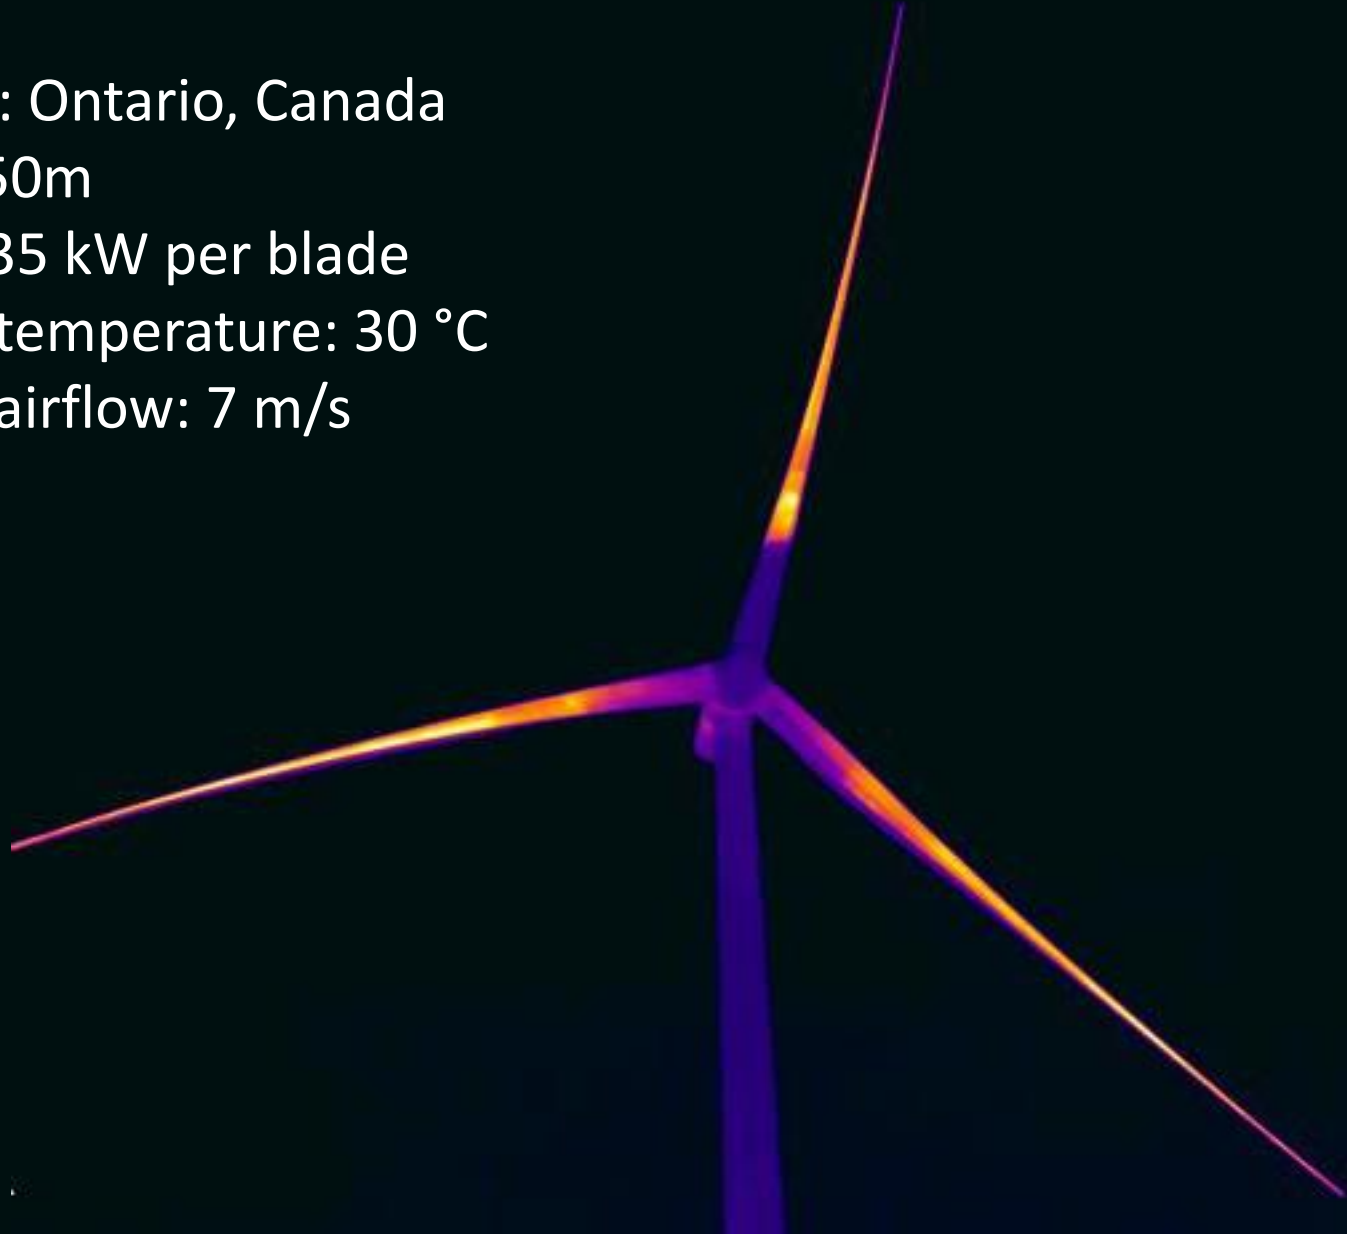
Field Test Results

Location: Ontario, Canada

Blades: 50m

Heater: 35 kW per blade

Internal temperature: 30 °C

Internal airflow: 7 m/s

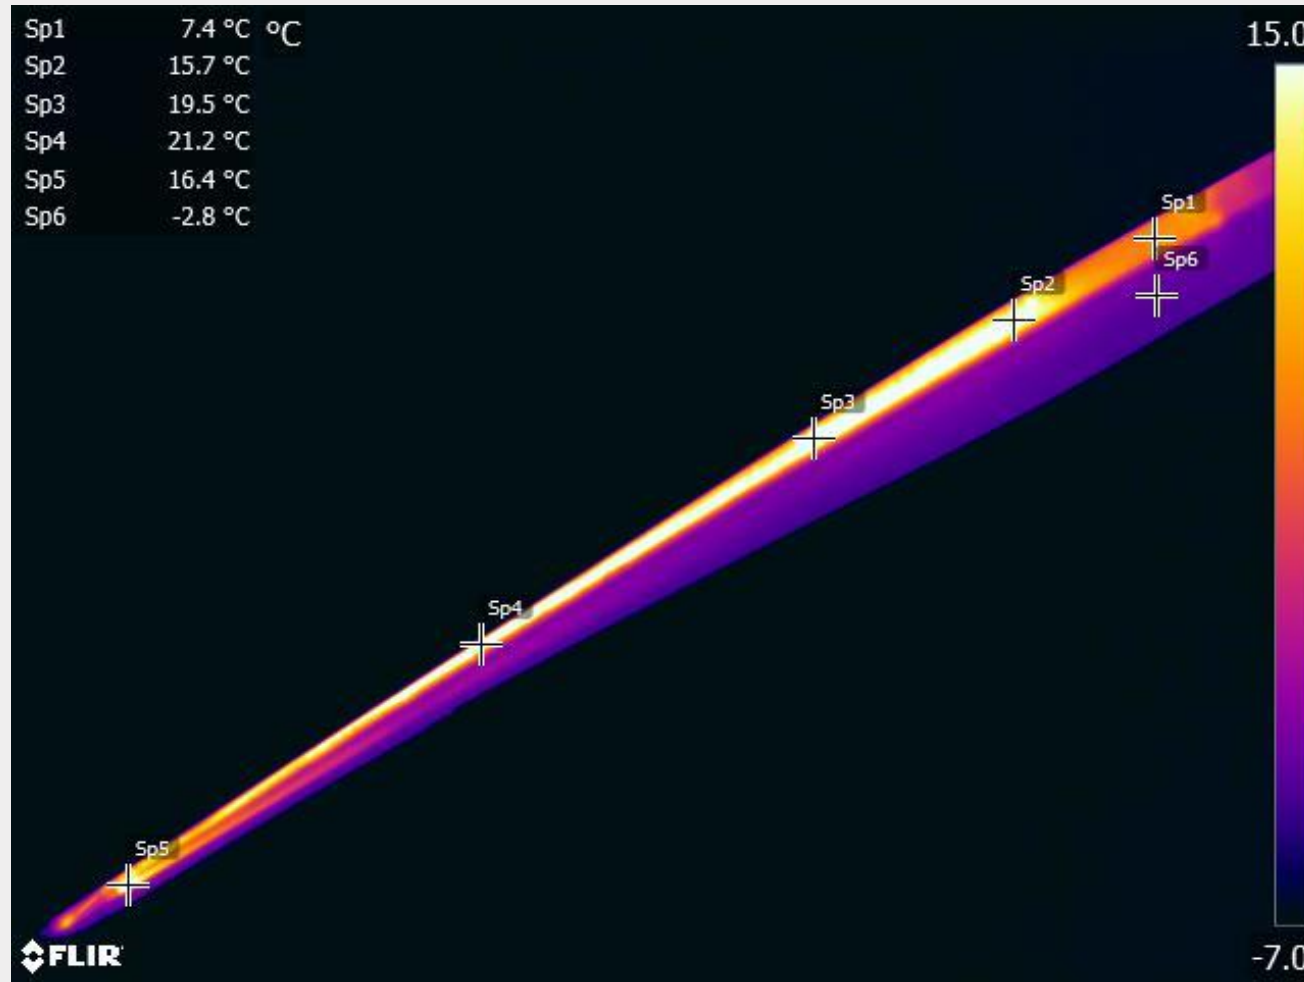
Modelled	Measured
Ambient Temperature (°C)	-2	-2
Wind Speed (m/s)	2.2	1.2 to 3.2
Blade Surface Temperature (°C)	14.5 to 20.0	15.7 to 21.2 (+/-2)

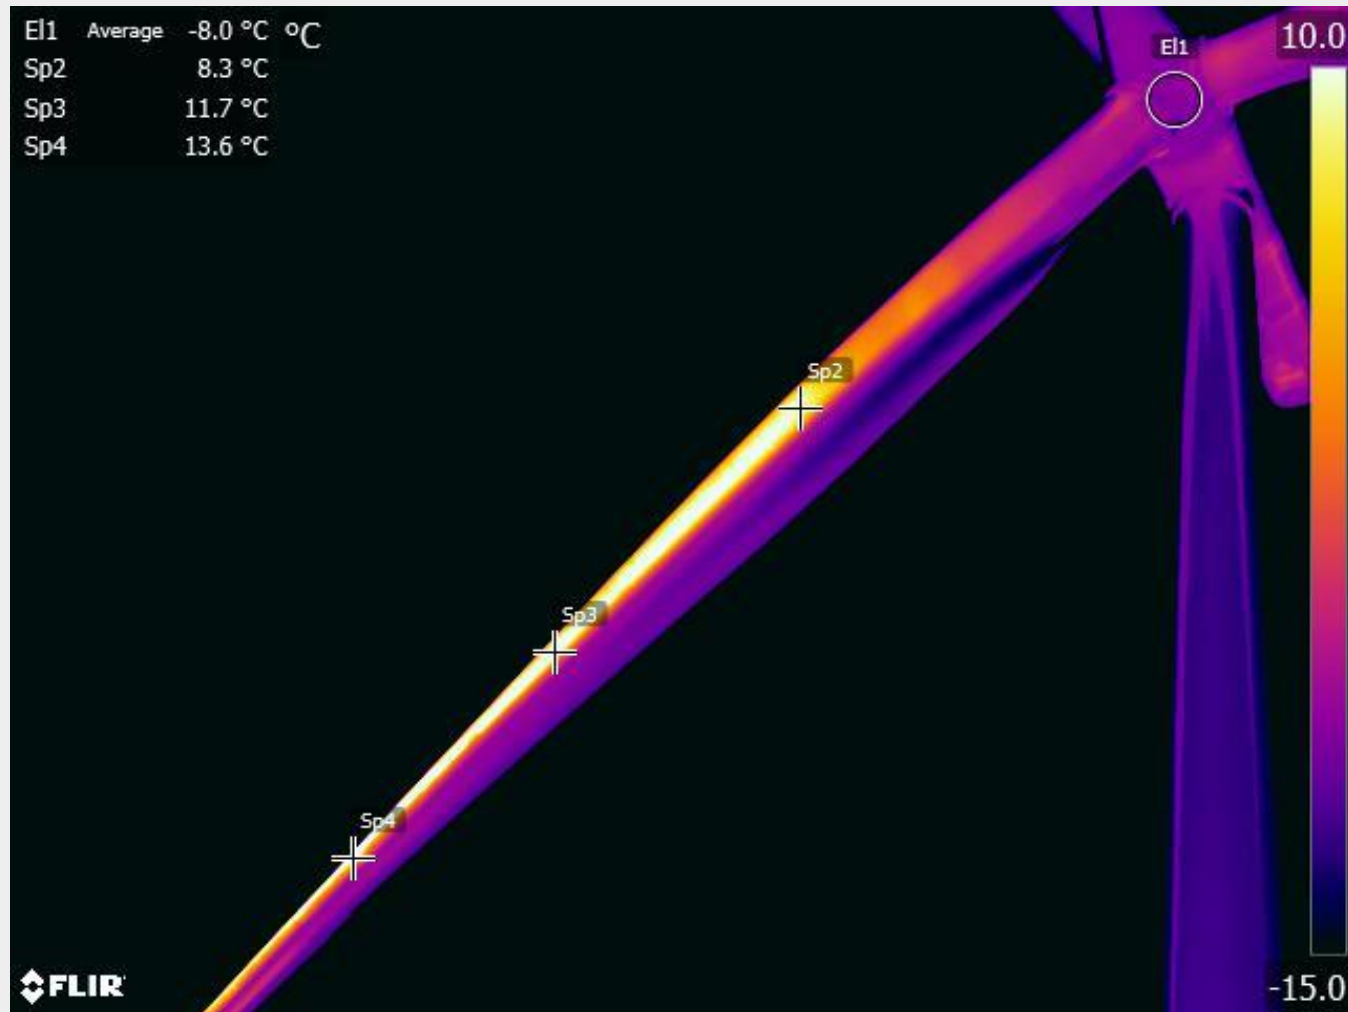
Modelled	Measured
Ambient Temperature (°C)	-7	-7
Wind Speed (m/s)	5.8	4.8 to 6.8
Blade Surface Temperature (°C)	6.3 to 12.9	8.3 to 13.6 (+/-2)

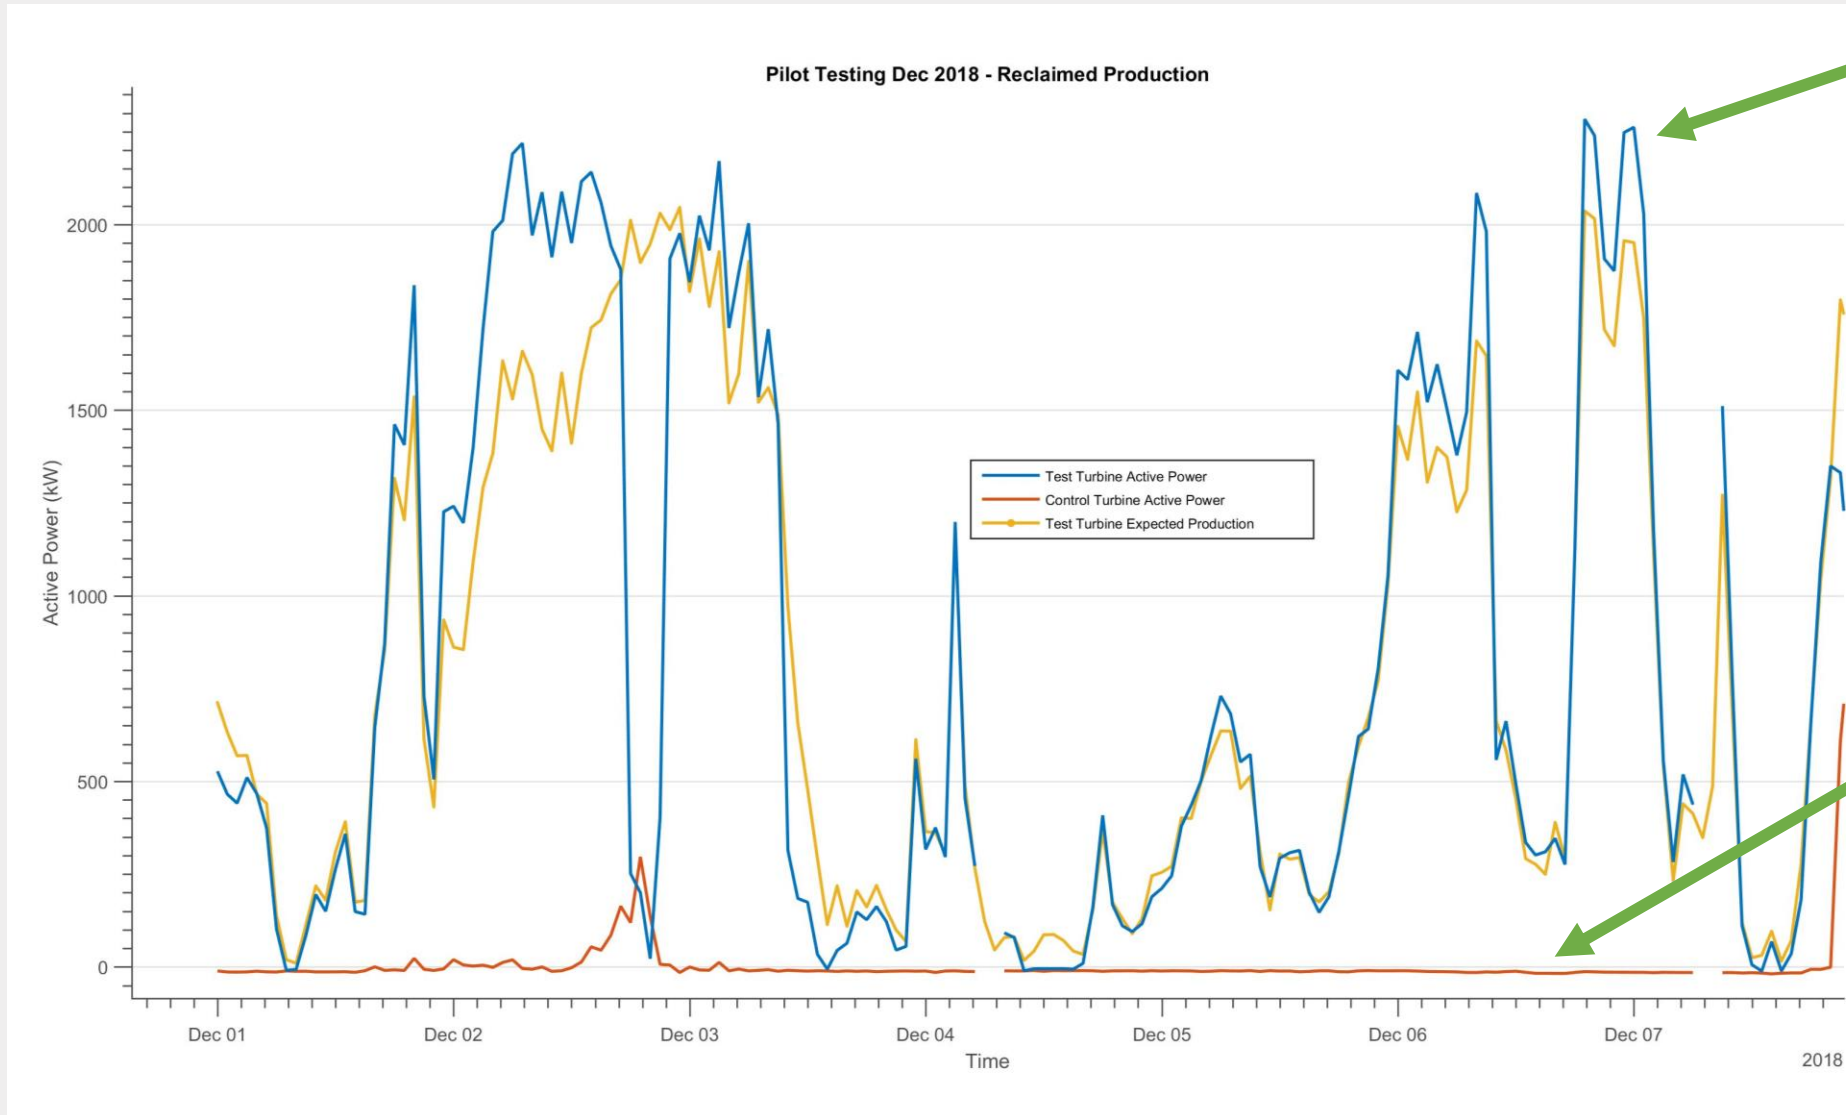
Icing Event Performance

Turbine **with** the Borealis System

Turbine **without** the Borealis System

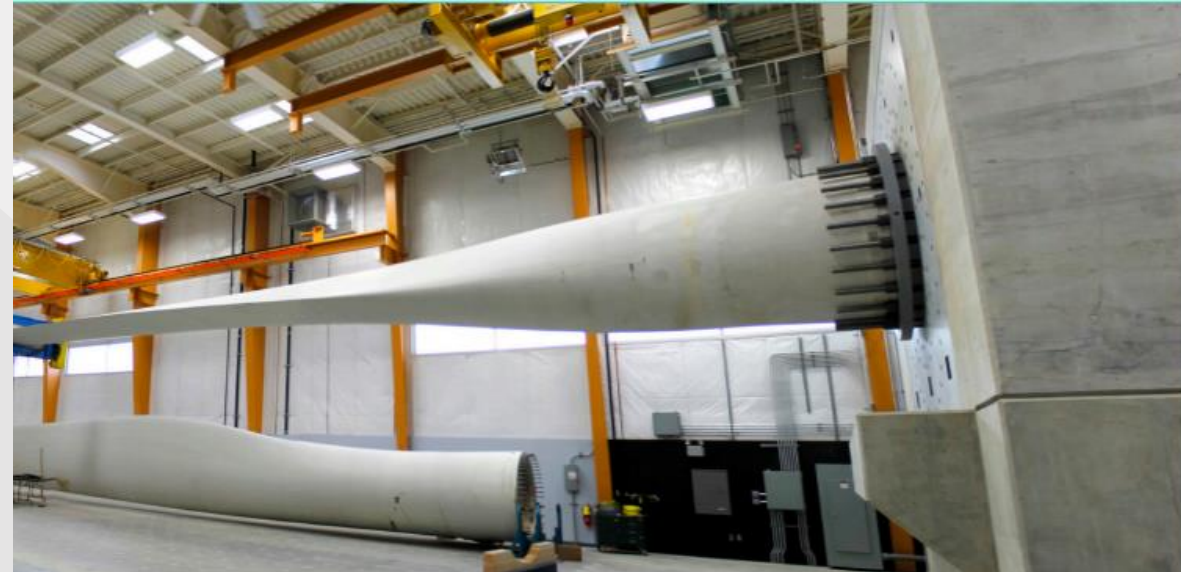
- Purpose:
 - Simulate the loads created by the de-icing system and measure the resulting strains

The Advanced Composites and Structures Center is an ISO 17025 accredited testing laboratory with 15 years of experience testing blades to IEC 61400-23.

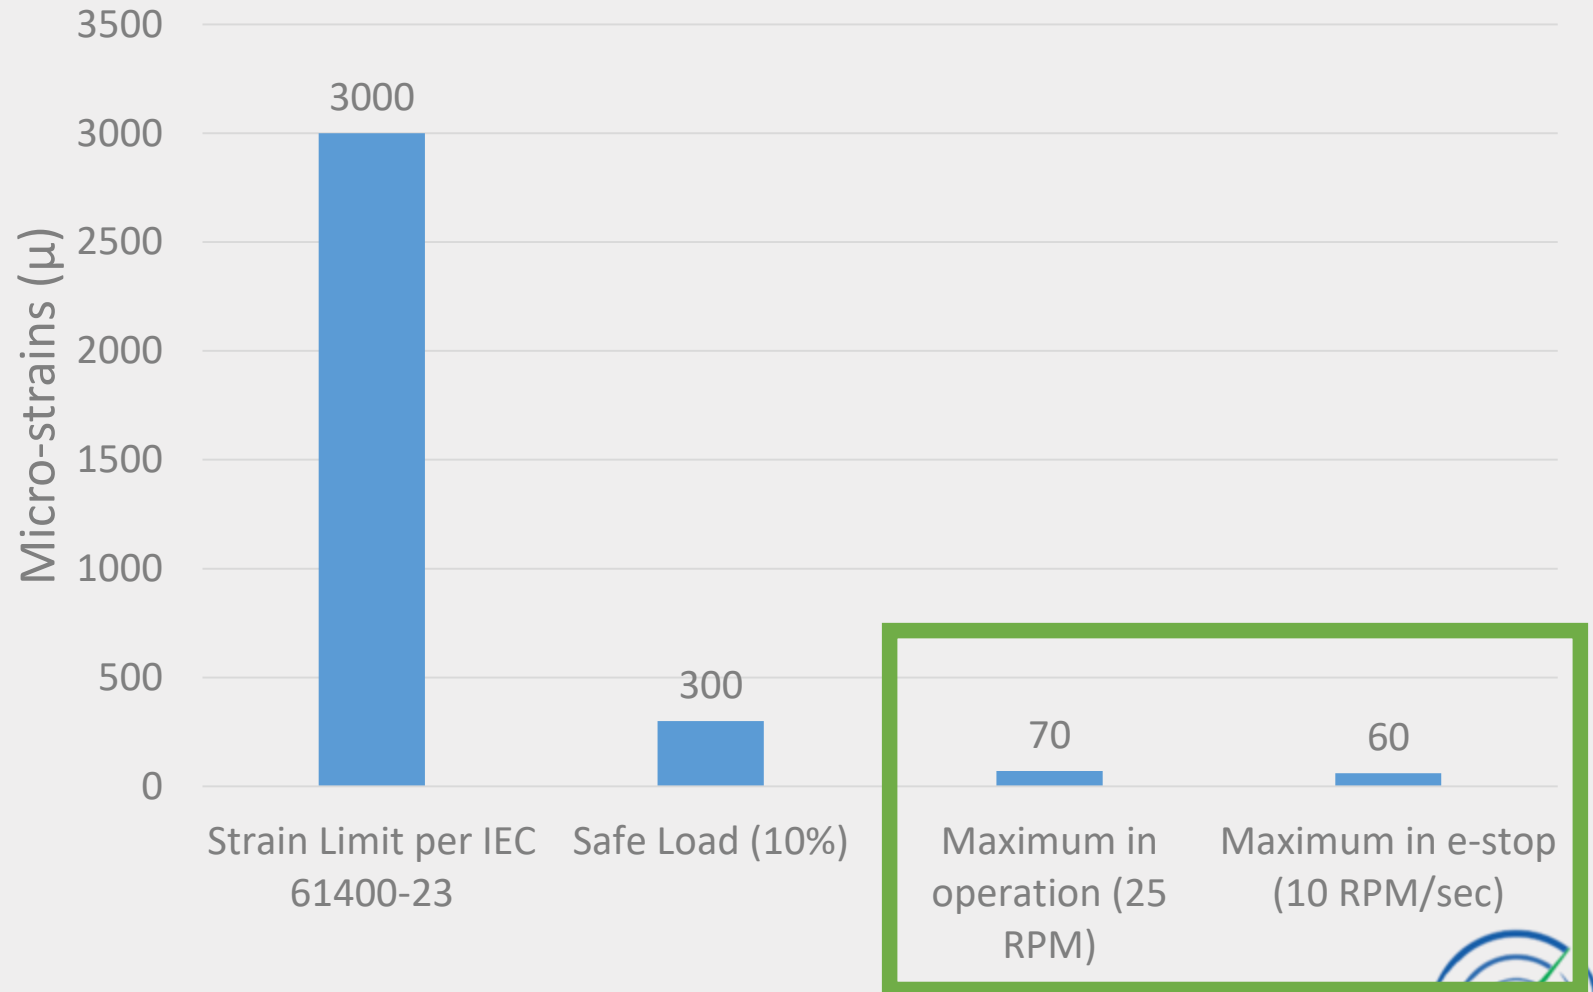
Strain Comparison

Maximum strain measured was **70 μ** at the blower during 25RPM operation, **much less than the safe load**
