## Results of the application of a hydrophobic coating base polymer on stranded OHL Cu cable

### Background

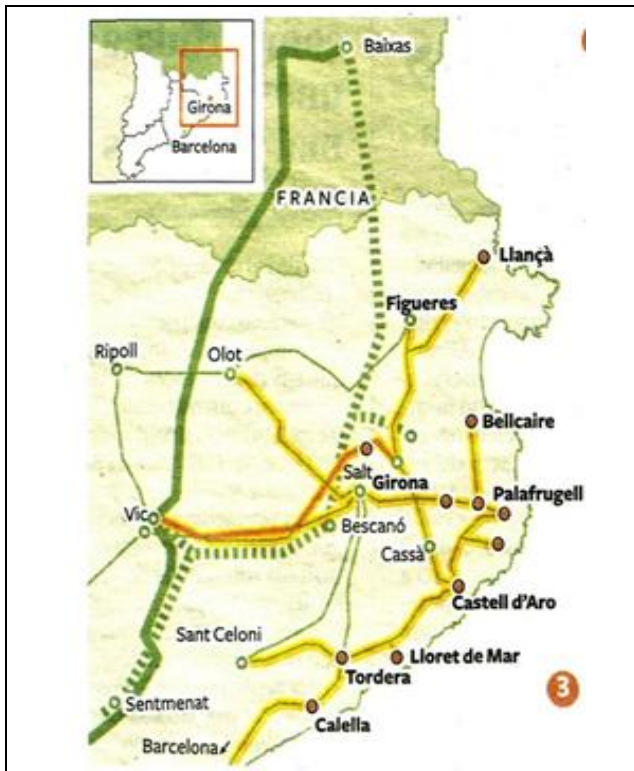
Fig 03 Detail of the most affected area, highlighted in yellow the affected set of distribution lines

During this episode in the geographical area shown in Fig. 03 a snowfall of 500 mm (equivalent to 50 mm of rainfall) of wet snow occurred over a period of time of 1.5 h, this resulted in the accumulation of layers of snow with a thickness of up to 300 mm on almost the

entire 45 kV, 25 kV and lower voltages electrical distribution network, which jointly with winds of 50-70 km/h , produced the collapse of a large number of towers. This occurred area shown in Fig. 03 which includes populated and tourist areas such as the Costa Brava. In total there were 11 days without electric service in the area with resulted in heavy economical losses both for the local D.S.O and its customers.

Figures 04 and 05 exhibit some of the damage caused by the accumulation of snow and ice weight on the distribution lines in the area shown in Fig. 03.

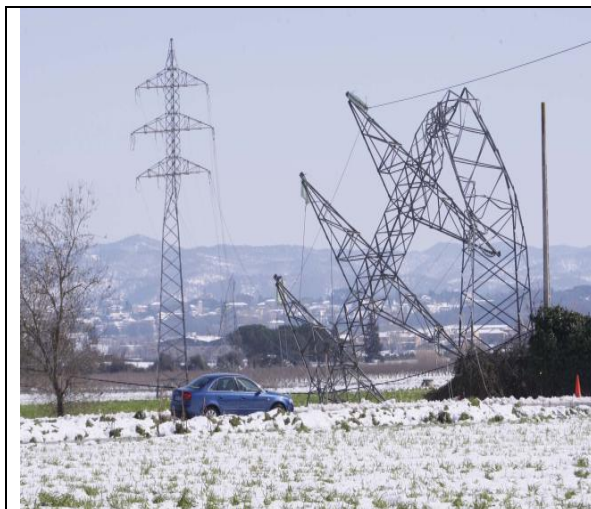
Fig 04 : Tower line 110kv, 2 circuit , bent by the combined action of wind and snow

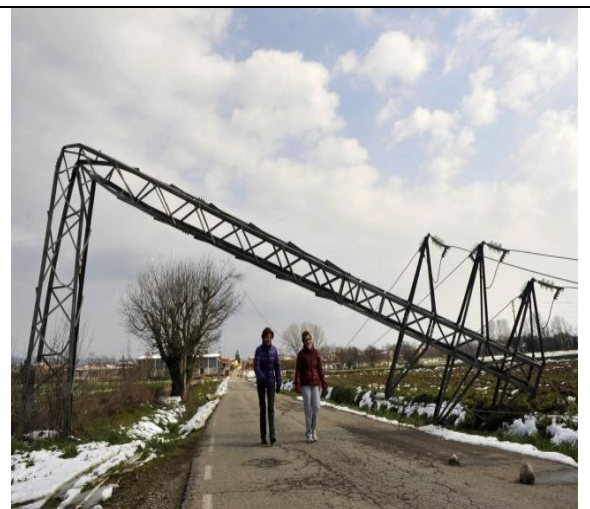
Fig 05 : Tower of 25kV line , 2 circuit, collapsed by the weight of the snow

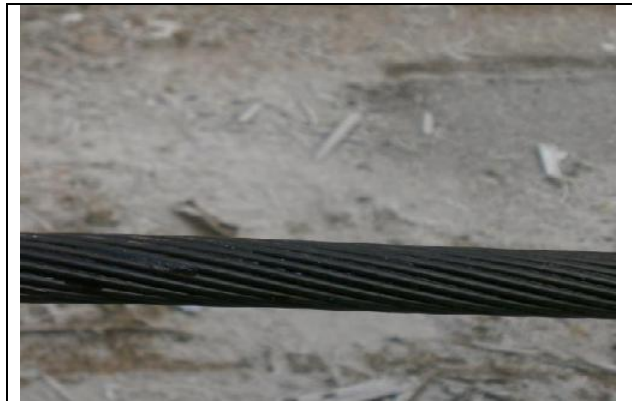
Fig 06 : CAC coated section

The solution adopted includes coating each stranded wire of hydrophobic polymer material

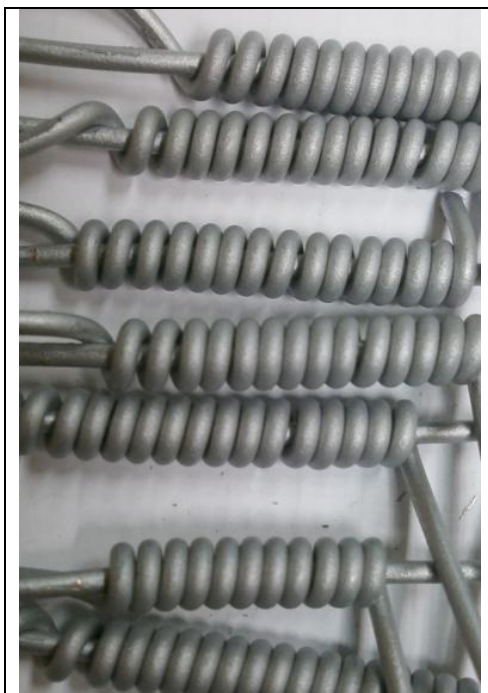
Fig 07 : Quality test of coating: the "tie" test

In Fig. 07 can be seen one of the quality procedures conducted to check the coating adherence to the wires to be stranded, this test, known as "tie", winds the yarn around a equivalent diameter to itself: in practice between 2.0 and 2.5 mm; the coating must remain perfectly bonded to copper surface as can be see in Fig. 07.

Until now only polymeric coating adhesion has been achieved on the polished surface of freshly drawn copper; in the case of the aluminum the constant existence of an Aluminum oxide layer on the surface gives a lower adherence of the coating on the Aluminum surface and as a consequence the "tie" test failure.

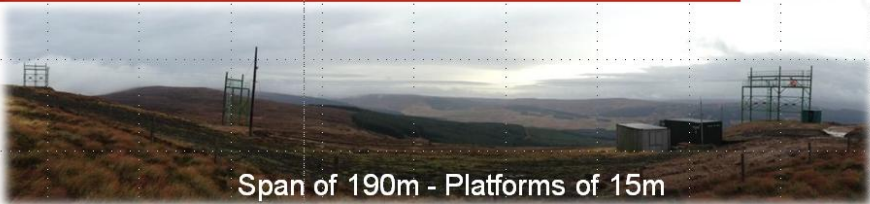
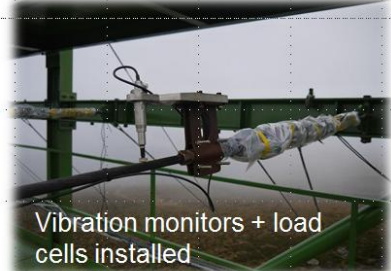
Span of 190m - Platforms of 15m

Vibration monitors + load cells installed

The site is situated at a height of 580m on an isolated, exposed hill top near the Scottish/English border.

Fig 09 : Dead Water Fell facilities to test OHL cables against real whether conditions

Tests conducted on Dead Water Fell facilities in the UK during the winter of 2013-2014 were designed to test the behavior of the polymer coating on CAC HLS-95 and 150 cables (95 and 150 mm<sup>2</sup> cross-sections) against a non-coated ACSR-180 cable

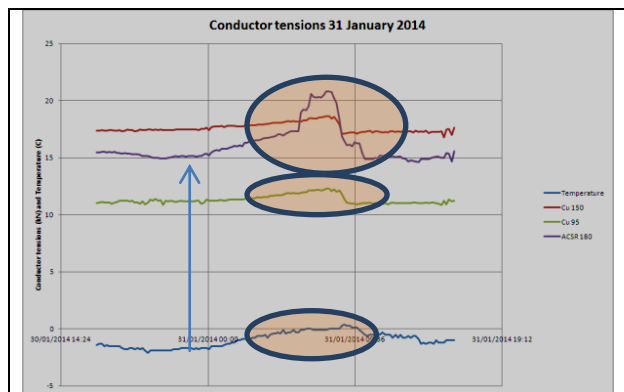
Fig 10 presents the behaviour of the 3 cables under conditions of wet snow: temperature while the snow was falling was close to 0° C . In this case the effect of snow on coated wires is practically negligible compared to the great increase of ACSR cable mechanical stress. The data presented in Fig. 11 was acquired in colder conditions and the increase in mechanical stress due to the ice load is bigger in the ACSR cable and remains

Fig 10 cables CAC behaviour in comparison of a ACSR 180 in wet snow conditions

The graphs displayed in figs 10, 11 and 12 give a synopsis of the behaviour

found. The color code is:

- Dark blue : ACSR-180
- Red : CAC-HLS 150
- green : CAC-HLS 95
- Light blue: ambient temperature evolution

The most outstanding fact is that the cables coated with polymer facing ambient temperatures in the range: - 2 to - 3 ° C take much longer to put on stress as a result of snow or ice accretion; Furthermore it is also observed that cable ACSR-180 has a much higher mechanical stress than the cable CAC-HLS-150 despite the fact that the copper cable is significantly heavier than the aluminum cable.

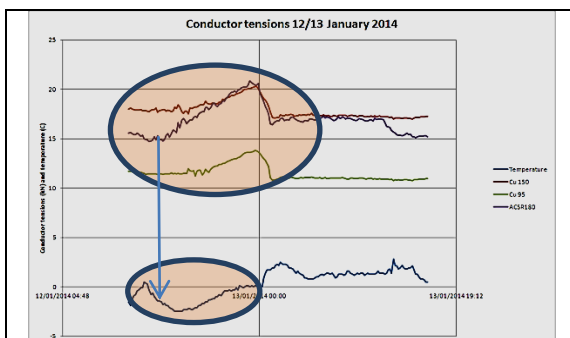
Fig 11 : CAC cables behaviour front ACSR 180 in wet snow conditions

for longer than on the coated cables.

- It can be seen that in case of lower temperatures: < - 3 ° C snow accretion increases but is always less than a non-coated cable.
- The time that the ice remains on the cable is less if it is coated: see Figure 11 in which it can be seen that a certain layer of ice remains on the cable ACSR-180 for ½ day while CAC wires lose the layer of ice accreted when the temperature reaches 0°C. Also, the ice accretion starts later in coated cables than on the uncoated. ***Then the ice layer is smaller and it remains less time over a polymeric coated copper cable.***

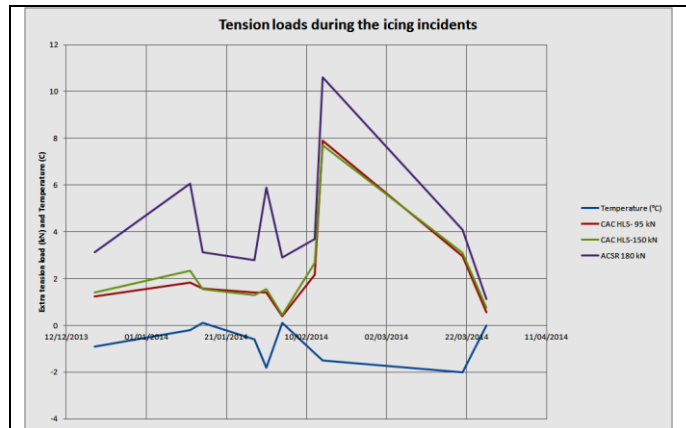
Fig. 12 is a summary of the results obtained in the 7 episodes reported; the graph shows the maximum increases in mechanical stress recorded in each cable in each event. As shown in the graph there is a dependency between the ambient temperature and the increase of stress in such a way that at temperatures close to 0°C CAC coated cables hardly register increments of mechanical stress, unlike the ACSR cable that

displays substantial increases in mechanical stress : more than double that of the CAC cables . When the temperature is lower than - 3 ° C CAC cables have higher mechanical stress increases but, anyway, they are always lower than the uncoated ACSR-180 cable

Fig 12 : Overview of stress increases experienced by strand coated CAC and uncoated ACSR..
