Effect of icephobic coating on ice protection of ultrasonic anemometer with stack-type transducers

S. Kimura¹, K. Sato², H. Morikawa³, J. Hietanen⁴, Y. Yamagishi¹, T. Kojima³, T. Saito¹

¹Kanagawa Institute of Technology, ²National Research Institute for Earth Science and Disaster Prevention,

³Meteorological Research Institute for Technology, ⁴Vaisala Oyj

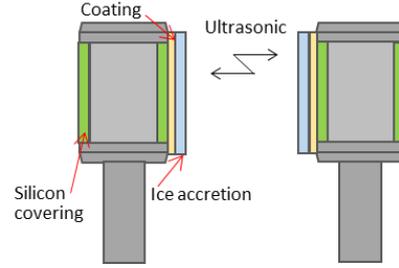
Fig.1 shows a schematic of a situation for the VAISALA WMT 703 transducers where ice adheres to the coated transducer surfaces that face each other. In this case, the ultrasonic waves transmitted from one side travel to the receiver of the other successively through the silicon covering, ice accretion, air, ice accretion, and silicon covering.

Fig.1 Schematic of ultrasonic transmission/reception between iced coated transducers

The transmissivities calculated for all conceivable cases that may be considered in iced conditions are summarised in Table 2. In the table, the symbols S, A, I, and C, respectively denote the silicon covering, air, ice, and the coated film. For instance, Eq. 1 calculates the transmissivity to be approximately 3.5e-4 for the case shown in the figure. The surface which is clean, as expressed by the code S-A-S in an abbreviated form, is approximately 1e-3.

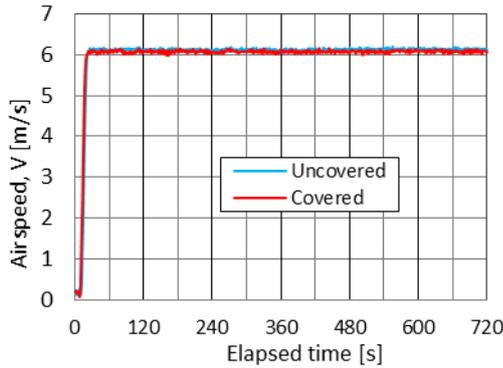
The comparison of the measured wind speeds developed by the ultrasonic anemometer under the two different transducer surface conditions can be seen in Fig.3. The red curve shows the wind speed of the covered anemometer, while the blue curve shows the uncovered anemometer. The normalised absolute difference of the averaged wind speeds measured by these two ultrasonic anemometers in the range of the constantly regulated wind is 0.85%. This suggests that correct wind measurements using the ultrasonic anemometer with icephobically-coated transducers are feasible.

Fig. 3 Wind speeds measured by covered and original anemometers

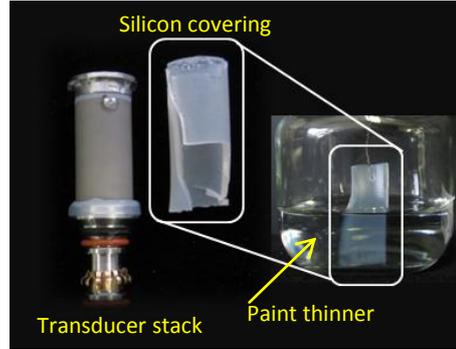
Silicon covering peeled off from the transducer surface Silicon covering immersed in the paint thinner for 21 days

Fig.4 Immersion test (shortened duration)

The icephobic paint used for the present research was HIREC100. The paint thinner of butyl acetate was used to make a coated film on the surface of the body. Therefore, for the application of this paint to the ultrasonic anemometer, the chemical influences of the thinner on the properties of the silicon covering of the transducer were examined using the immersion test since the materials used for the coating of other surfaces were metallic, and are thus not subjected to a chemical change by the thinner. The immersion test was carried out in accordance with the guidance of the Japanese Industrial Standard k 5600-1 (ISO 2812-1) as shown in Fig.4[5]. The duration of the process was shortened to 21 d for the snowing wind tunnel test. The test results showed that no damage of the silicon-made covering was observed in terms of the thickness and surface conditions. We then applied the paint to the transducers, upper and lower arms, and to the top cover of the ultrasonic anemometer.

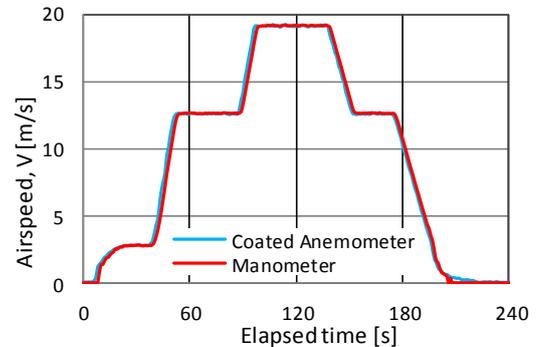
different wind speeds equal to 3, 6, 12, and 19 m/s. Based on this procedure, the ability of the anemometer to follow the changing wind speed could be examined at the same time. For comparison, the wind tunnel airspeed was measured by the pitot-tube and digital-manometer (P-M) system during each test run. The variations of the wind tunnel airspeed measured by the anemometer and the P-M system are shown in Fig.5. The chart indicates that negligible discrepancies exist between the two wind speeds not only at steady state but also in the ascending and descending modes. This outcome can be interpreted as a capability of the coated anemometer to conduct highly reliable wind speed measurements.

Fig.5 Wind speeds measured by coated anemometer and Pitot-tube manometer system

At the next stage, another wind tunnel test was conducted at room temperature in order to confirm the function of the anemometer equipped with the transducers that had a thin coated-film on their surfaces. The test was carried out by changing the airspeed in the test section of the wind tunnel. During the test, the flow started from a rest (calm) state and was then increased in speed. It was successively maintained at four

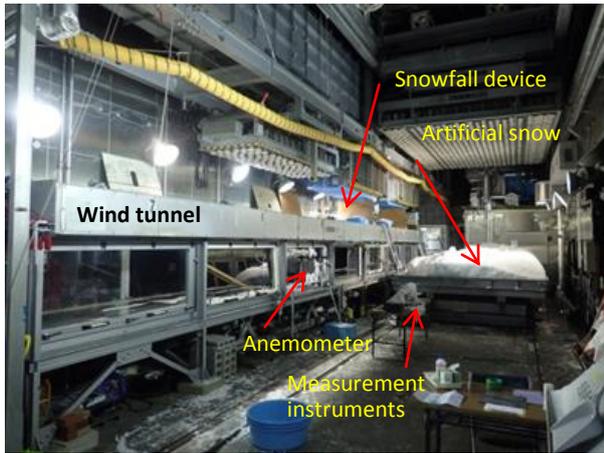
The snowing wind tunnel test was conducted at the wind tunnel placed inside the Cryospheric Environment Simulator (Fig.6) of the Shinjo Cryospheric Environment Laboratory of the National Research Institute for Earth Science and Disaster Prevention. The aim of the test was to evaluate the effectiveness of the icephobic coating for snow/ice prevention in the case of the heated ultrasonic anemometer equipped with stack-type transducers, which are the original versions of the VAISALA WMT-703. The heating elements were embedded in the middle part of the transducers and the lower arms. As mentioned earlier, the paint was applied to the transducers, to the upper and lower arms, and to the top cover of the anemometer (Fig.7). Fig.8 depicts the schematic of the snowing wind tunnel test. The snowfall device was placed on the ceiling of the test section from which snowflakes were supplied into the test section. The ultrasonic anemometer was placed in the leeward side of the snowfall device at a distance that was determined in accordance to the airflow speed in the test section in order to optimally create the snowing environment around the anemometer.

Fig.6 Snowing wind tunnel facility at Shinjo Cryospheric Environment Laboratory

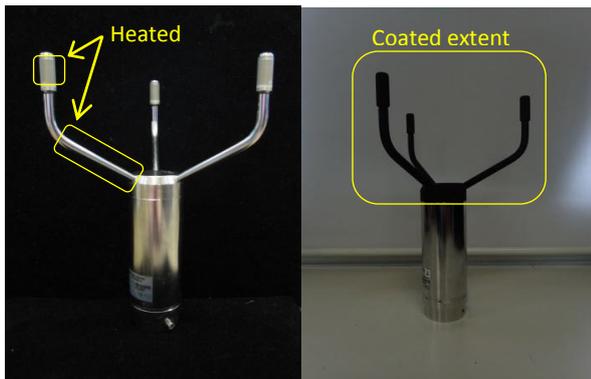
(a) Uncoated ultrasonic anemometer (b) Coated ultrasonic anemometer

Fig.7 Heating parts and coated extent of the ultrasonic anemometer VAISALA WMT 703

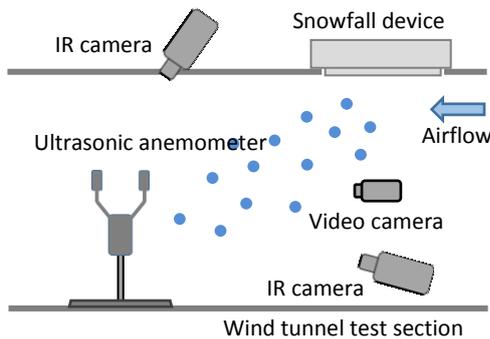
Fig.8 Schematic of snowing wind tunnel test

All tests were carried out at -12°C . The airflow speed was set at values between 1 and 6 m/s. In each test, the surface conditions were monitored using two video cameras set up in the windward location and outside of the wind tunnel test section. With the use of the video cameras, the frontal and side views of the anemometer were recorded throughout the test. For reference, two infrared(IR) cameras were used to measure the surface temperature. One IR camera was placed on the ceiling of the test section and the other besides the video camera in the windward. The measured wind data were transferred to the personal computer and stored in the hard disc. However, the wind data were not used for the evaluation of the effectiveness of the coating for ice/snow protection for two reasons: one was the inherent shortcoming of the characteristics of the snowing wind tunnel test for the wind sensors because ice and/or snow accretion occurs in the limited area of the transducer stack due

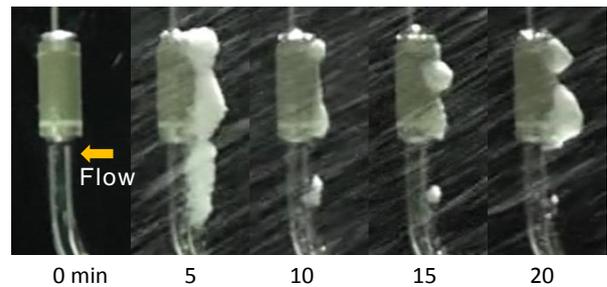
The duration of the snowfall test under the weak wind condition of 1 m/s was 30 min for the uncoated ultrasonic anemometer and 20 min for the coated one. In this wind condition, snowflakes fell from the ceiling at an angle that was approximately 45° . Figs.9 and 10 show the change of the surface condition along with the elapsed time of the test for the uncoated and coated transducers, respectively. It is clearly understood from Fig.9 that secondary icing occurred within a 10 min interval after the onset of the snowfall even if the transducer was heated. Ice grew to the windward side, spreading the covering area on the transducer frontal surface. At 30 min, snow largely accumulated on the ice deposit and covered the entire frontal area of the transducer. It has to be noted that even in a snowfall environment, ice accreted on the heated surface of the transducer through the secondary icing process, in the early stage of the icing event.

The middle part of the transducer was heated and regulated for temperature maintenance at 30°C regardless of the ambient temperature, so that a contact surface of an ice deposit totally covered the windward side of the transducer surface. This was shaped like an arch, maintaining a gap at the interface. As explained earlier, the presence of an air gap decreased the transmissivity of ultrasonic waves. Hence, the ice formation, as seen in Fig.9, led to incorrect wind measurements.

Fig.9 Original transducer stack at 1 m/s

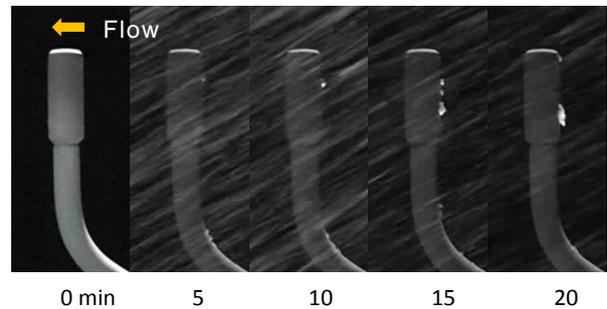
Fig.10 Superhydrophobically coated transducer stack at 1 m/s

In contrast, the surface of the transducer had been kept clean during the 20 min test run even though a minute quantity of ice deposit was found on it. In Fig.10, which was obtained at 10 min, although one small ice deposit was found on the heated middle part, it disappeared in 10 min. However, interestingly, another thin layer of an ice deposit that was larger than the ice that was previously accreted was observed at a location different than the location of the transducer in the picture at 20 min. Nonetheless, in all cases, no obvious ice accretion was

formed on the coated surface, which resulted in the deduction that the superhydrophobic coating was dramatically effective in preventing the transducer from accumulating ice/snow accretion. Moreover, absence of ice accretion ensured the correct and stable wind measurement of the ultrasonic anemometer.

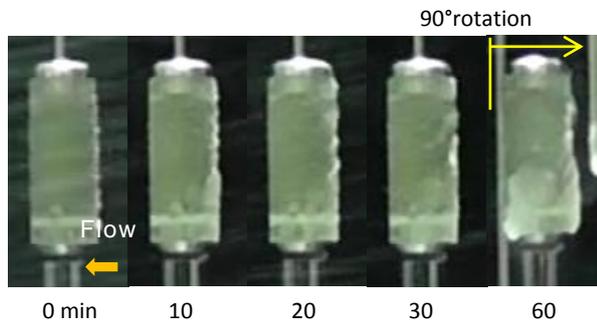
Ice accretion on the coated and the uncoated transducers at the wind speed of 6 m/s are shown in Figs.11 and 12. In this wind condition, the snowflakes travel and collide with the transducer surface almost horizontally.

Fig.11 Uncoated transducer stack at 6 m/s

For the uncoated anemometer, the total test duration was 60 min. After the first half of this time interval, the ultrasonic anemometer was rotated by 90° for widening the icing area on the transducer surface. Since the values of the snow flux and the speed in the weak and higher wind conditions were different from each other, the growth and range of ice accretion may undergo a different process. Therefore, the comparison between the higher and weak wind conditions in terms of the shape of the ice accretion cannot be simply conducted. Even so, as shown in Fig.11, ice grows on the surface as time elapses.

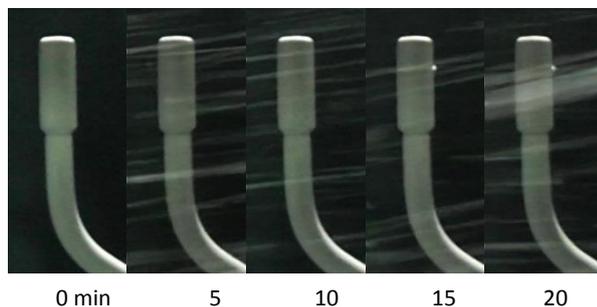
Fig.12 Superhydrophobically coated transducer stack at 6 m/s

For the coated transducer, Fig.12 indicates that nothing happens on the transducer surface even though, as in the weak wind condition, a very small ice deposit like a frozen droplet is found at 20 min. From the video analysis, it is observed that the ice was blown off shortly after its formation. In addition, the small ice deposit formed on the transducer surface at almost the same area as in the weak wind condition. This implies that the surface roughness in the area was a bit different from the other area. Hence it would be required that painters have to carefully make a coating film on the surface since it should be as uniform as possible.
