Effect of icephobic coating on ice protection of ultrasonic anemometer with stack-type transducers

S. Kimura¹, K. Sato², H. Morikawa³, J. Hietanen⁴, Y. Yamagishi¹, T. Kojima³, T. Saito¹

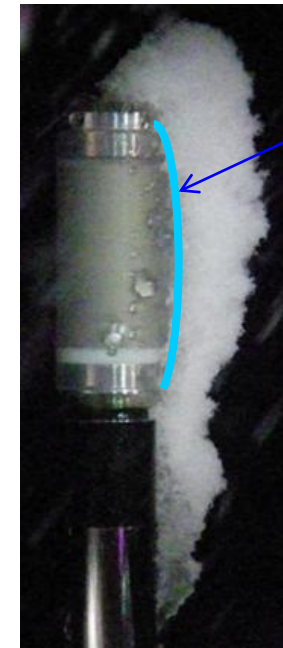
Ice-bridge with an air gap at the interface

Conditions of transducer stack	Combination of media	Transmission coefficient
Ice free	S-A-S	1.10e-03
Iced/ Iced + gap	S-I-A-S	1.96e-04
	S-I-A-I-S	3.92e-04
	S-A-I-A-I-S	5.16e-07
Coated	S-A-I-A-I-A-S	2.41e-10
	S-C-A-C-S	1.54e-03
	S-C-I-A-I-C-S	3.50e-04

No more correct wind measurement

the order of magnitude of -7 to -10

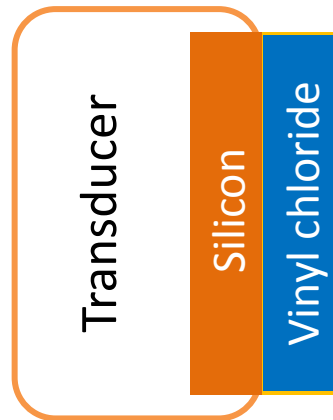
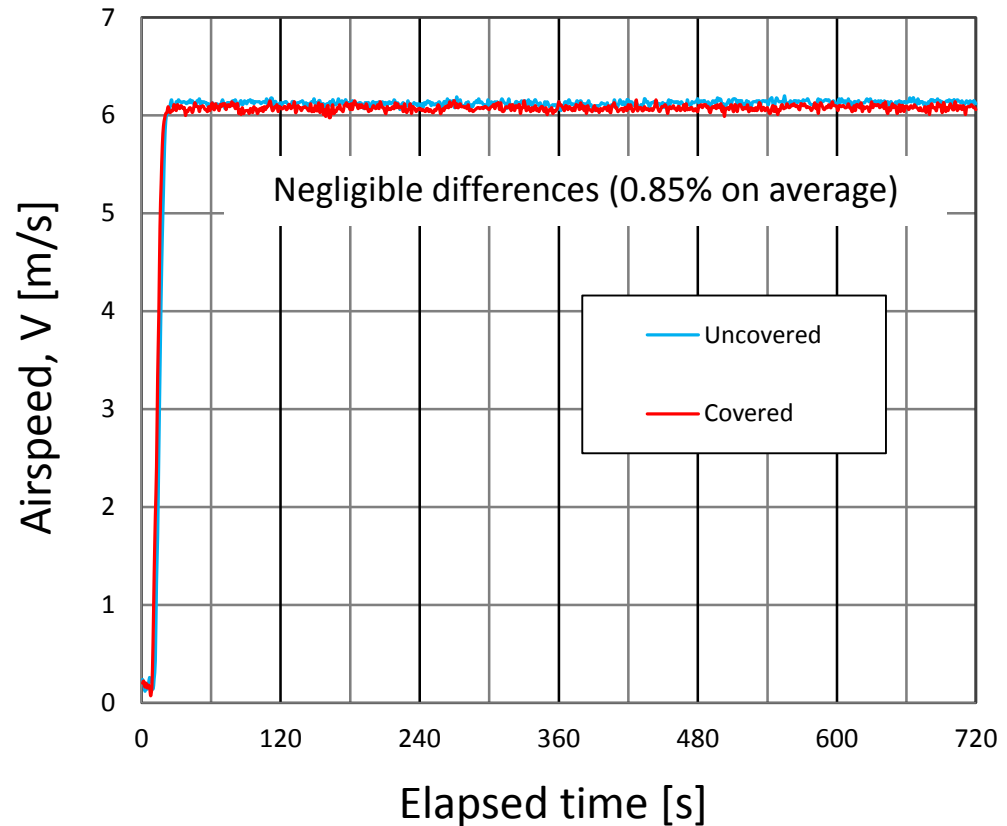
To evaluate the effect of the presence of the membrane on the transducer surface on wind measurement

Imitated coating by a membrane covering of vinyl chloride (similar acoustic impedance value of the paint)

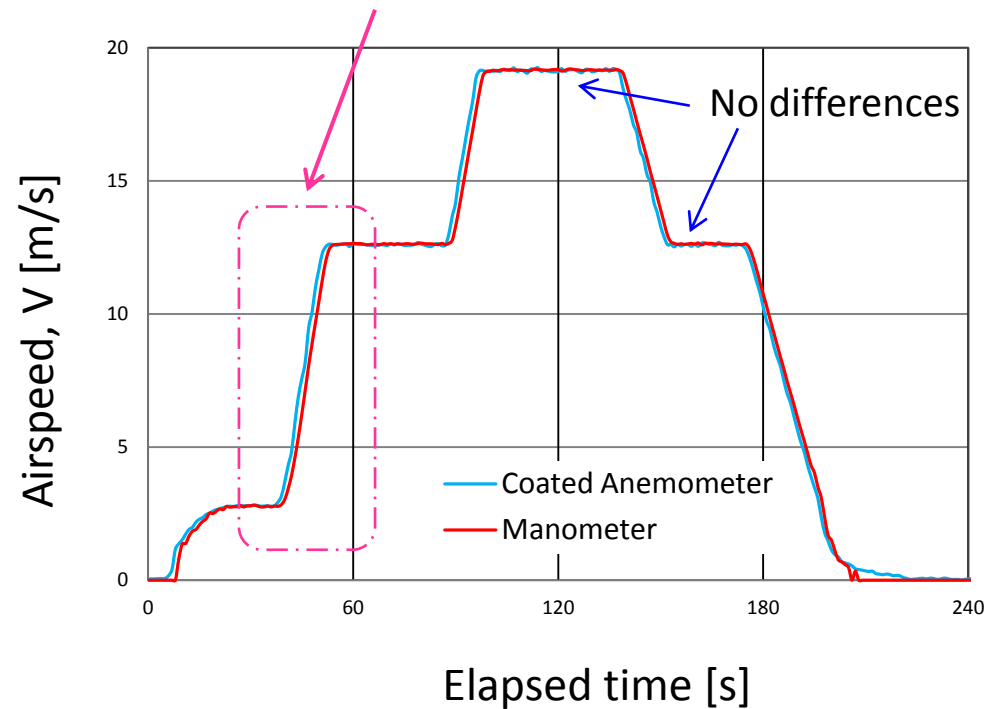
To examine the performance of the coated ultrasonic anemometer by the wind tunnel test with changing the airspeed at room temperature

The coated ultrasonic anemometer responds to the change of the airspeed in the wind tunnel more quickly than the Pitot-manometer system

The coated ultrasonic anemometer works
