REVIEW OF ICING RELATED FAILURES OF WIND MASTS IN BULGARIA

Dimitar Nikolov,
National Institute of Meteorology and Hydrology –
Bulgarian Academy of Sciences

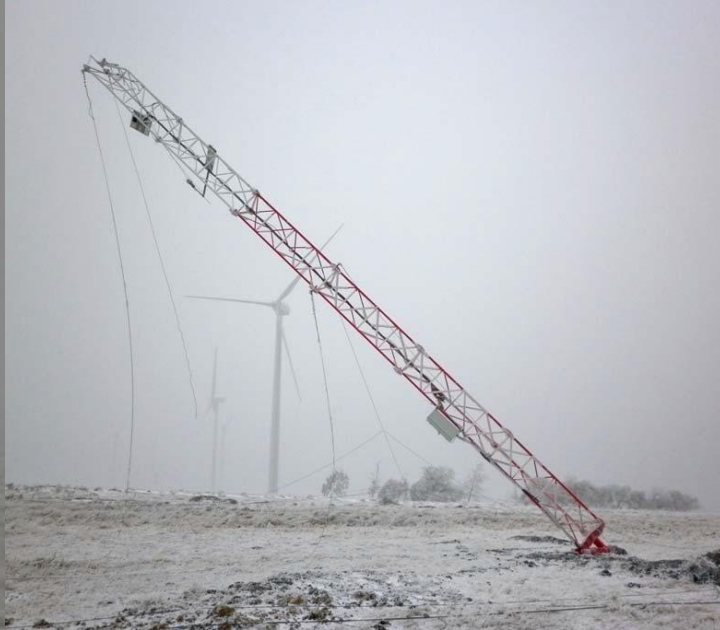
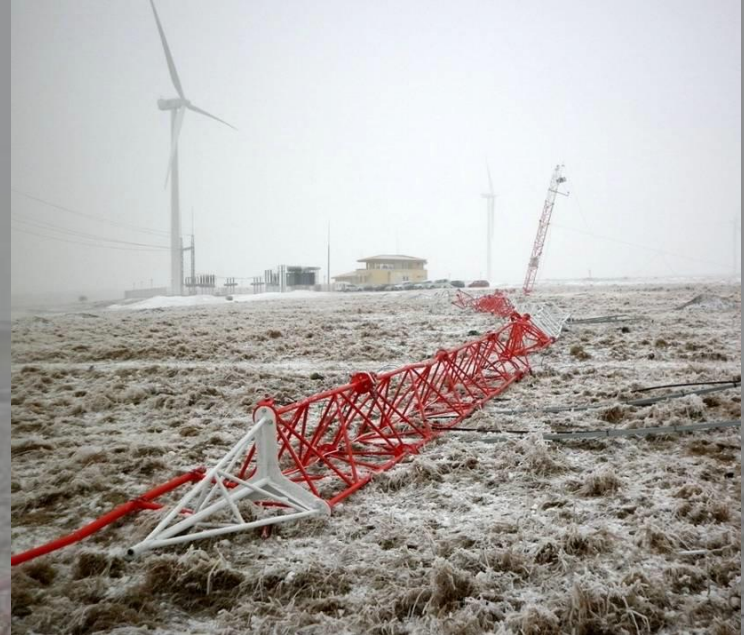
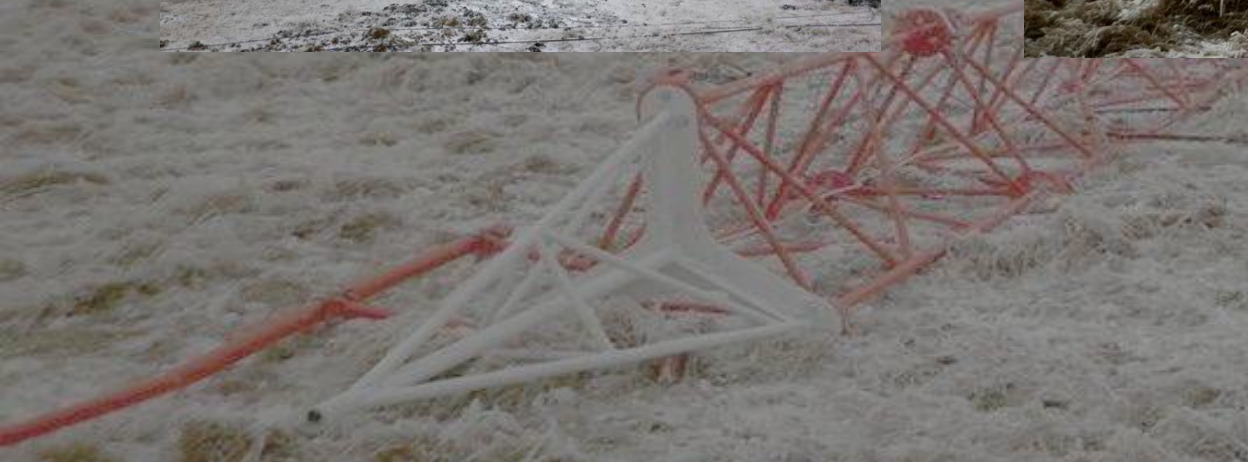
Case 1, 05-08.02.2012, NE Bulgaria

- Unfortunately only in two of the cases there are some measurements of the ice depositions.
- The first of these cases is better documented. The case happened on 05-08.02.2012 and was caused by the combined influence of freezing fog and freezing rain.
- For the second case there is only one measurement of the ice thickness available. The process was freezing rain.

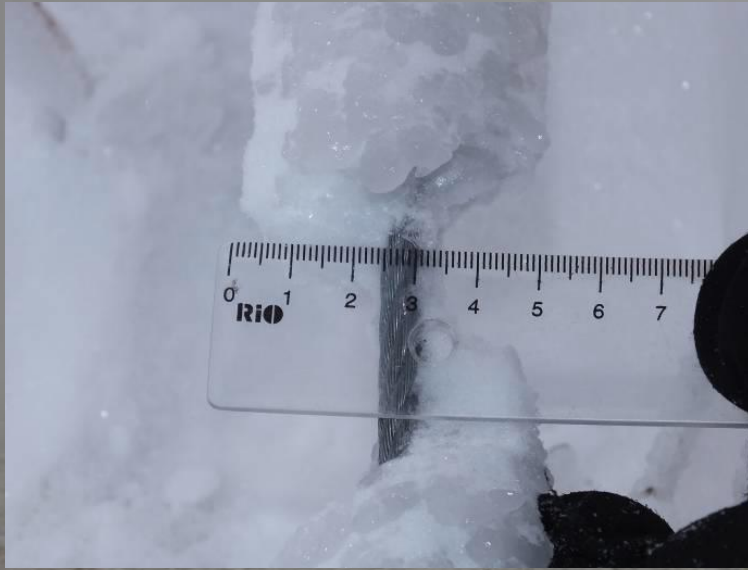
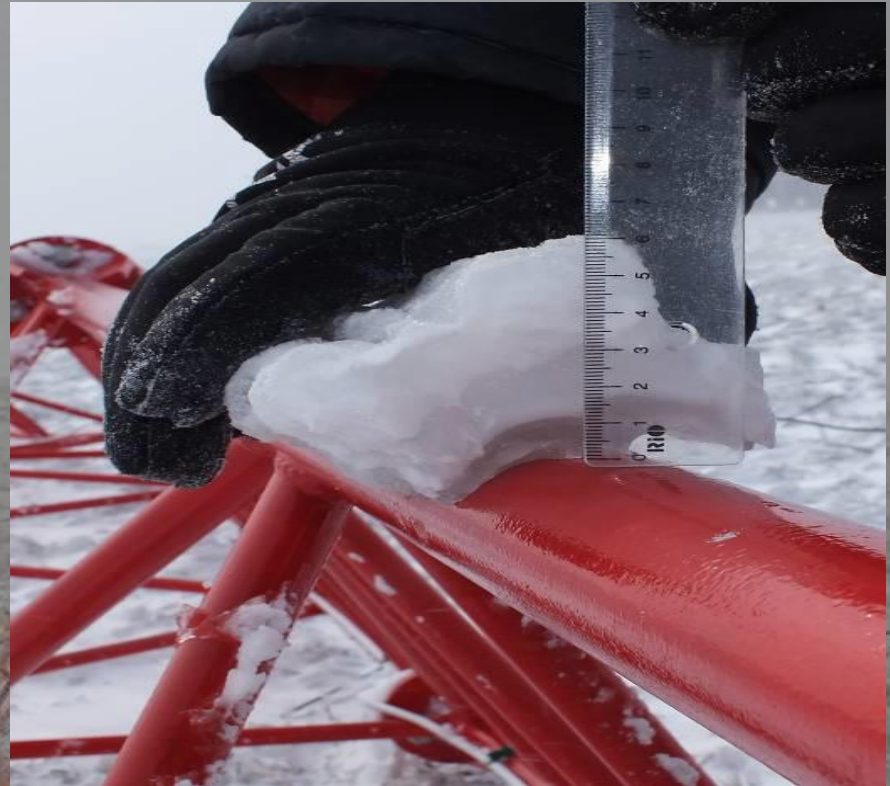
Case 1, 05-08.02.2012, NE Bulgaria

- Measurements of the ice depositions – on the guy ropes (left) and on the main body of the mast (right) at height level of about 80 m.

Good agreement of the estimation for height level 80 m with the measurements – see next slide.

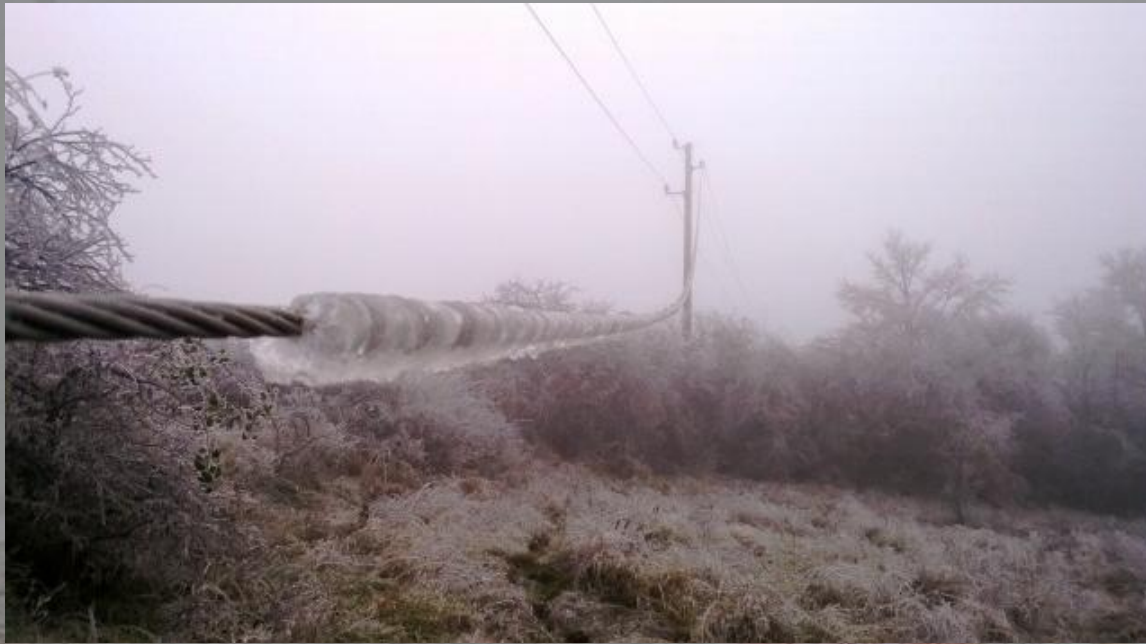
Case 2, 01-02.12.2014, NW Bulgaria

- Type of the icing – glaze;
- Used model – KJ;
- Measured value – about 1.8 cm thickness but not equal distributed;
- Estimated value – 7.0 mm equivalent radial thickness;
- Model underestimates little the measured value in this case.
