Icing Measurements at Berlin TV Tower A case study on ice fall on 23rd December 2012

Bodo Wichura, German Meteorological Service

December 23rd, 2012: Chunks of ice fall from Berlin TV Tower

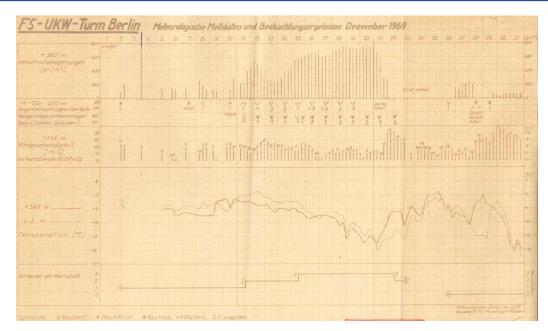
Vom Kuppeldach des Fernsehturms drohen wegen des Tauwetters Eisplatten herabzurutschen. - FOTO: DPA

Sperrung wegen herabstürzender Eisbrocken wieder frei. Das Areal sei seit Sonntagabend wieder für Fußgänger begehbar, sagte ein Polizeisprecher am Montag. Wegen des Tauwetters mit Eisregen waren von der rund 200 Meter hohen Restaurant-Kugel größere Eisbrocken abgerutscht und auf den Platz gestürzt. Um die Passanten zu schützen, hatte die Polizei den Bereich Sonntag gesperrt. "Verletzt wurde niemand, Schäden gab es auch nicht", sagte der Polizeisprecher. Am verkaufsoffenen Sonntag waren viele Menschen rund um den - samt Antenne - 368 Meter hohen Fernsehturm unterwegs gewesen.

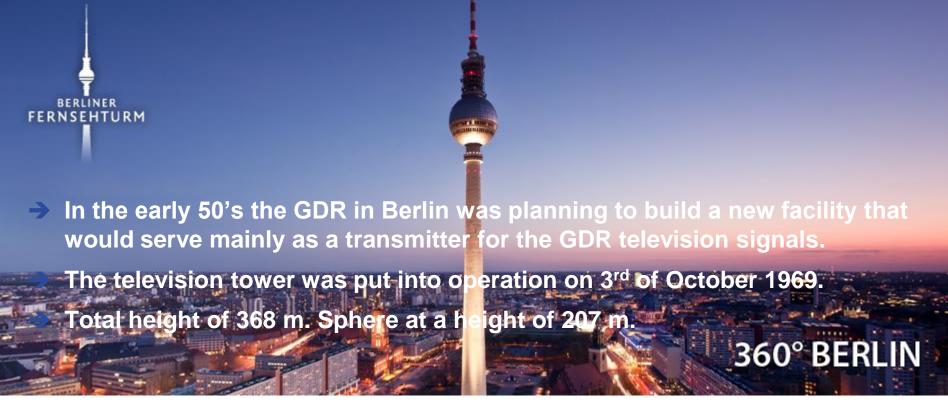
Berlin TV Tower: General Remarks

→ Architecture: The enthusiasm for technology and space in late 60's are noticeable. In cross-section, the TV tower resembles a space rocket. The sphere of the TV tower should remind of the Soviet Sputnik satellite.

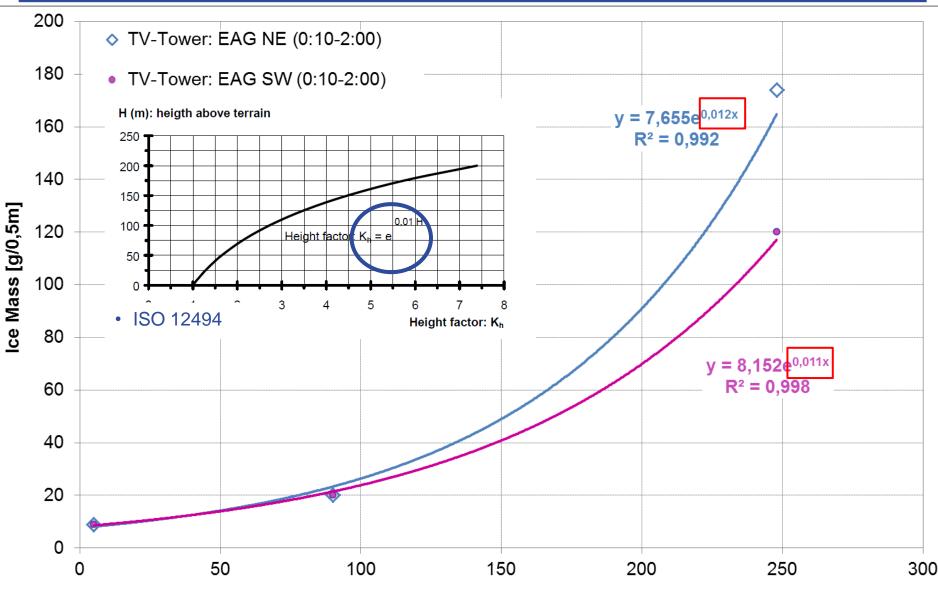
Analysis of height dependence of ice loads Deutscher Wetterdienst Wetter und Klima aus einer Hand

Height [m]

- The time courses of ice loads were similar for the event. The ice loads differed for different heights above ground (Berlin, Falkenberg) as well as for different locations of the instrument (Berlin TV Tower).
