Further development of ENERCON's de-icing system

Winter Wind, Skellefteå, 2012-02-07

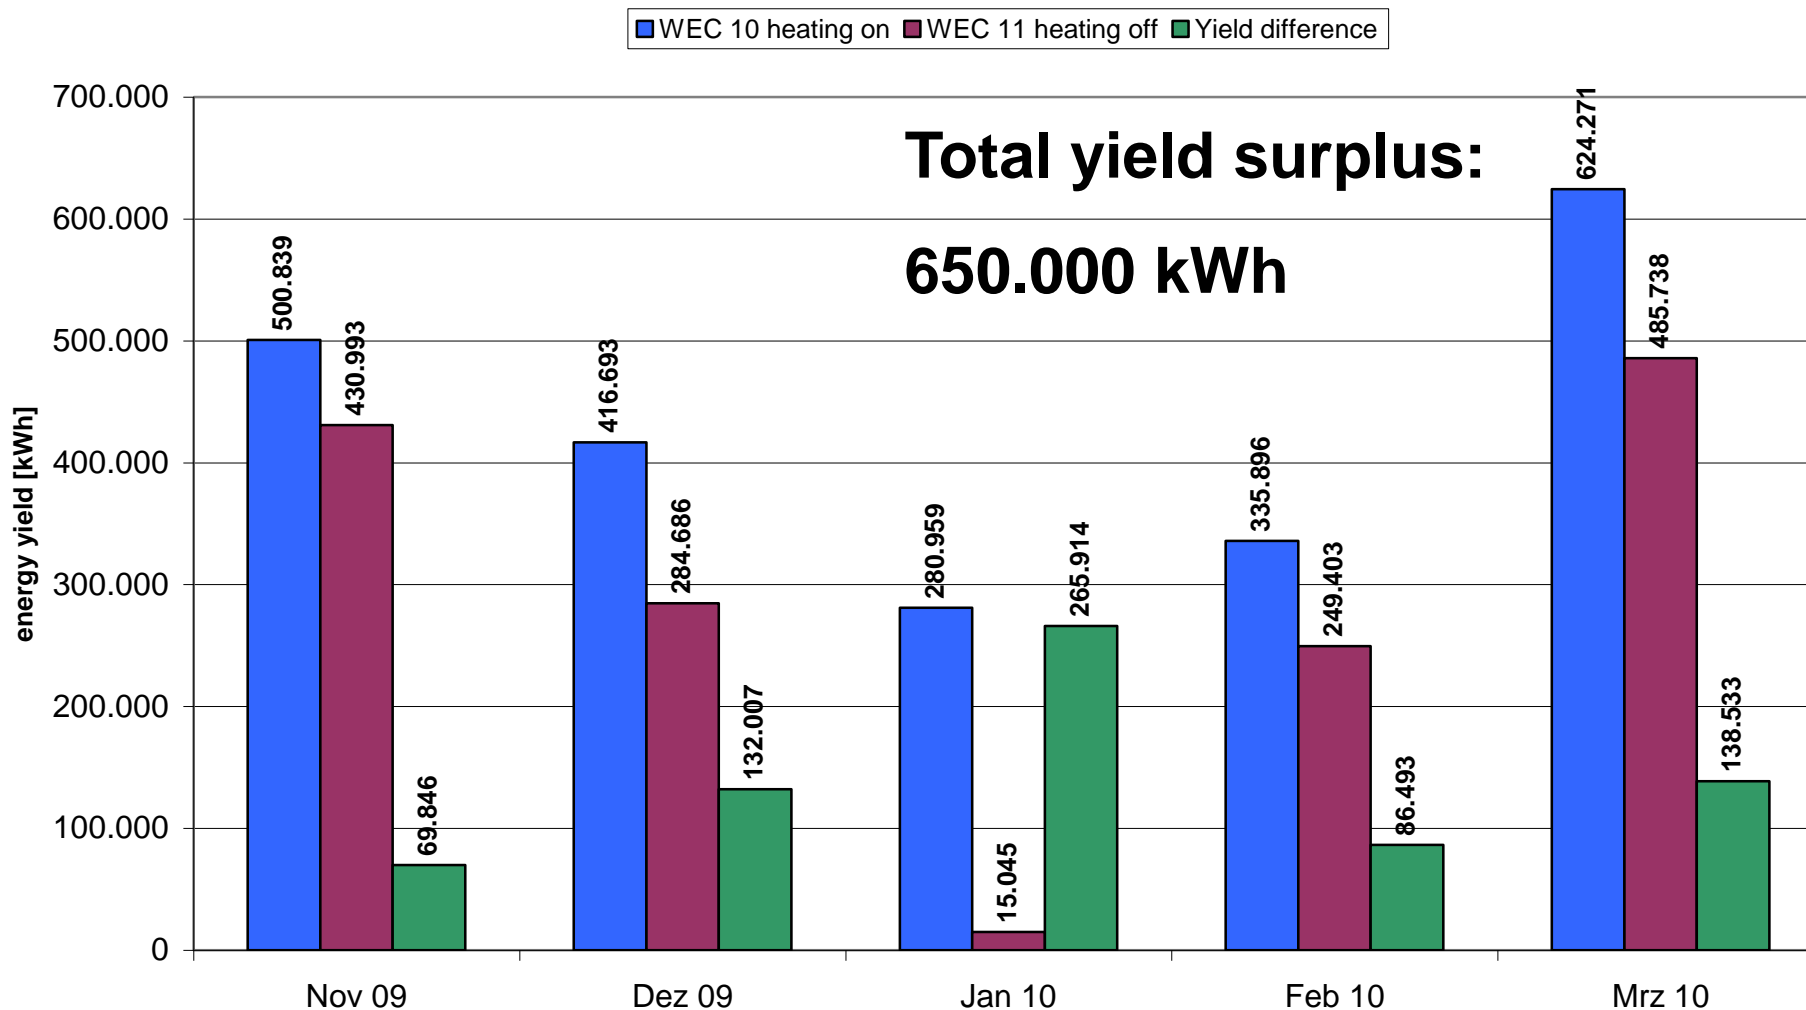
Energy yield surplus due to Rotor blade de-icing in Krystofovy-Hamry (CZ), energy meter readings

Difference in yield per month between heated and unheated WEC E-82
2MW at location in Czech Republic

Location	unit	Krystofovy-Hamry (CZ)	Dragaliden (SE)
Amount of test month in winter	month	5	5
Energy meter difference between WEC with and without blade de-icing	kWh	870.000	650.000
Average monthly energy surplus in winter month with icing	kWh	174.000	130.000
Percentage of energy surplus in relation to WEC without de-icing system	%	48	54

The energy yield surplus due to the rotor blade de-icing system strongly depends on meteorological conditions like icing and wind speed on site.

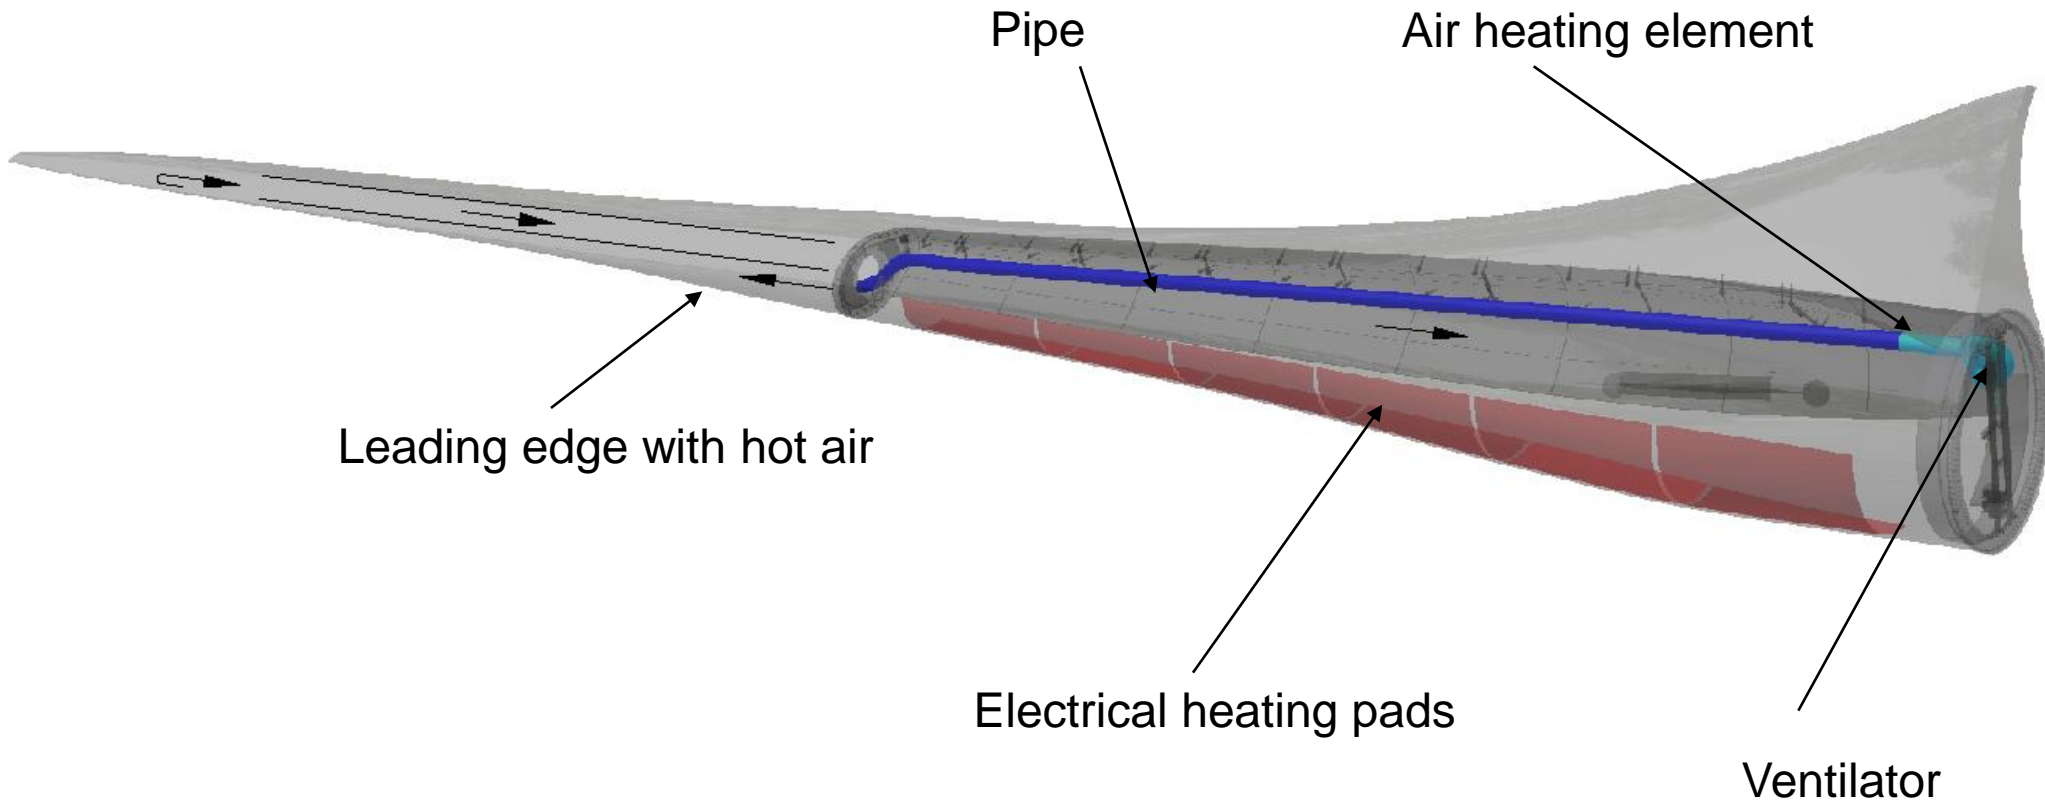
De-icing system for the ENERCON E-126 7,5 MW

- The new de-icing system for the E126 is under development.
- The de-icing system is divided in two different systems. A new inner blade concept and the approved concept for the outer blade.

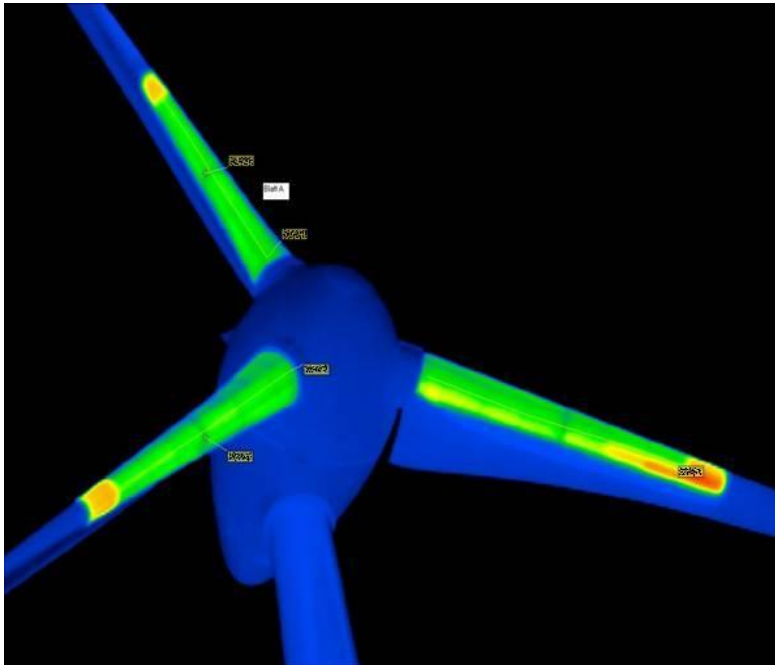
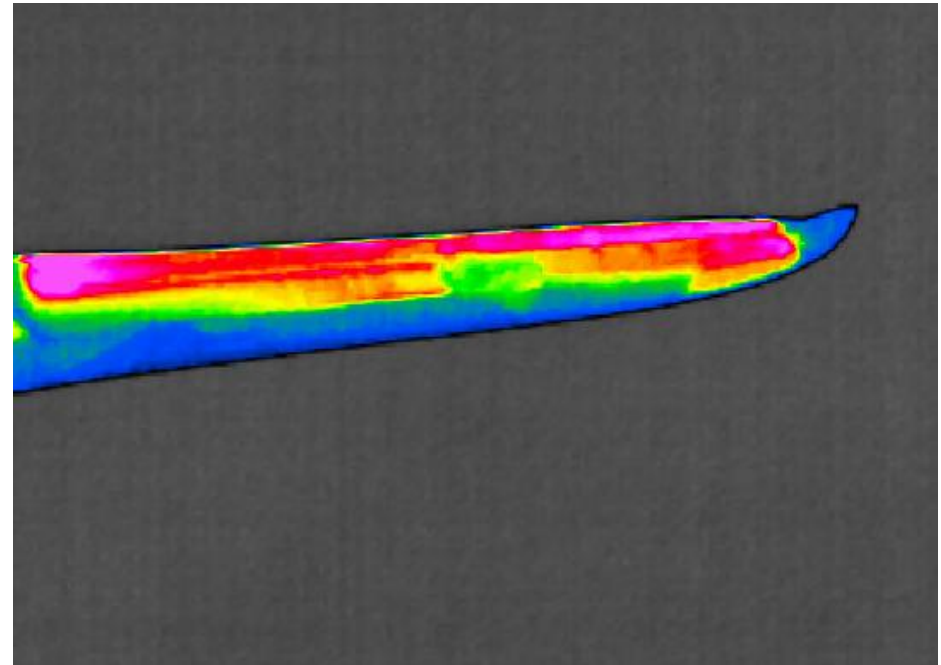
- Infrared photo with a first result of heating tests of the inner blade **while the rotor is rotating.**
- Heating pads inside the steel blade heating up the outer surface and hot air heating up the outer blade.

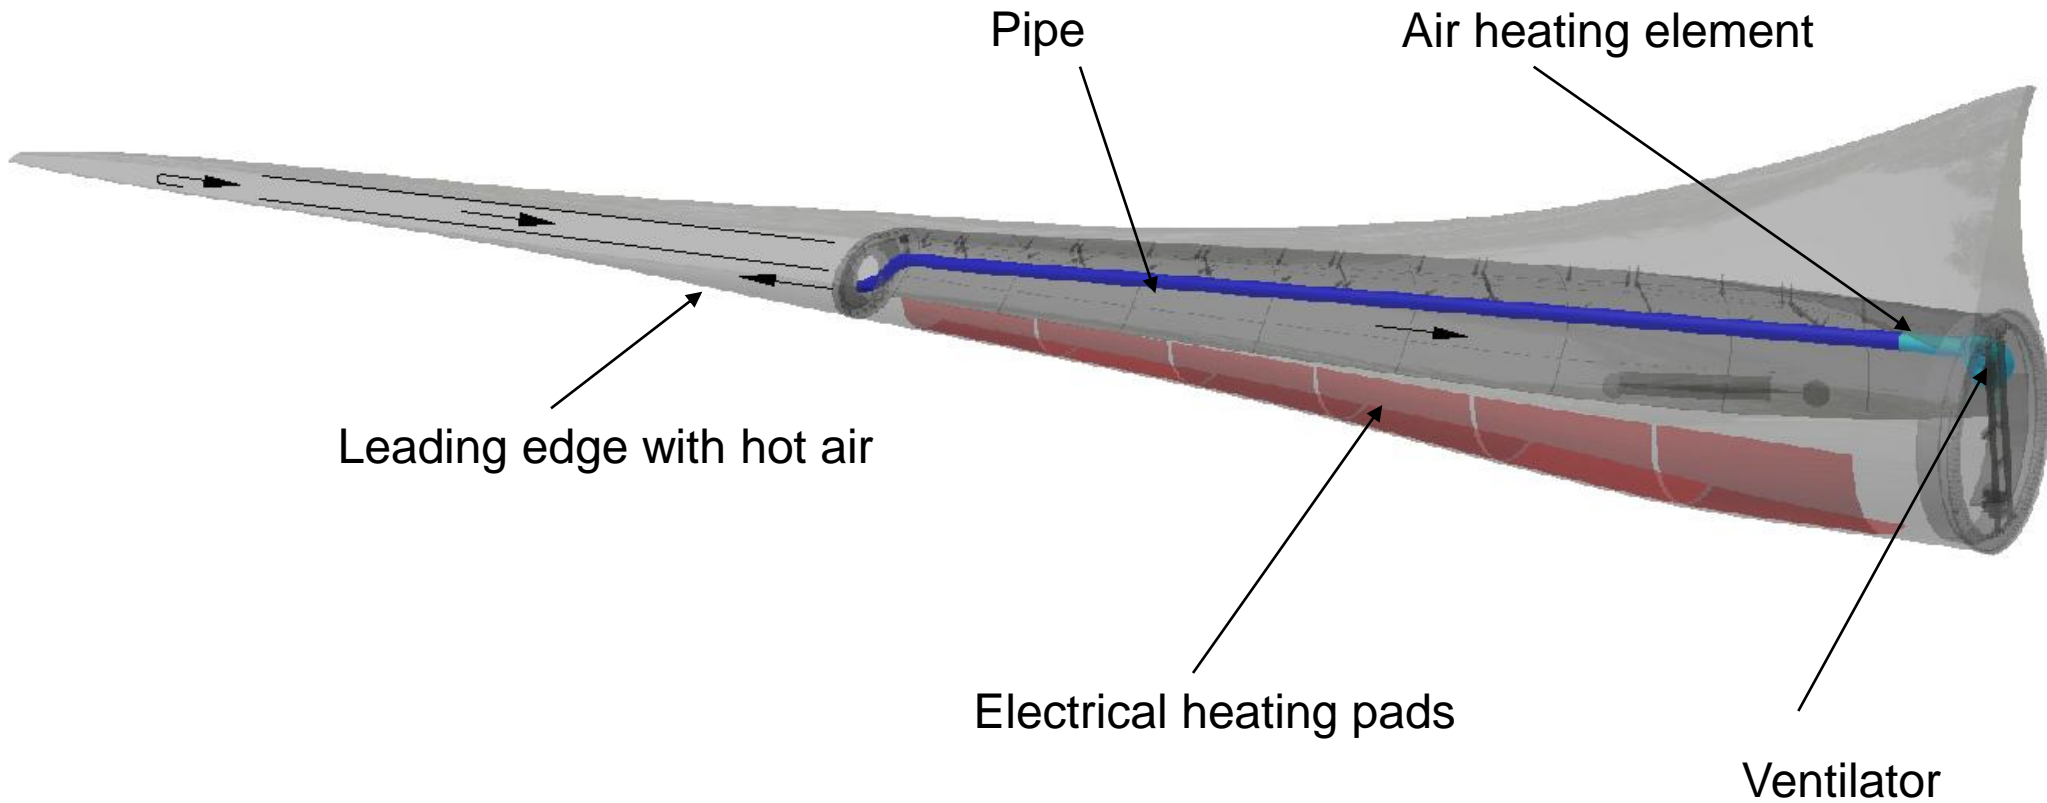
De-icing system for the ENERCON E-126 7,5 MW

- All systems are safe against lightening
- There are only two additional approved components
- There is no need to use specially designed blades
- Inexpensive
- Easy to handle for maintenance (all components are exchangeable)
- High efficiency to reduce energy yield loss due to icing
- System can work while rotor is rotating => leads to minimize the power consumption from the grid
- **It is simple, safe and works just great!**
