Borealis Wind

Winterwind 2020

Borealis Ice Protection System

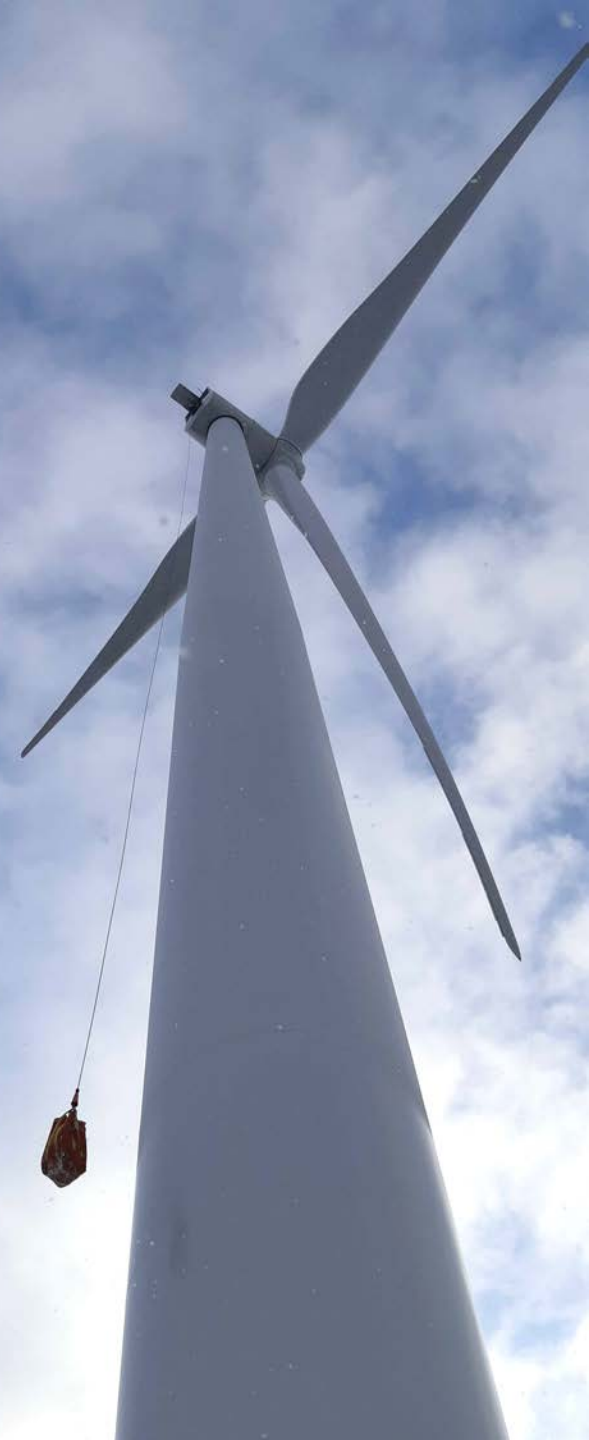
Installation

- 9 days to retrofit the Borealis System
- Schedule is designed to have the turbine operational overnight
- All materials are sized so they can be easily passed into the blade
 - Less than 50 cm x 50cm in cross section
 - Less than 70 lbs.

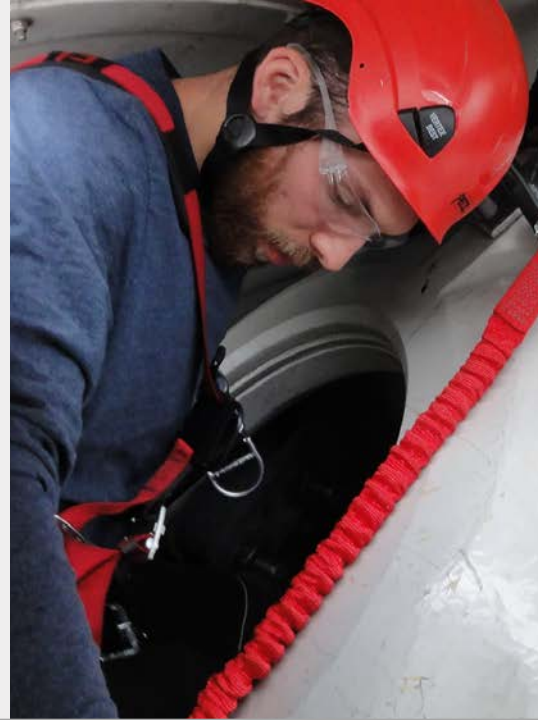
Each Day

7 am	Safety meeting
8 am	Climb, Crane-up materials
9 am	Pin blade horizontally and pass materials into the blade
10 am – 5pm	Planned work
6 pm	Clean up, move materials out of blade
7 pm	Return turbine to operation

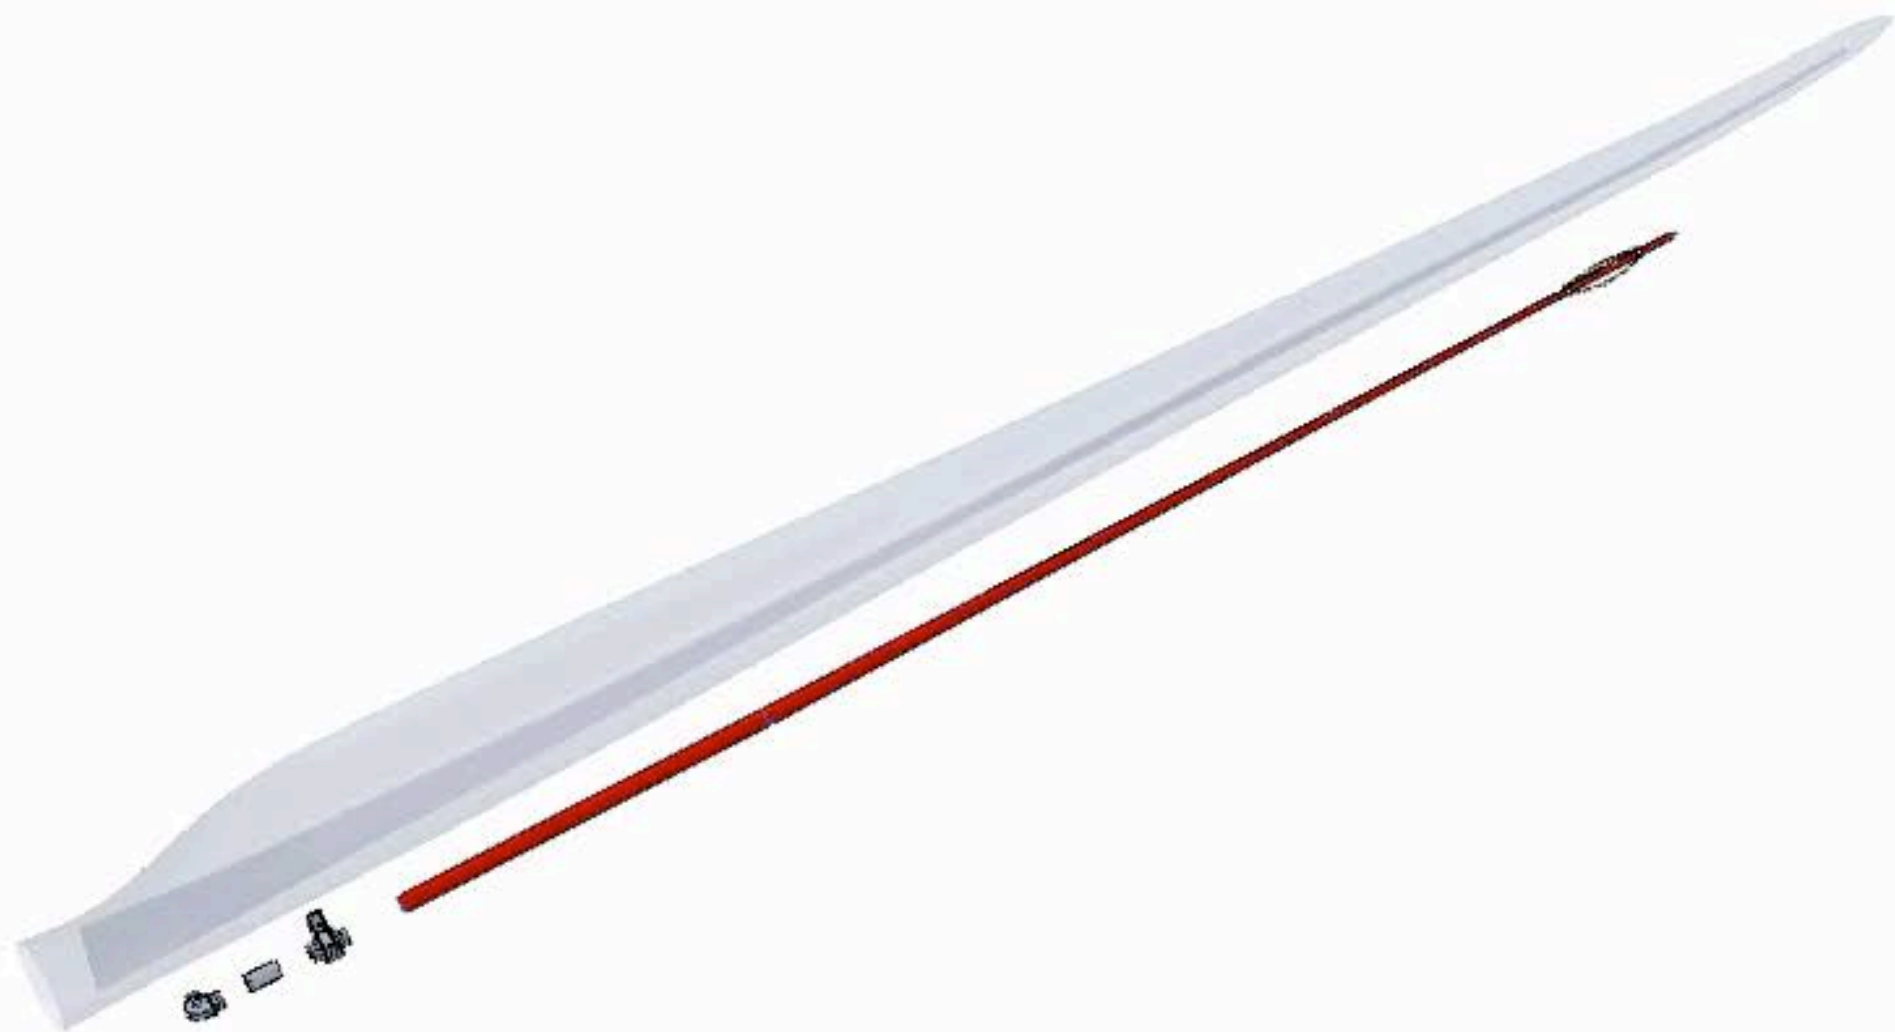
Install Procedure

1	2	3	4	5	6	7	8	9
Team 1	Install duct and electrical panel in Blade A, B, C			Install blower and heater in Blade A, B, C			Run cable from the hub to the heating system in Blade A, B, C		
Team 2	Mount hub and nacelle panel		Run Cable from nacelle to hub		Mount tower electrical panels		Run cable up tower		Slip ring

Optional Feeder Circuit

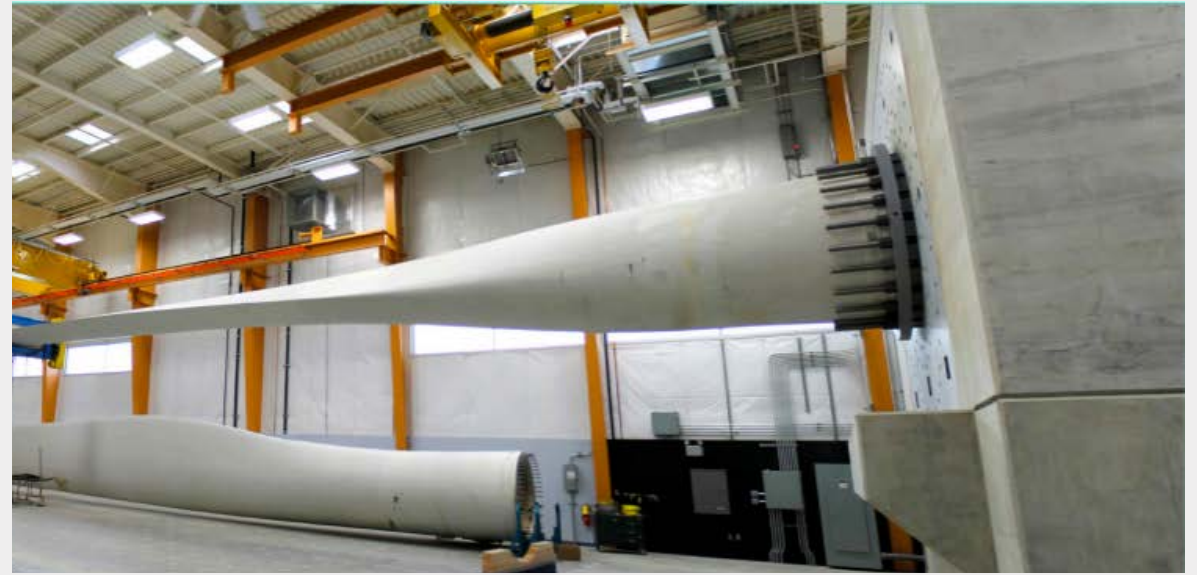
- Load testing with the University of Maine, Advanced Composites and Structures Center
- Thermal impact analysis with the Composites Research Network and University of Waterloo
 - Physical testing and improvement of the model are ongoing
- Strain much less than the strain limit defined by IEC 61400-23

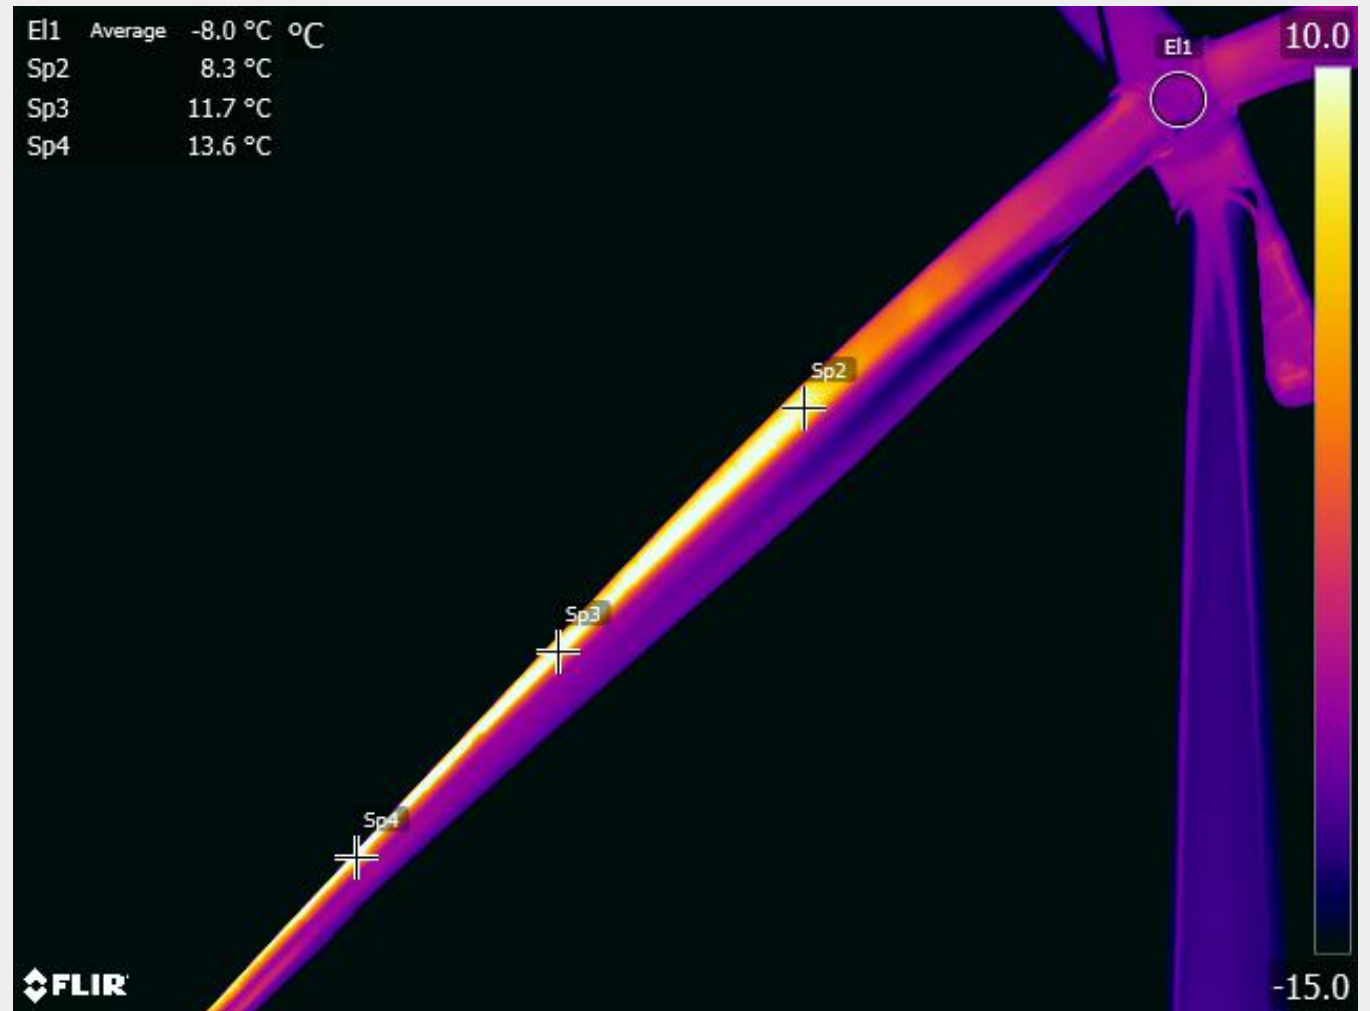
Infrared Photo of blade with Borealis IPS

Ambient Temperature	-7°C
Wind Speed	6 m/s
Blade Internal Temperature	32°C
Blade External Temperature	11°C
