# Suorva

A 600 kW cold climate  
research turbine

A journey from 1998  
till today

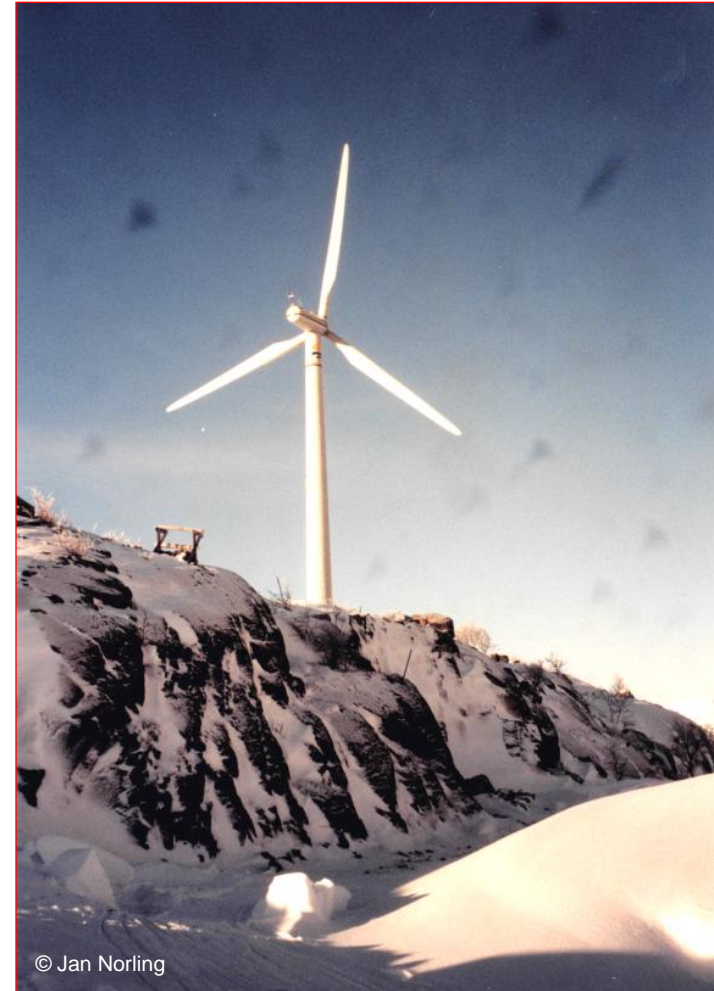
# Background – Some Data

600 kW Bonus (Siemens)

Commissioned 1998

Hub height 40 m, rotor  $\varnothing$  44 m

Stall regulated

Cold Climate equipped

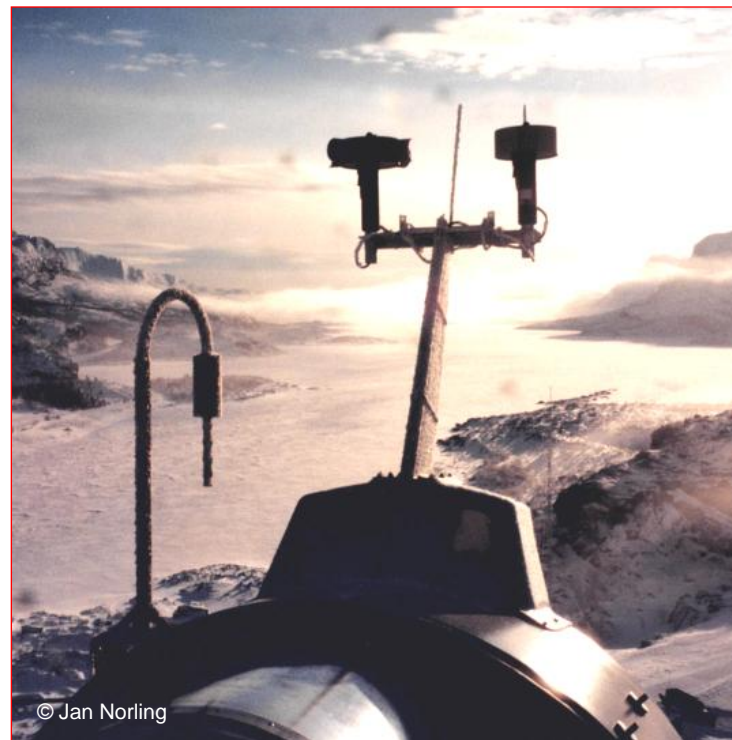
# Background - Cold Climate Equipment

Blade heating system (JE-system)

Heated

- gear box housing
- anemometer (Hydrotech)
- wind vane (Hydrotech)
- tower bottom
- blade tip shaft
- controller box

Ice detector (Vaisala → Labko)

Low temp oils

No low temp steel → operative  $> -20^{\circ}$

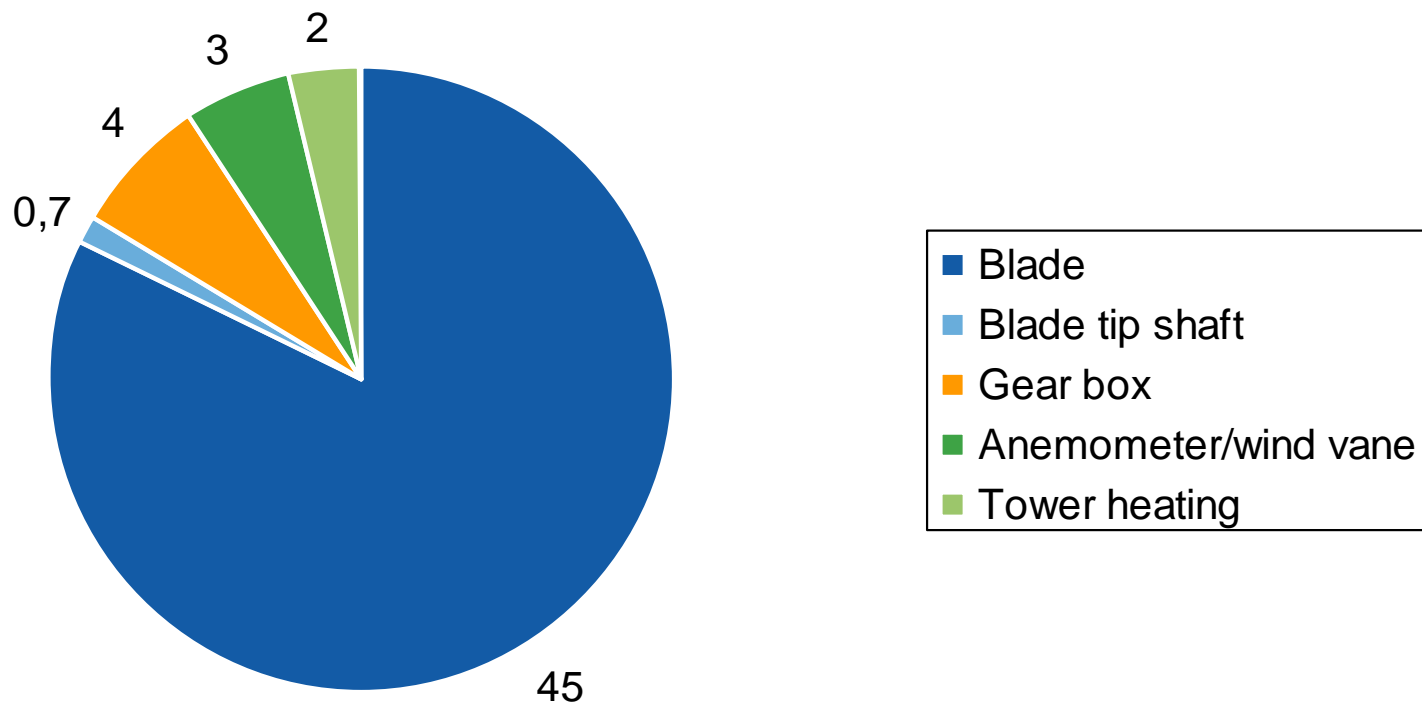
# Background- Heating Equipment

Installed kW-capacity for heating, total 55 kW

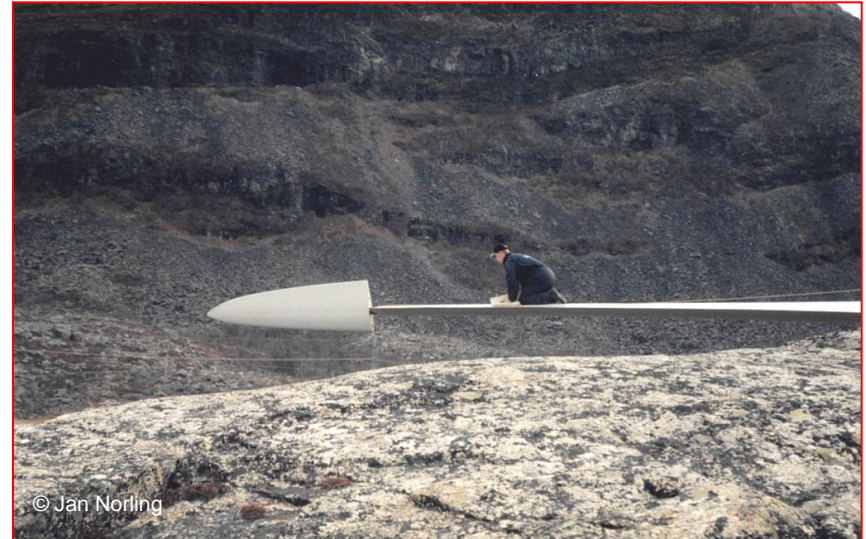
# Experience – Consumption of Heating Energy

Production 1999-2013  
21,7 GWh or 1,45 GWh/year

Energy for heating  
380 MWh

**1,7 % of total production**

During winter season 2008/09 blade heating system was in operation constantly due to ice detector failure

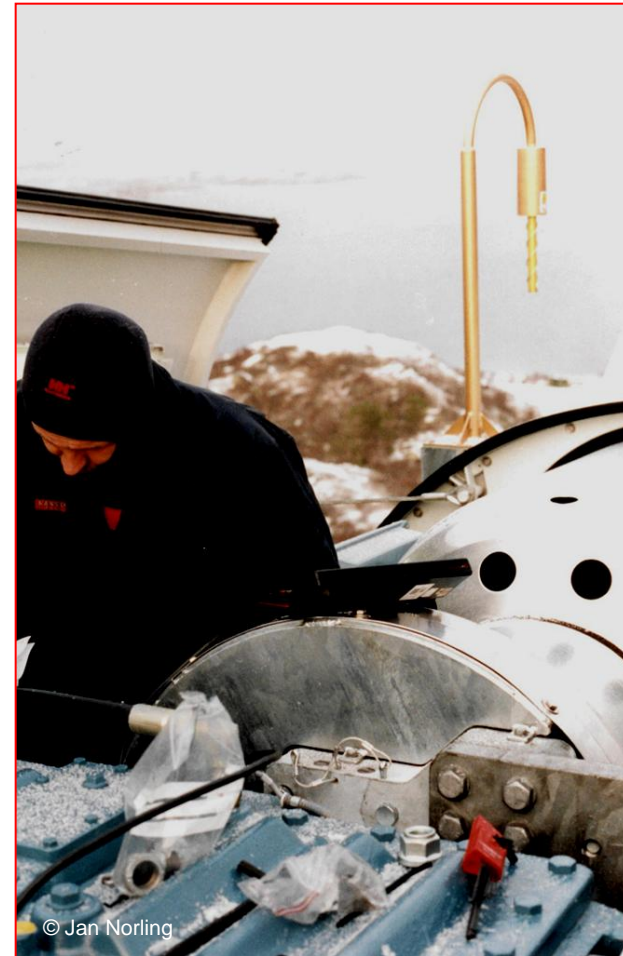
# Experience – Causes of Failure / Standstill

Remote turbine → longer calling-up time than usual

Service by nearby hydro technicians, b-priority

Small turbine, b-priority

Some spare parts have long delivery time

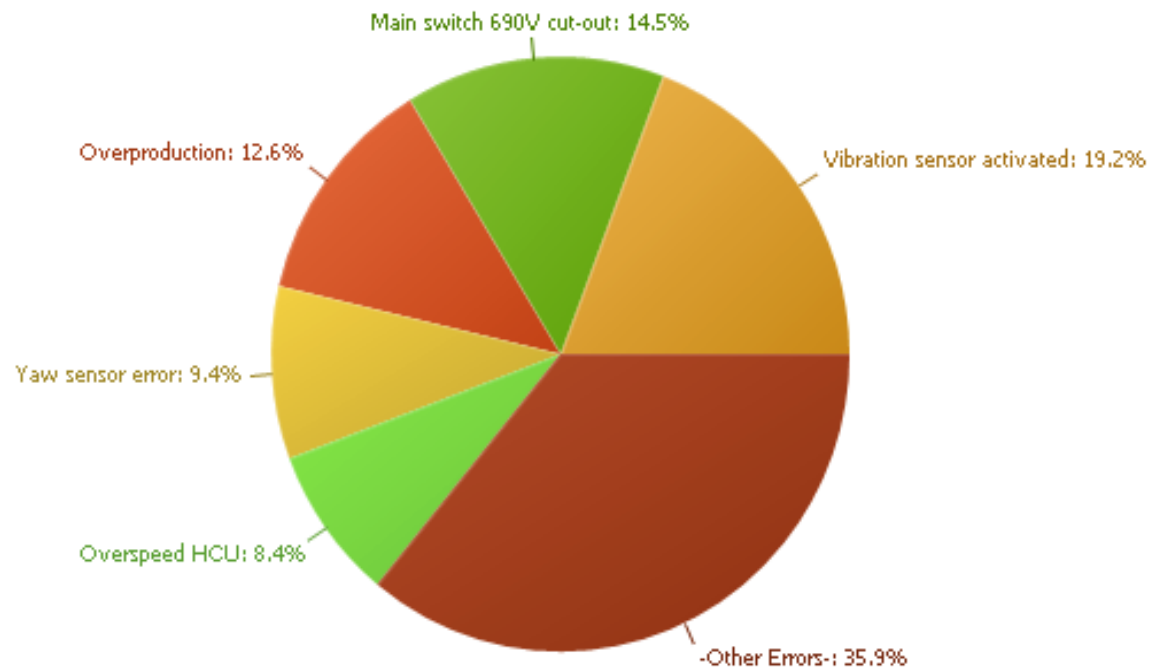
# Experience – Common Failures

Percentage per error of total downtime 2010- Jan 2014
