Monitoring Icing Events

With remote cameras and image analysis

At WinterWind 2014

SNEEC

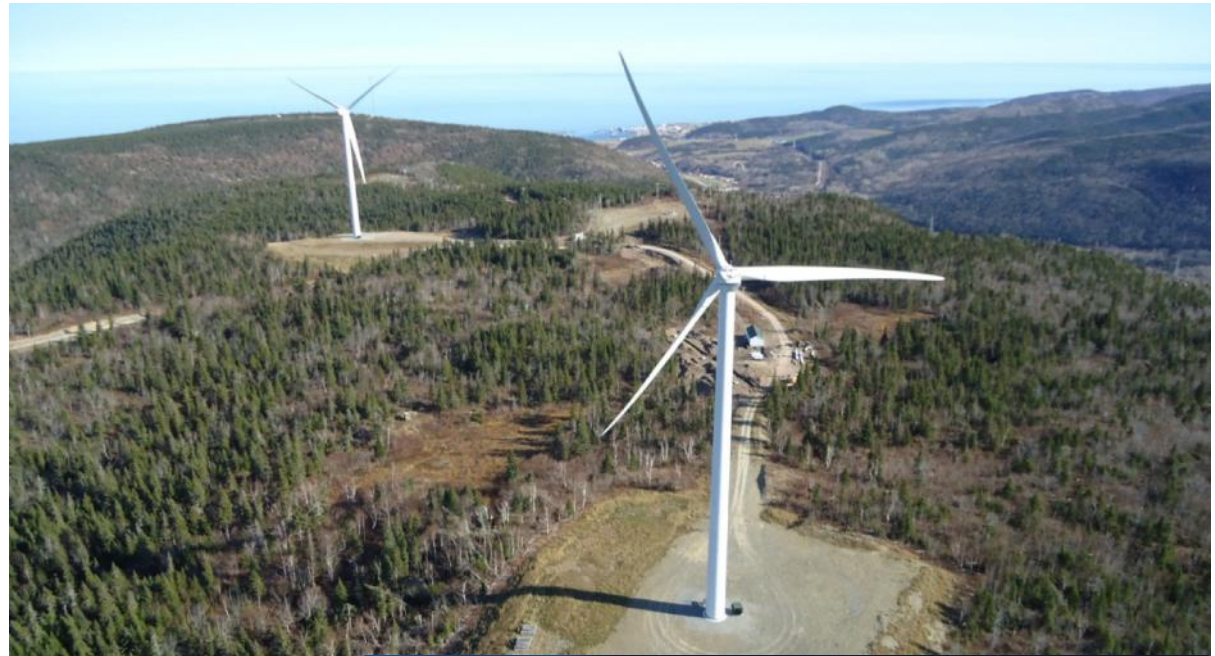
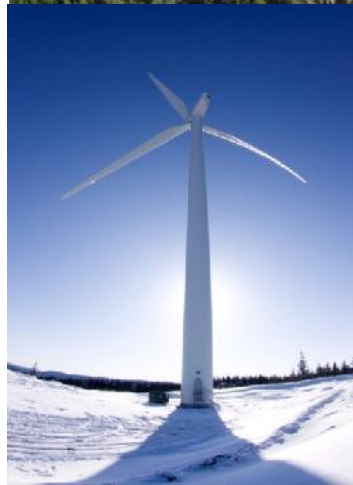
- Two 2.05 MW SENVION MM92 CCV

- Commissioned March 2010
- Icing & complex terrain
- R&D, technological transfer, technological validation, performance assessment.

Description	Value
Number of wind turbines	2
Model	REpower MM92 CCV
Rated power / Wind turbine	2.05 MW
Frequency	60 Hz
Rotation speed	7.8 – 15 RPM
Start-up speed	3 m/s (10.8 km/h)
Shut-down speed	24 m/s (86.4 km/h)

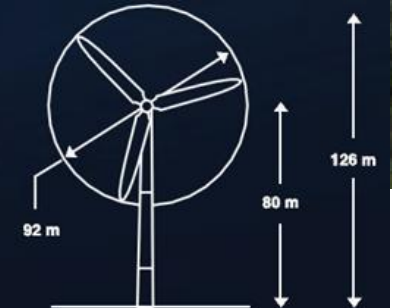
IEC wind class: 2
 Annual average wind speed: 7.9 m/s
 Topography: Complex site with high turbulence, near the sea
 Temperature: -30°C to +30°C
 Ice conditions: Up to 40 mm of ice

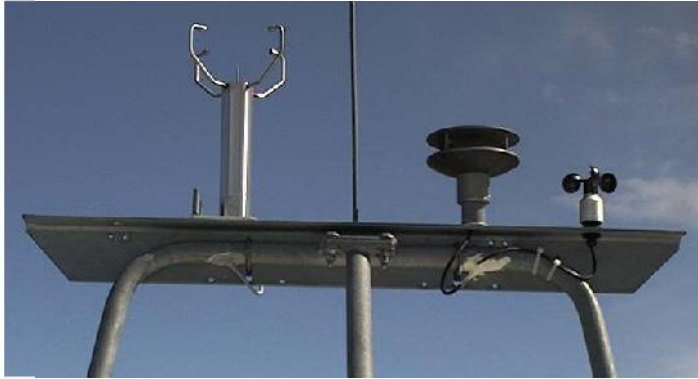
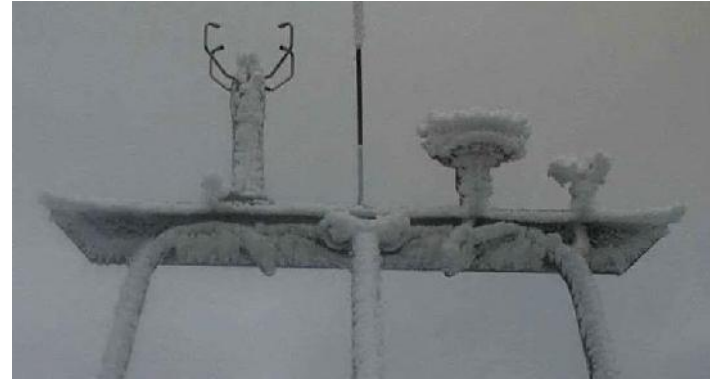
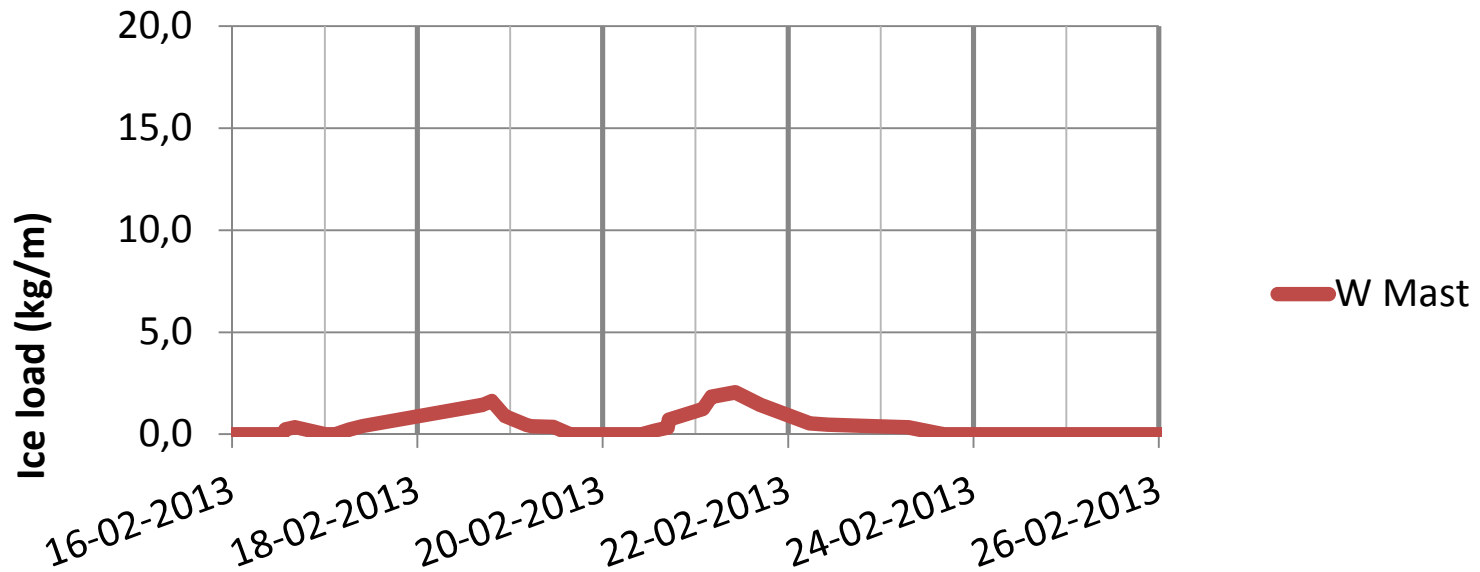
Icing severity assessed on nacelle weather mast

Ice load estimated from width measurement on images

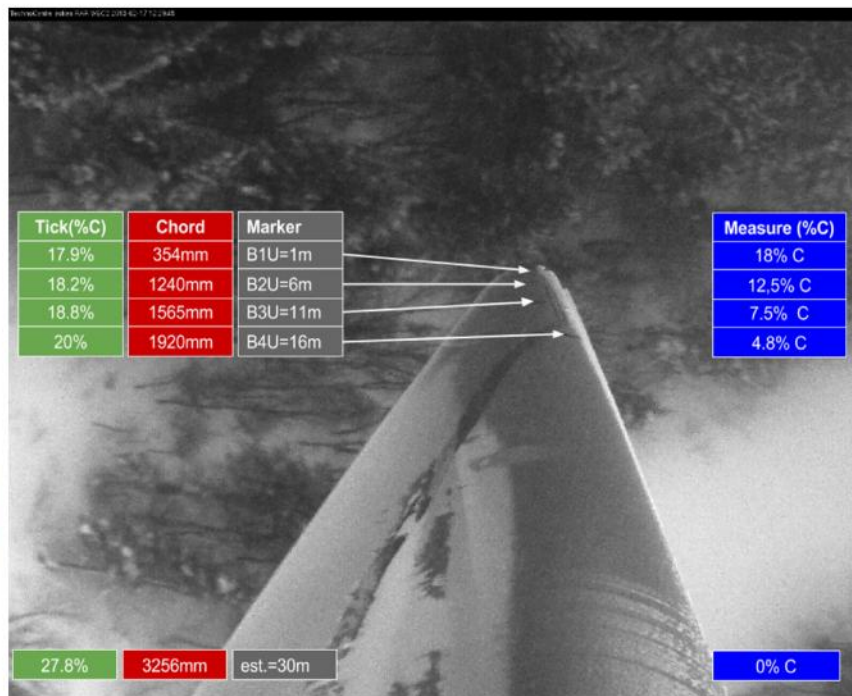
Hub camera – image analysis

Ice load estimated at 5 positions along span

Average ice load determined base on weight function

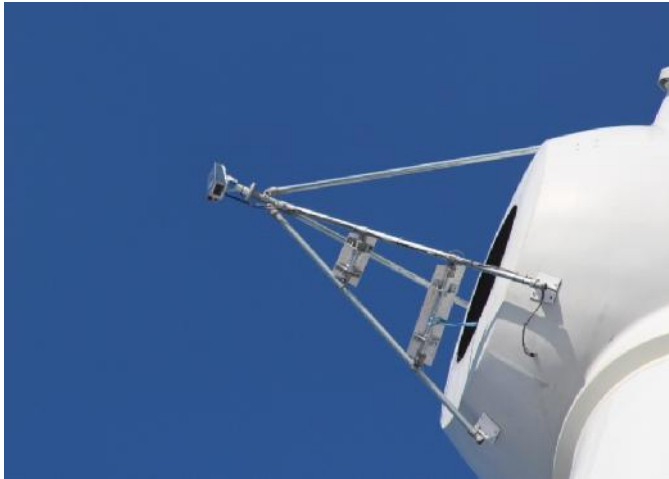
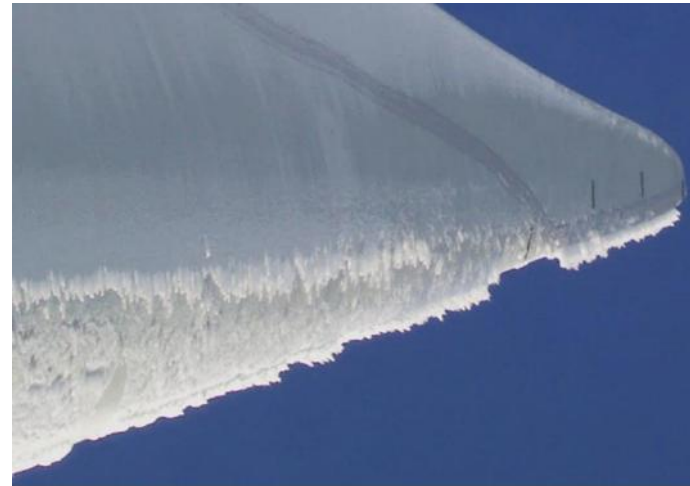
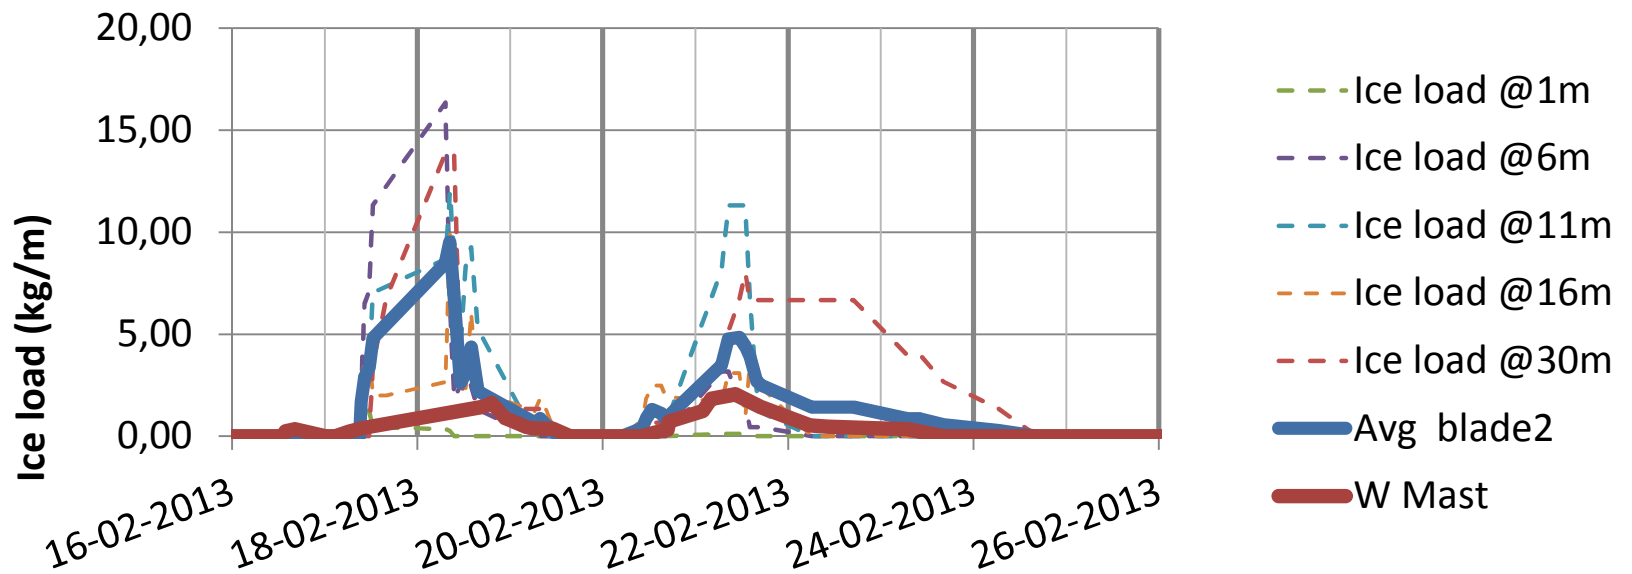
Icing severity assessed blades with hub camera

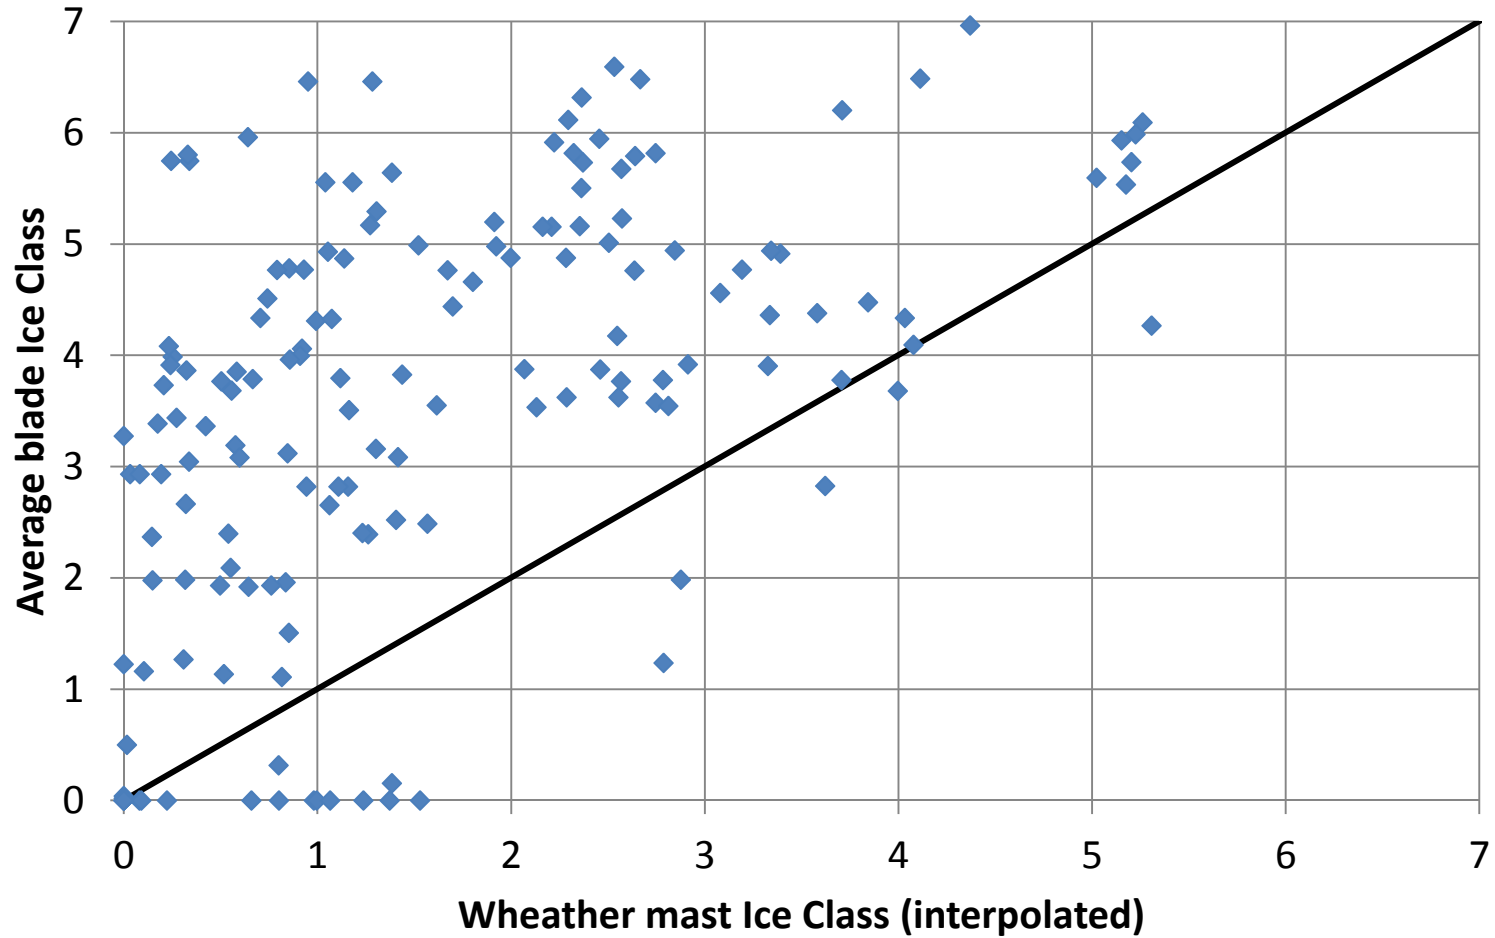
Blade vs WM icing

- Presence of ice on weather mast indicates presence of ice on blades
- Ice load on weather mast underestimates ice load on blades
- Hub camera provides insight on ice accretion and ice shed

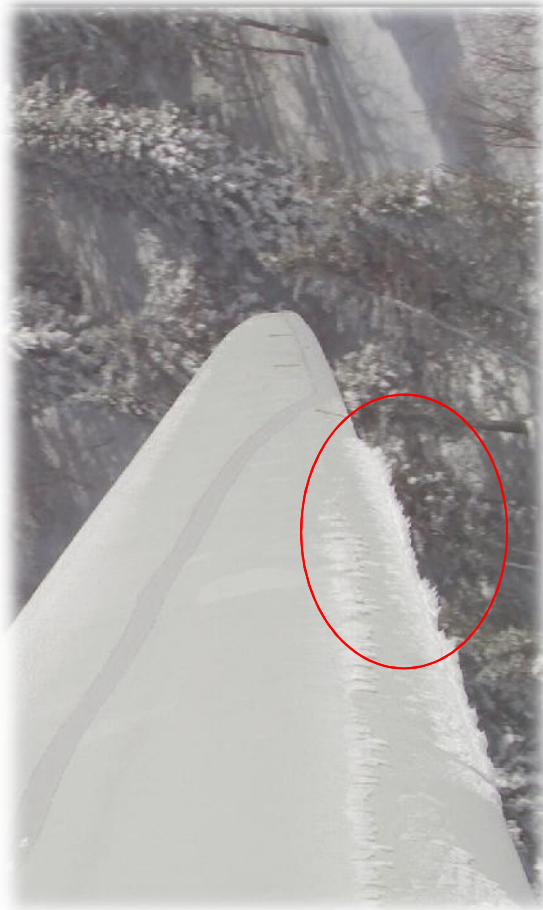
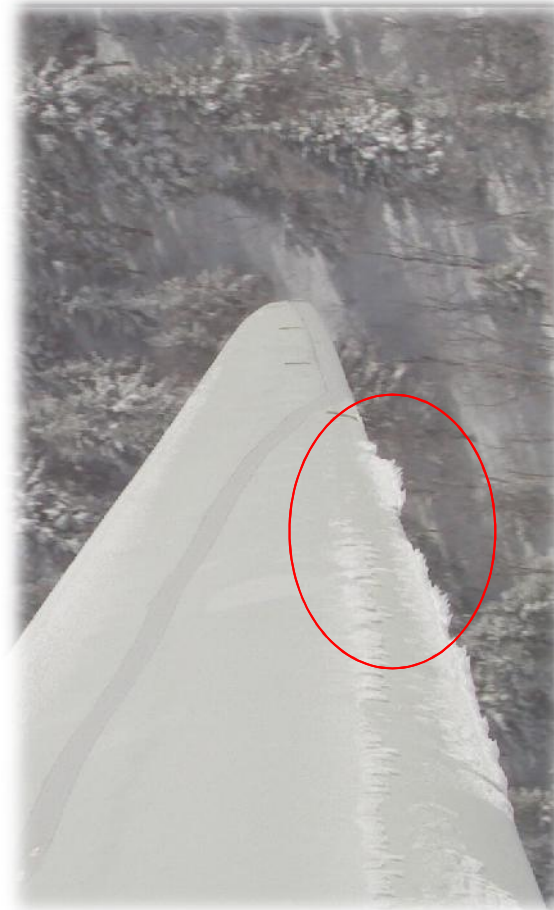
Hub camera – ice shed

10 min. later
