# Performance of two nacelle-mounted ice detectors: A case study

WinterWind 2016, Åre, 10.2.2016

Katja Hynynen  
Svetlana Afanasyeva  
Olli Pyrhönen  
Lappeenranta University of Technology

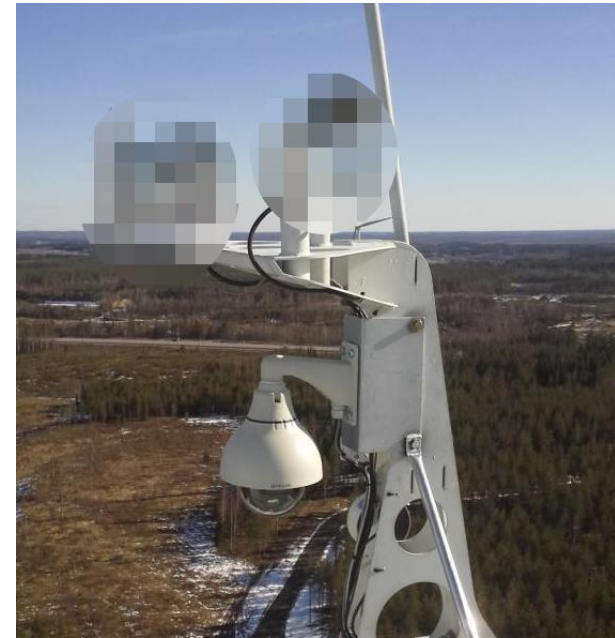
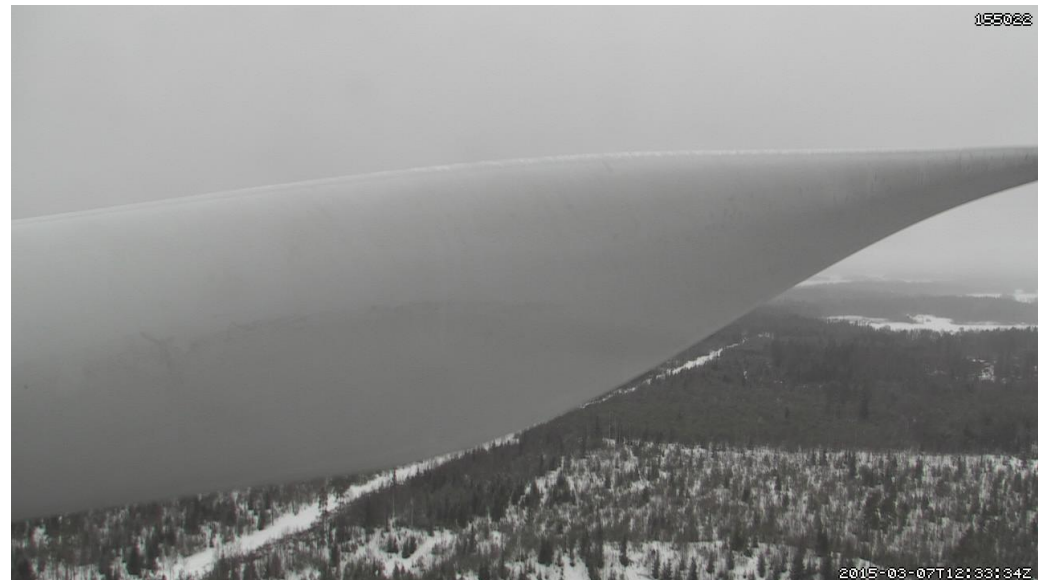
# Sensors and measurements (1/2)

- Ice detector, Sensor A
  - Freezing rain sensor
  - Ice detection is based on change of resonant frequency of vibrating probe
- Ice detector, Sensor B
  - In-cloud icing sensor
  - Ice detection is based on ultrasonic principle.
- Both sensors have heating switched on at the time of alarm
- Web camera mounted on nacelle and shooting blades

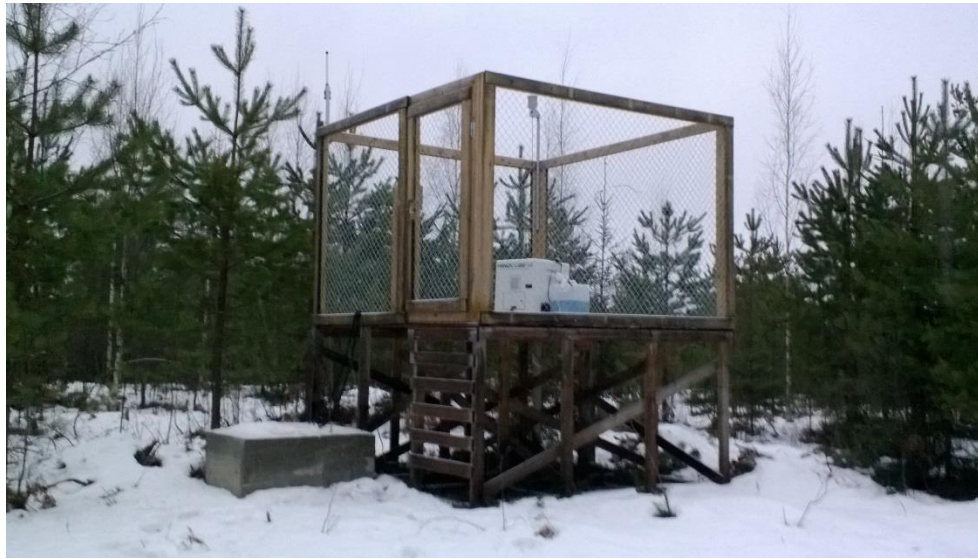
## Sensors and measurements (2/2)

Other measurements used in the study

- Weather data of nearby Lidar
- Weather data from FMI
- SCADA data of the turbine
- Measurement period 18.10.2014 – 15.4.2015 (6 months)

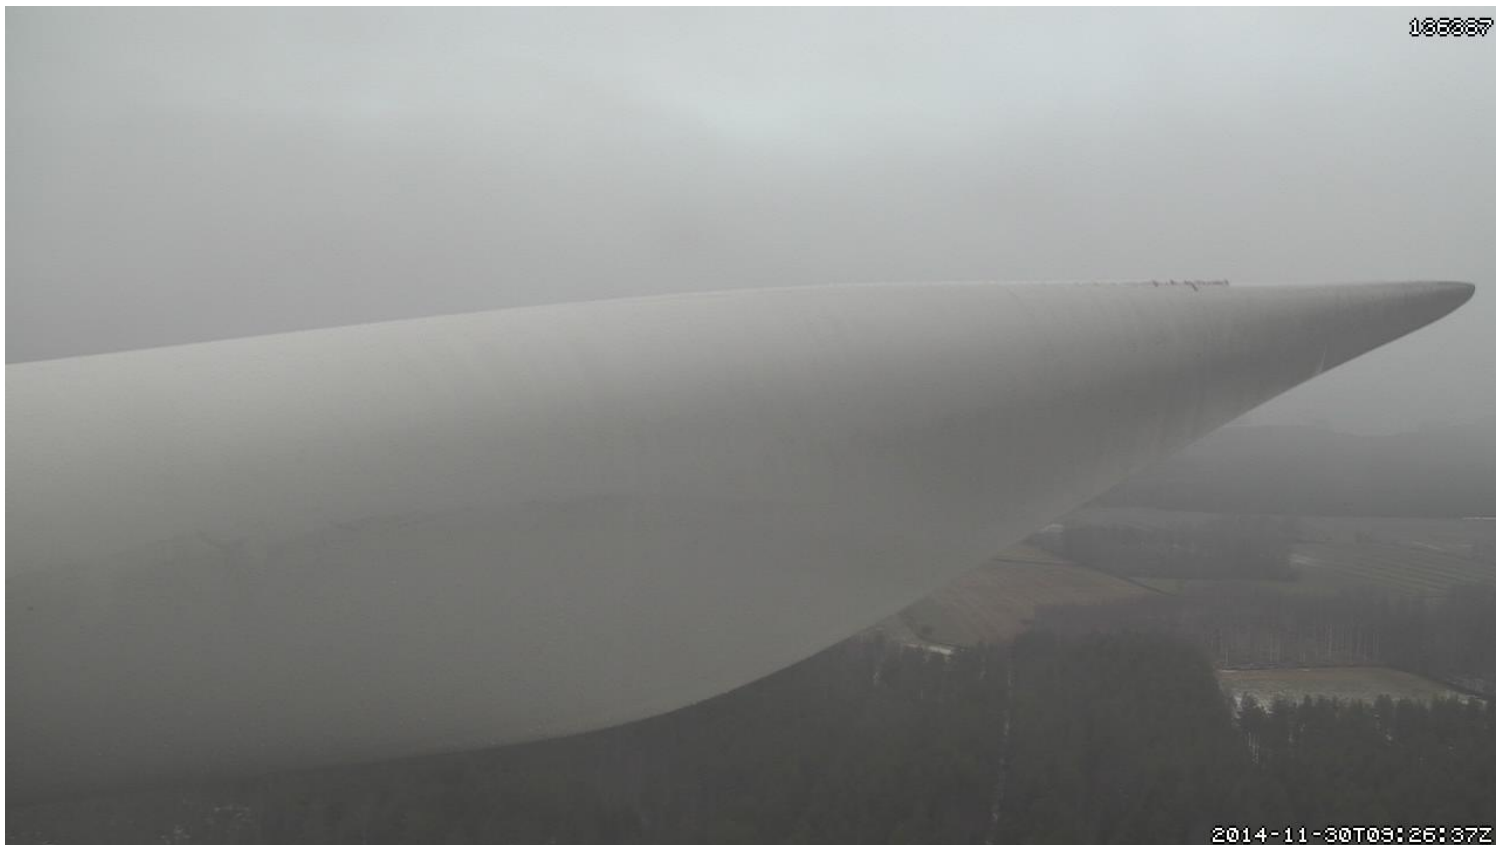
## Ice types found by web camera (1/2)

- Rime ice on leading edge found in 20 days

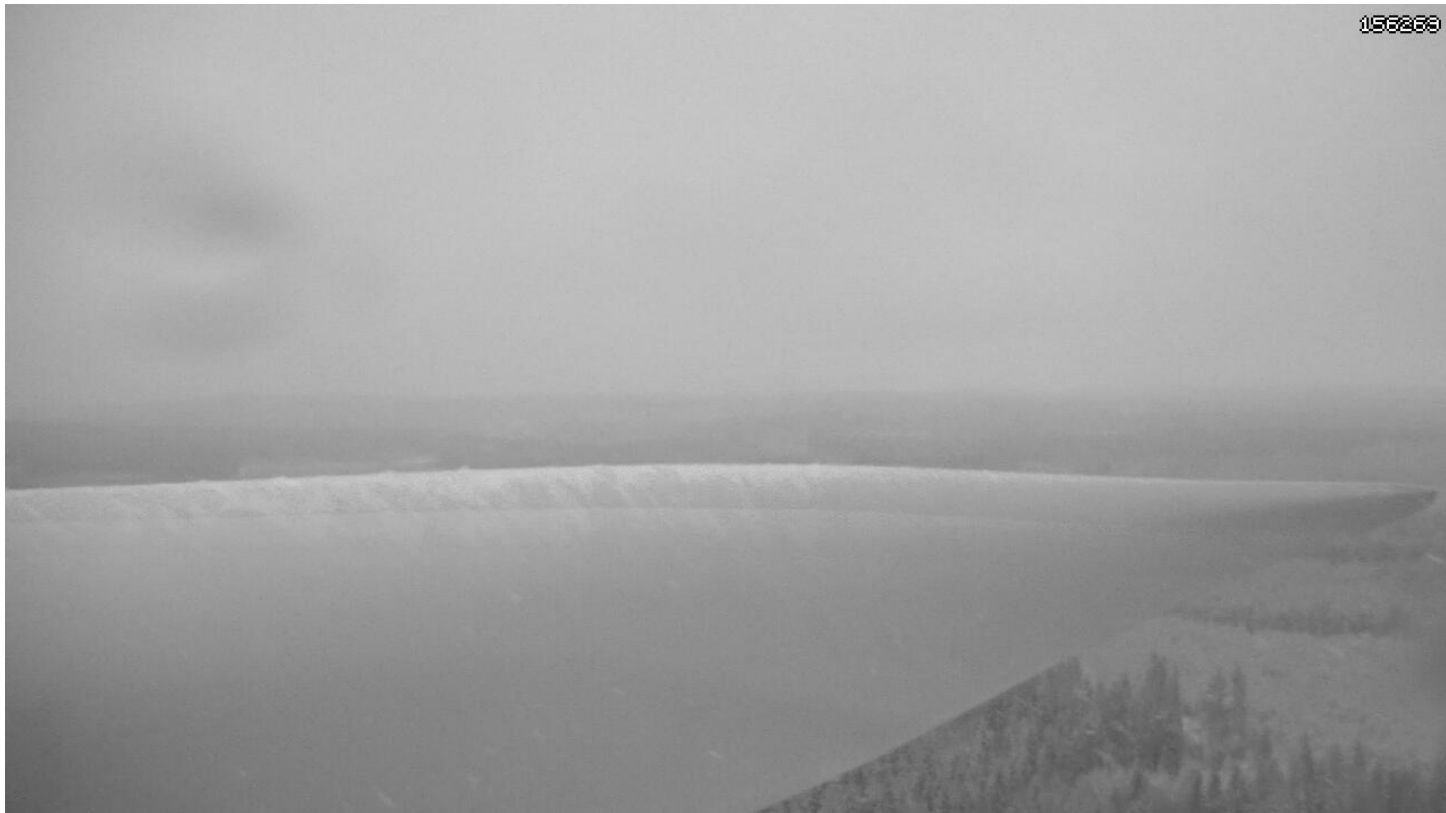
## Ice types found by web camera (2/2)

- Snow-type of ice on the blades in 47 days
- In total, some type of ice (may be several types) found in 59 days

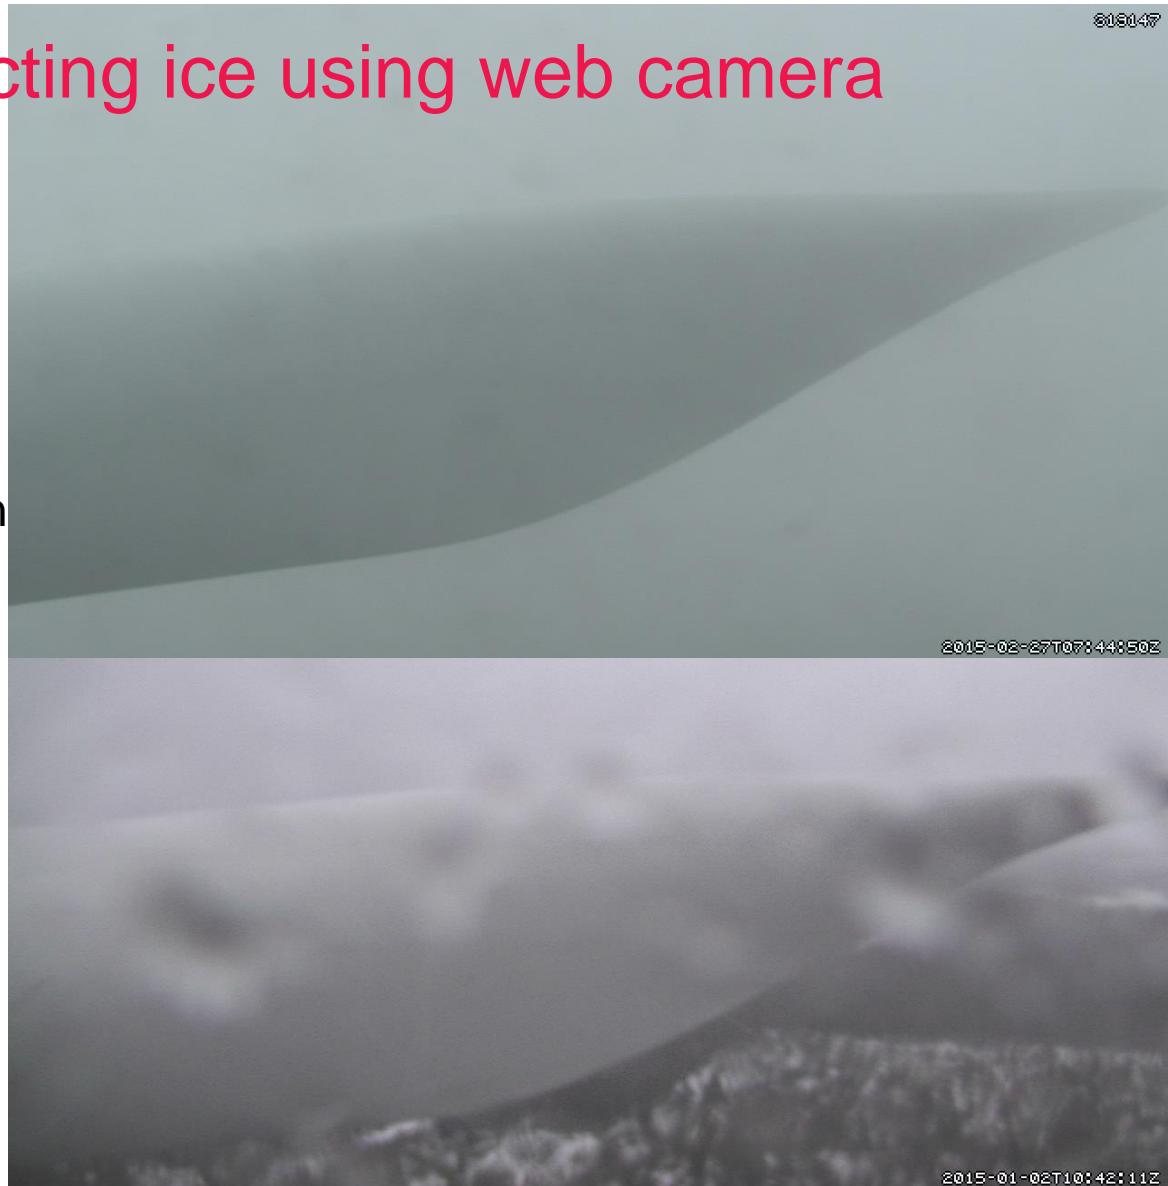
# Challenges in detecting ice using web camera

- Camera far from the blade
  - ⇒ Not possible to see glaze or other thin formation of ice
- Poor visibility during dark, fog and heavy precipitation
- Camera with motion detector does not take pictures when turbine is standing
- ⇒ Most probably there has been
  - ice more often than in 59 days
  - also glaze

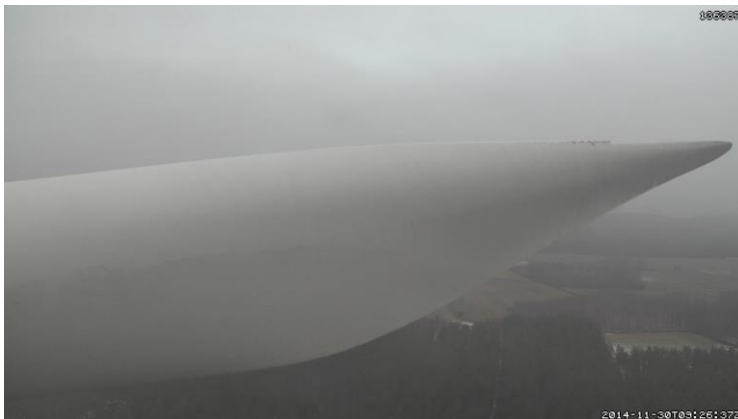
# In-cloud icing causing rime ice

- In-cloud icing occurred especially on November 2014
- In total, 13 in-cloud icing cases were found
- Rime ice accreted according to the camera
