Cost Effective De-icing Repairs

SUPPORTING the WIND industry

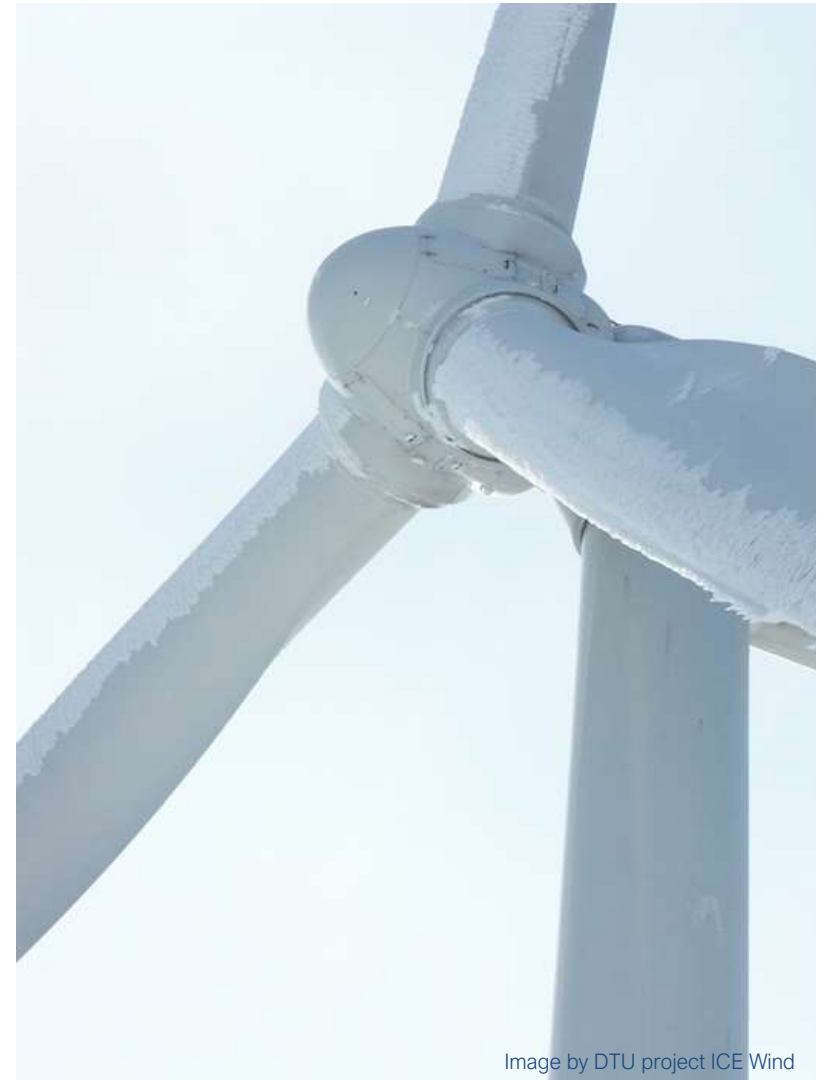
Carbon Electric Resistance

- Biax ply laminate running along LE center on blade PS and SS
- Efficient system to heat blade surface during icing events
- System input between 25-60kW

Blade De-Icing effect pr kvm – 50m blade	
input effect kW	60
CFRP length m	96
CFRP width m	0,6
Area m ²	57,6
Effekt kW pr m ²	1,04

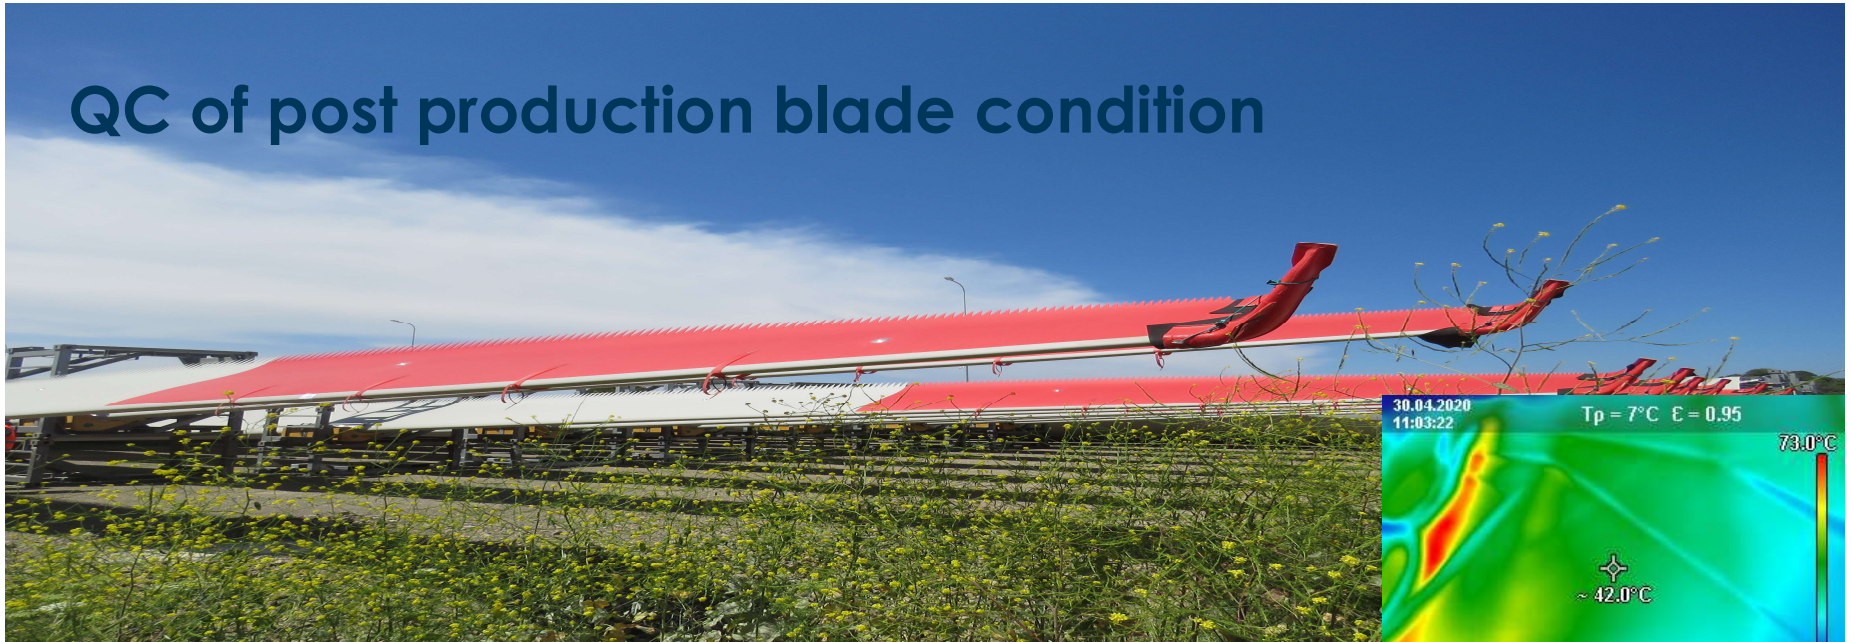
QC of post production blade condition

Avoid unnecessary repairs by

- Inspect de-icing systems against OEM factory condition specifications
 - Acquire report on system functionality test

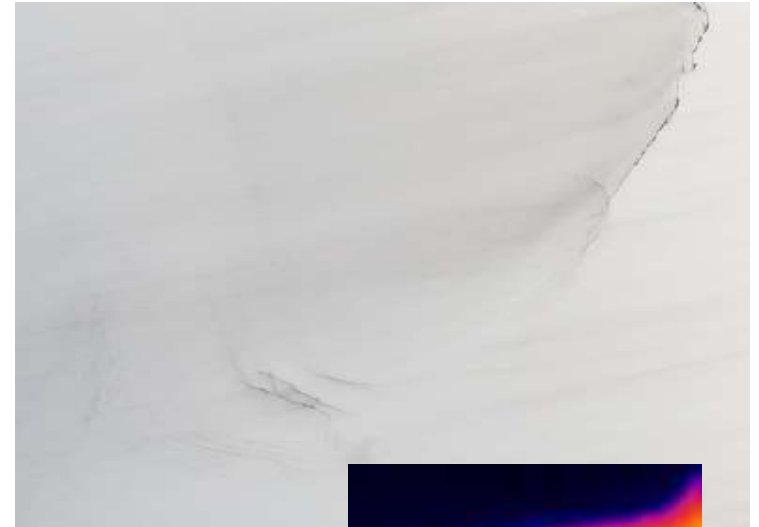
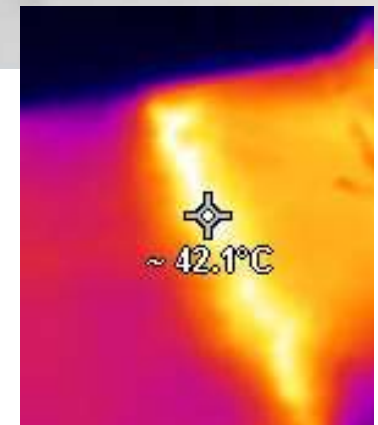
De-icing defects

Common damages in the Carbon Ply

- **Wrong lightning attachments**
Striking the De-Icing system that with sufficient energy can cause an immediate delamination between the blade surface and the carbon ply.
- **Transport**
Impact/scraping on the blade surface can cause tremor or removal of carbon fibers.
- **Fatigue**
Delamination cause by inadequate adhesion or air inclusion between carbon ply and blade surface.

Any of the above damages will reduce the local deicing area where the heat is distributed, causing a hotspot in the remaining healthy area and a cold spot in the damaged area.

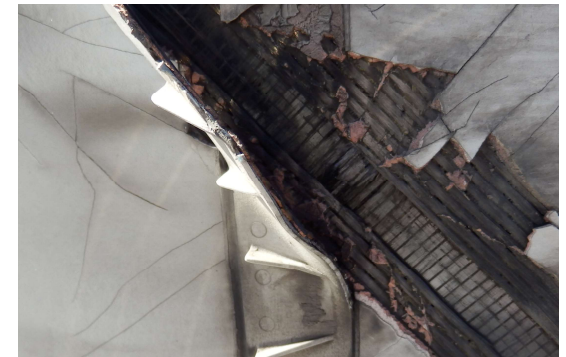
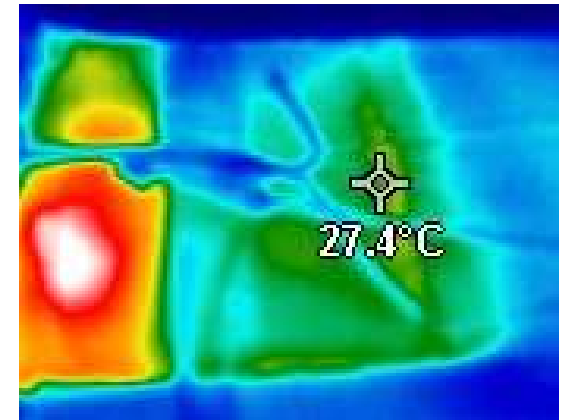
De-icing defects

Consequences of defect

Blade De-Icing effect pr. m healthy laminate	
input effect W	600
CFRP length m	1
CFRP width m	0,6
Area m ²	0,6
Effekt kW pr m ²	1

Blade De-Icing effect pr. m 75% width reduction	
input effect W	600
CFRP length m	1
CFRP width m	0,15
Area m ²	0,15
Effekt kW pr m ²	4

- High spike in local heat distribution can damage laminate if the temperature increases above 80dgr
- In severe events it can render the system inoperable due to risk of fire damage in the hotspot

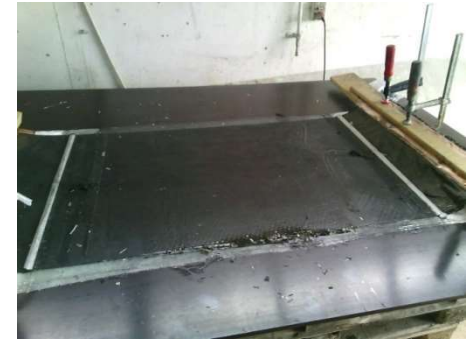
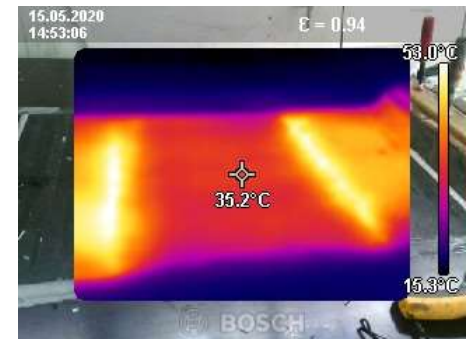
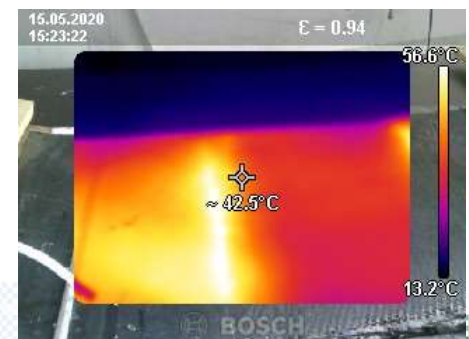
Repair of Carbon De-icing

- Must enable heat transfer over the entire width of the carbon ply
- Effects of heat transition zones must be minimal
- Any hotspots must not exceed 80 degree during max-load on the system
