# Investigation of Using Icephobic Coatings on a Cable Stayed Bridge

*ABSTRACT:* Icing is a significant challenge that affects structures in many countries. Bridges are an example of structures that may be severely affected by atmospheric icing. The Veterans' Glass City Skyway (VGCS) is a single pylon cable stayed bridge with a main span of 375 m in Toledo, Ohio which was opened to traffic in 2007. The VGCS is owned by the Ohio Department of Transportation (ODOT). Six major icing events have occurred on the bridge which led to the closure of bridge lanes and damaged cars. Therefore, over 80 anti-icing/de-icing technologies were investigated. In addition to considering active and passive technologies, bridge management was considered as an approach to assist the bridge operators.

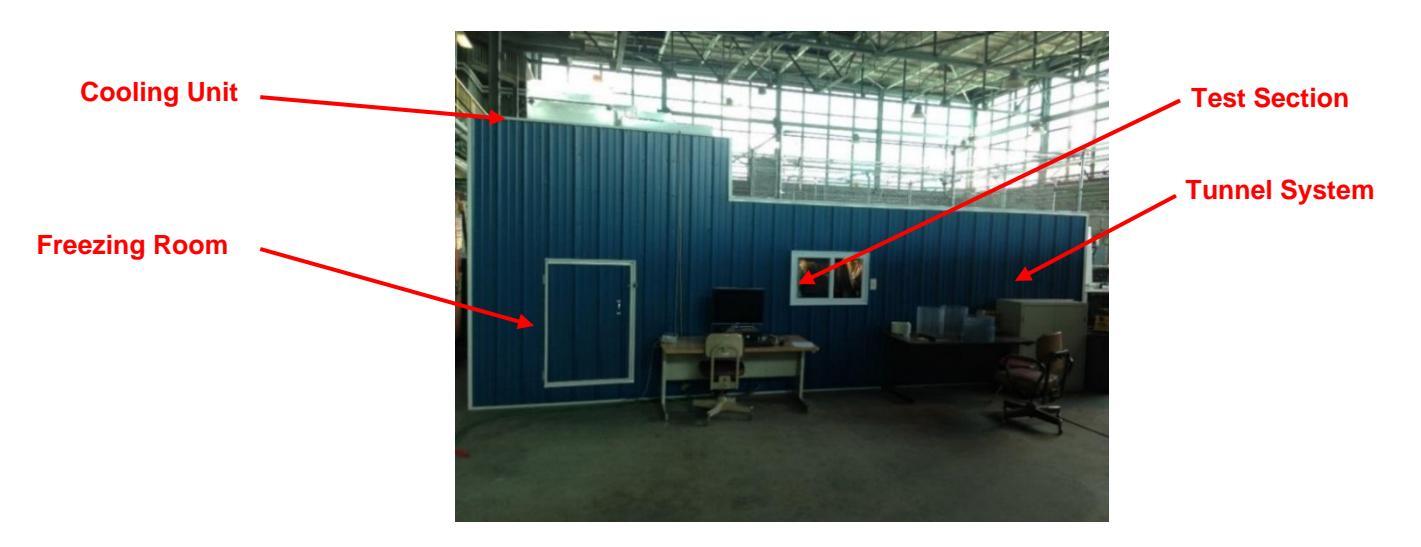
## Figure 1: UT Icing Tunnel

In order to conduct experiments with scenarios similar to a natural environment, an icing tunnel was designed and built by the University of Toledo. The icing tunnel consists of two main parts, i.e. freezing room and a tunnel system. All the icing tunnel parts are shown in Figure 1[7].

The icing tunnel is a closed loop system. The cooling unit is capable of keeping the temperature constant as low as -20°C. A multispeed fan was installed for adjusting the wind speed. The test section is made from a clear tube to allow for photography. The test section has a misting system to simulate rain and mounting system to support the specimen.

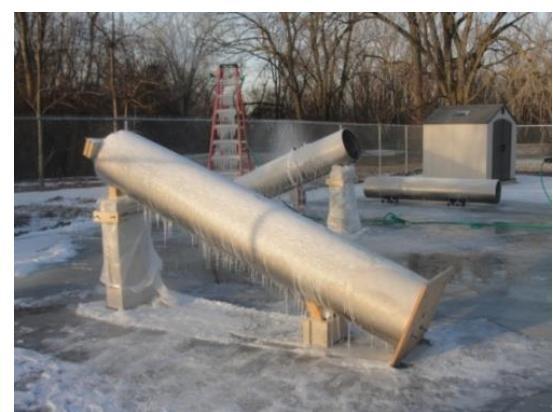
Figure 3: Three specimens with different orientations

full scale sheath specimens were used for the experiments. The specimens were positioned to simulate the stays' orientation with respect to the sun.

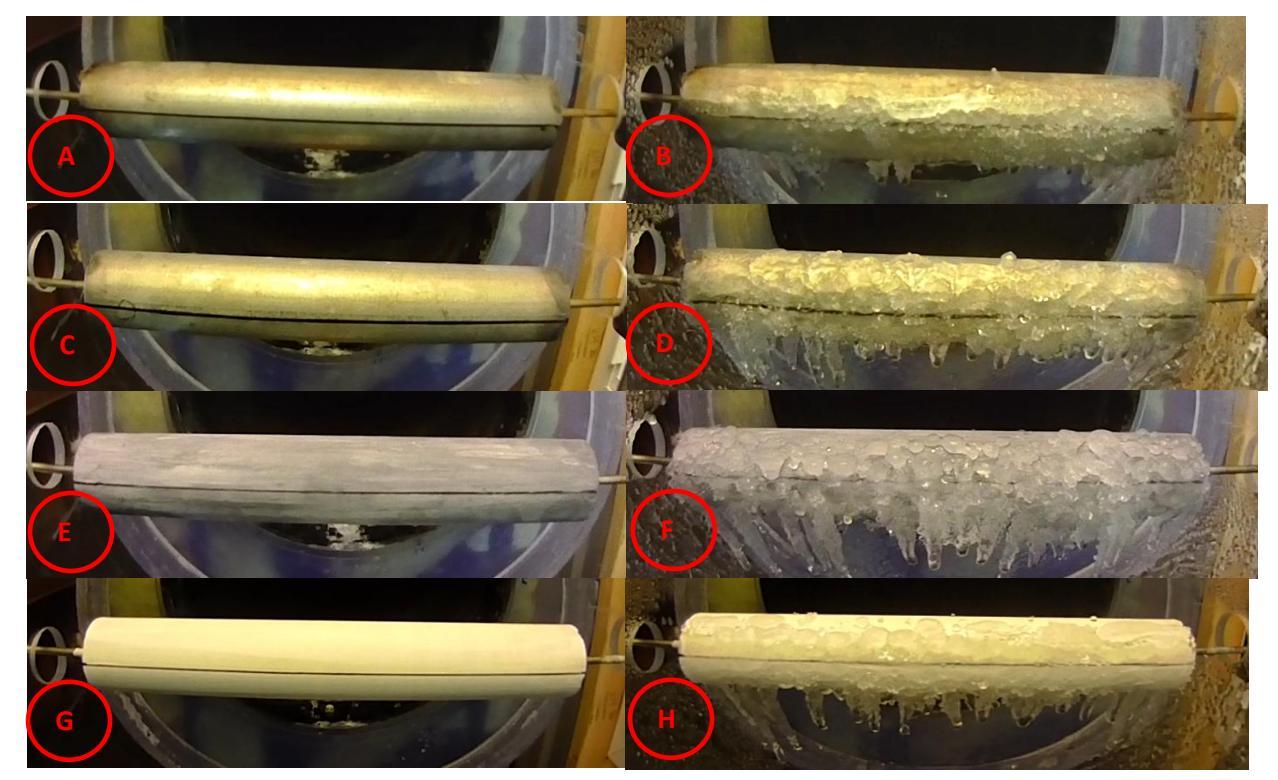
**Figure 4**: A) Uncoated - 40 Micron - 0:00 min, B) Uncoated - 40 Micron - 10:00 min, C) Aliphatic petroleum distillates with proprietary additives -40 Micron - 0:00 min, D) Aliphatic petroleum distillates with proprietary additives -40 Micron - 10:00 min, E) Epoxy polymers, silicate mesh with new melt-point-depressants - 40 Micron - 0:00 min, F) Epoxy polymers, silicate mesh with new melt-point-depressants - 40 Micron - 10:00, G) Fluorocarbon polymer and aliphatic, moisture-cure, three-part polyurethane - 40 Micron - 10:00 min

In this experiment, the air speed was 8.8 m/s and the cooling unit was turned on until the temperature reached to -5.5 °C, as these conditions were reported as typical conditions for a freezing rain storm. Moreover, the misting system was turned on to simulate freezing rain. This experiment was done for all three coatings as well as the uncoated specimen. For each case three different nozzle sizes, i.e., 40, 42, and 50 microns, were used to simulate different rain droplet sizes. In this report, however, only pictures of the 40 microns nozzle size will be presented. The duration of each experiment was 10 minutes [8].Figure 4 shows the specimen before and after 10 minutes for the 40 micron nozzle system for all of the cases. Table 2 summarizes the results of all the experiments.

For the coated specimen experiment, three different coatings were used: the aliphatic petroleum distillates with proprietary additives (Coating 1); epoxy polymers, silicate mesh with new melt-point-depressants (Coating 2); and fluorocarbon polymer and aliphatic, moisture-cure, three-part polyurethane (Coating 3). In the case of aliphatic petroleum distillates specimen, the water began to show on the specimen's surface as small droplets, then these smaller droplets combined together forming bigger droplets that moved to the top and the bottom of the specimen. The frozen droplets continued to accumulate, covering the whole surface and forming icicles due to gravity. The thickest part of the ice approximately 10 mm. Similarly, for epoxy polymers and fluorocarbon polymer the same process occurred. However, the sizes of the water droplets on the specimens were smaller, and the icicles became longer and oriented downstream. The thickest part for the epoxy polymers was 10 mm, while the thickest part for the fluorocarbon polymer was 8 mm.

Coating Droplet Size	None	Coating 1	Coating 2	Coating 3
40 micron	6.5 mm	10.0 mm	10.0 mm	8.0 mm
42 micron	5.5 mm	6.5 mm	6.5 mm	9.5 mm
50 micron	5.0 mm	6.5 mm	5.5 mm	9.5 mm

As can be seen from the table, none of the coating types prevented ice from accumulating. Instead, the ice accumulation became larger. The reason for this situation was the rapid freezing of the water droplets on the specimen's surface. Additionally, the surface of the ice on the specimen was uneven which trapped water and increased the freezing rate. The table shows that the smaller the droplet sizes, the higher the ice accumulation except for coating 3 which may be due to the different chemical composition of the coating.

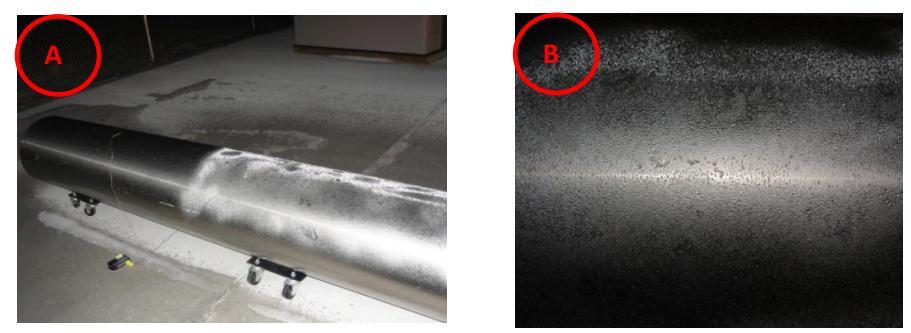
The aliphatic petroleum distillates with proprietary additives was selected for testing on a full scale stay because it is clear and will not affect the color or shine of the stays. The coating was applied to one side of half of the specimen, then a mist of water was sprayed onto the entire specimen. The coating caused water to bead into small droplets. Due to the brushed surface of the sheath, small water droplets did not roll and/or blow off the coated surface, but rather suddenly turned to ice. Figure 5 shows the stay before and after the mist was sprayed[8].

Figure 5: A) Aliphatic petroleum distillates with Proprietary additives Sprayed on half of the Specimen, B) Water Droplets due to aliphatic petroleum distillates with Proprietary additives

Therefore, it can be concluded that after conducting the coating experiments in both laboratory and field, the build-up of ice was not be prevented. Another concern was that the coating tested outdoors developed a gummy appearance on the stays after one month.

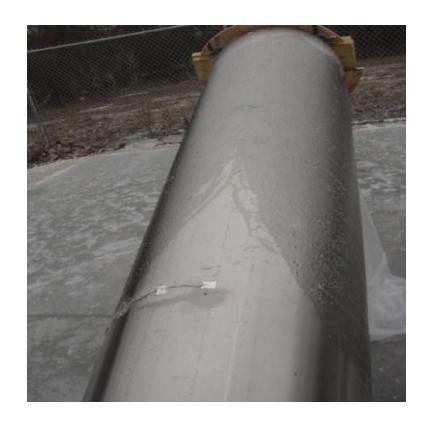
A de-icing and an anti-icing experiment were conducted. For the de-icing experiment, the stay had a 12 mm thick layer of ice accumulated and hot air was blown inside the pipe until the ice melted. Figure 6 shows the melting pattern in the thermal de-icing test. Results of this experiment showed that the heating system successfully melted the accumulated ice without shedding.

It was found that the hot air was effective in de-icing, but not in anti-icing where the ice still accumulated, which means that more heat is needed to prevent ice from accumulating. Also, the cost for heating a large bridge would be too high[8].

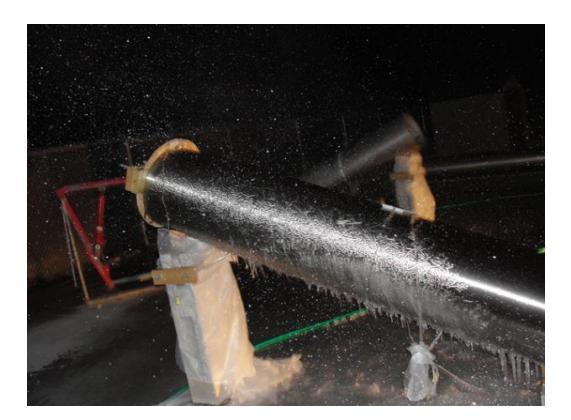
Figure 7: Accumulated Ice in Anti-icing Thermal Test

The second test was an anti-icing thermal experiment. Initially, the stay was clear with no ice accumulation and it was heated just above freezing, then a mist of water was sprayed onto the specimen. Results showed that after a period of time ice began accumulating on the stay, which is shown in Figure 7.

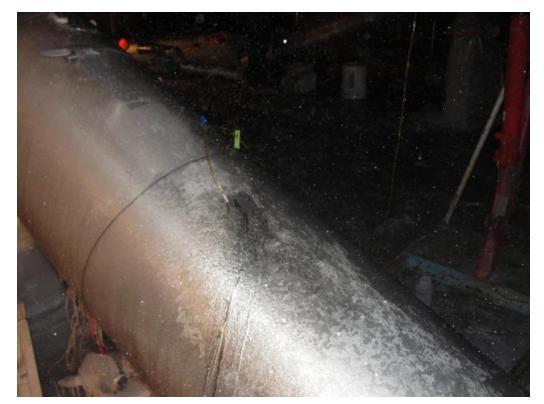
Experiments were conducted using chemicals to determine the efficacy as anti/de-icing technology and also the effect on the stay appearance. The material used was an organic based fluid made of refined molasses carbohydrate, NaCl, CaCl2, KCl, and MgCl2, and the efficacy of the chemical for de-icing of pavements was proven by ODOT[9]. Similar to the internal heating technique de-icing and anti-icing experiments were conducted. For the de-icing chemical experiment, a 1/8 inch thick layer of ice was accumulated on the specimen, and then the fluid was dripped onto the ice layer through a drip tube system. As shown in Figure 8, the chemical was only able to melt down a narrow rivulet through the ice due to its low viscosity [8]. For the anti-icing chemical experiment, the fluid was applied with a manual sprayer on half of the specimen and a mist of water was sprayed onto the specimen to see the efficacy of that anti-icing strategy. Figure 9 shows how ice accumulated on the specimen in the presence of the chemical. This chemical could neither prevent the ice from accumulating nor remove existing ice.

Figure 8: Drip Tube System used in Chemical De-icing Test

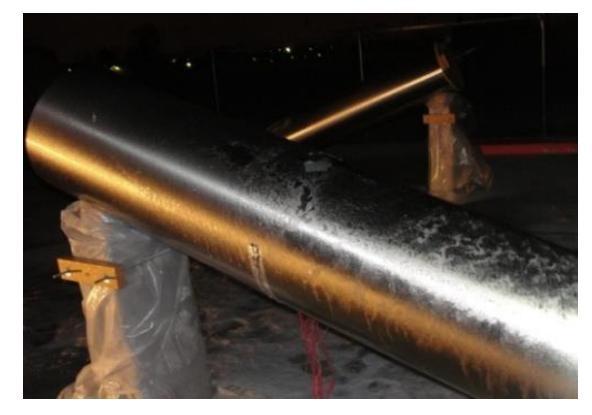
Figure 9: Formation of Ice in Chemical Anti-icing Test

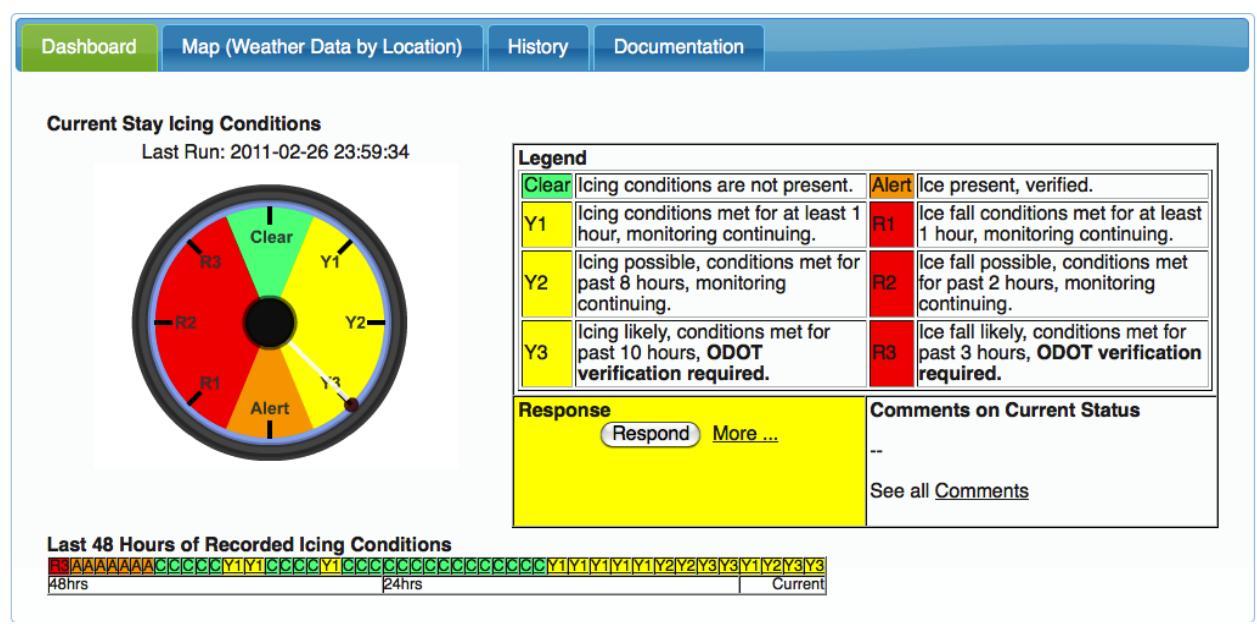
Figure 10, a screen shot of the dashboard, shows various tabs that allow the operator to view data in many ways. The Dashboard tab, which is the primary tab, provides the current status of VGCS stays with a speedometer-like indicator, a legend of the indicated state of transition, and a running history of the last 48 hours of recorded icing conditions. The Map tab shows weather data at locations where the weather stations exist. The History tab shows records of the weather stations and sensor readings, and finally the Documentation tab shows information about the accumulation, shedding algorithms, and criteria[1][2]. This information will help the operators in monitoring the bridge status and assist them in making the right decision to protect the motorists.

Figure 10: Screenshot of dashboard tab of the monitoring system[10].

The results showed that none of the technologies were suitable for application on the bridge. Thus, an automated real time monitoring system was built to observe the conditions on the bridge. The dashboard shows data from the sensors (stay temperature, ice accumulation, precipitation, solar radiation) that have been set up on the bridge. In addition, the dashboard shows data that were gathered from local airports and Road Weather Information System (RWIS) stations. An algorithm was developed based on the weather data that were derived from the bridge. This algorithm allows ice accumulation, ice shedding, and clear conditions on the bridge to be identified[1][2]
