IWAIS 2015 - 16th INTERNATIONAL WORKSHOP
ON ATMOSPHERIC ICING OF STRUCTURES
Uppsala, Sweden
June 28 - July 3, 2015

*Expansion of the ice deposition monitoring network
in Germany*

Bodo Wichura

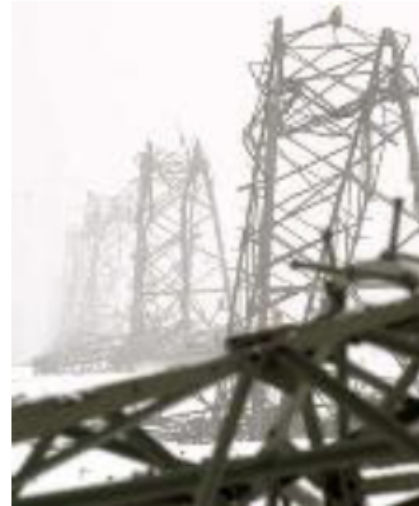
Fig. 3: Damaged power line poles in Münsterland area on 26.11.2005 (Photo © DPA, 2005; see [2] and [3] for more information)

- more than 80 power line towers were damaged as a result of wet snow accretion on power line cables (see Fig. 3, [2], [3]),
- due to the enormous economical impact of such damage the question arises as to how frequently similar climatic conditions may occur; such information forms the basis of structural design of power lines in areas prone to icing events,
- statistics on ice loads are scarce since they are seldom measured routinely.

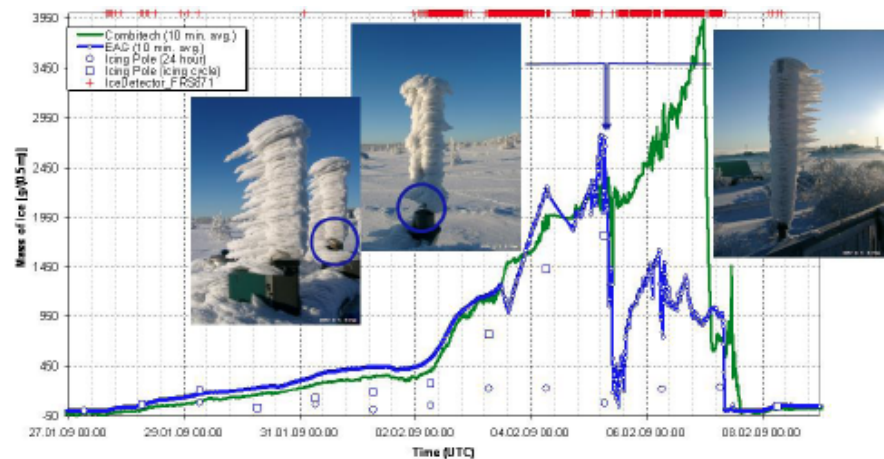
Fig. 4: Time series of icing variables as the result of test measurements with different instruments at weather station Zinnwald during the winter season 2008/2009 (see [4], [5] for more information). The photographs were taken in order to illustrate the result of icing measurements (blue arrows).

- a comparison of icing measurement devices was carried out at weather station Zinnwald during winter seasons 2007/2008 and 2008/2009 (see Fig. 4, for an example of results; [4], [5]),
- the comparison campaigns were part of the COST-Action 727,
- results of COST-Action 727 showed clearly the need of ice deposition measurements in order to monitor icing conditions for several applications [6].
