De-icing of wind turbine blades by means of an helicopter opens new opportunities.

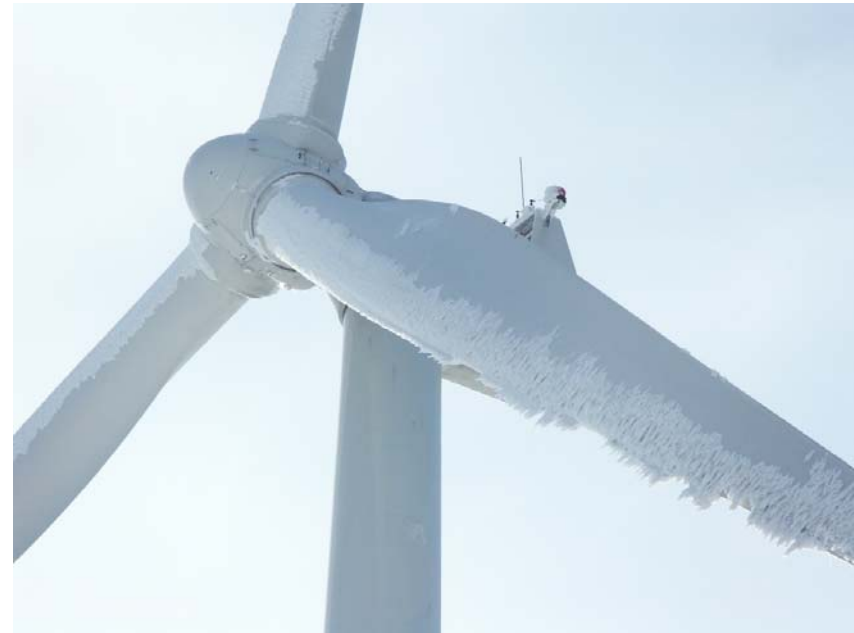
Icing on wind turbine blade

- Significantly reduce the aerodynamic properties.
- Mechanical failures due to increased load or unsymmetrical distribution of the ice.
- Damages on bearings and gear boxes.
- Safety risks

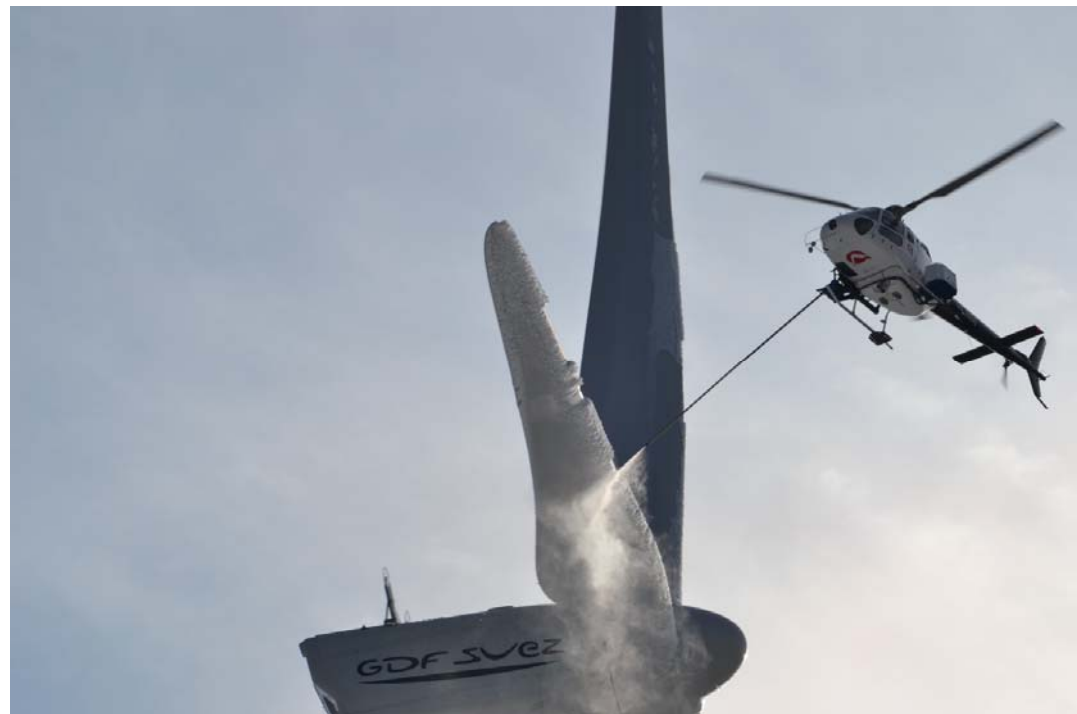
De-icing with hot water

Results from Canada shows that it is possible to remove ice from wind turbine blade (Vestas V90) with hot water.

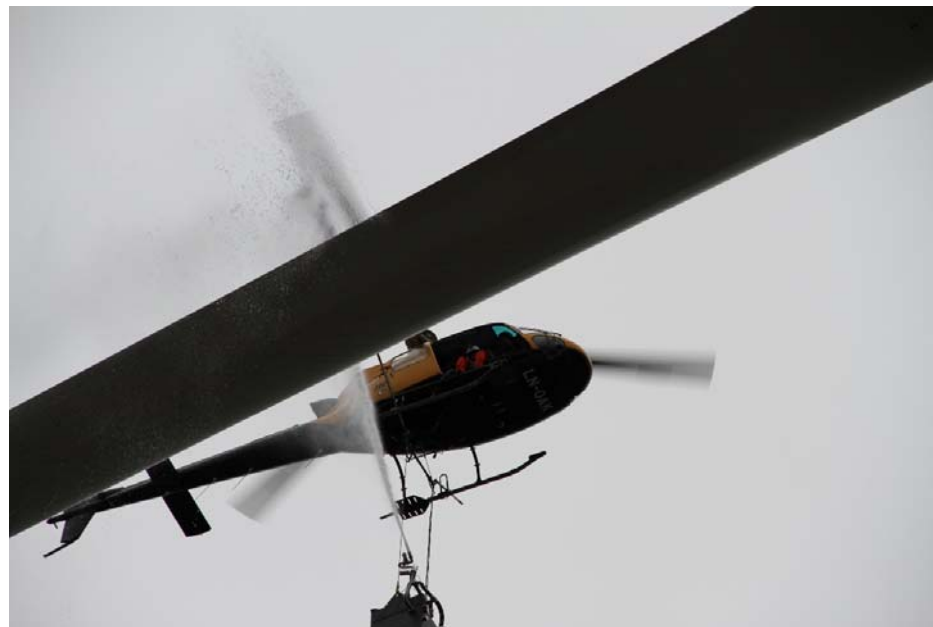
Truck equipped for fast field establishment.

Truck

Equipped with:

- 17 m³ water tank capacity, made of stainless steel
- Oil fuel depot and oil burner (260kW) for water heating
- Heating capacity from 7°C to 65°C in 6,5h for 17 m³ water.
- Helicopter fuel depot

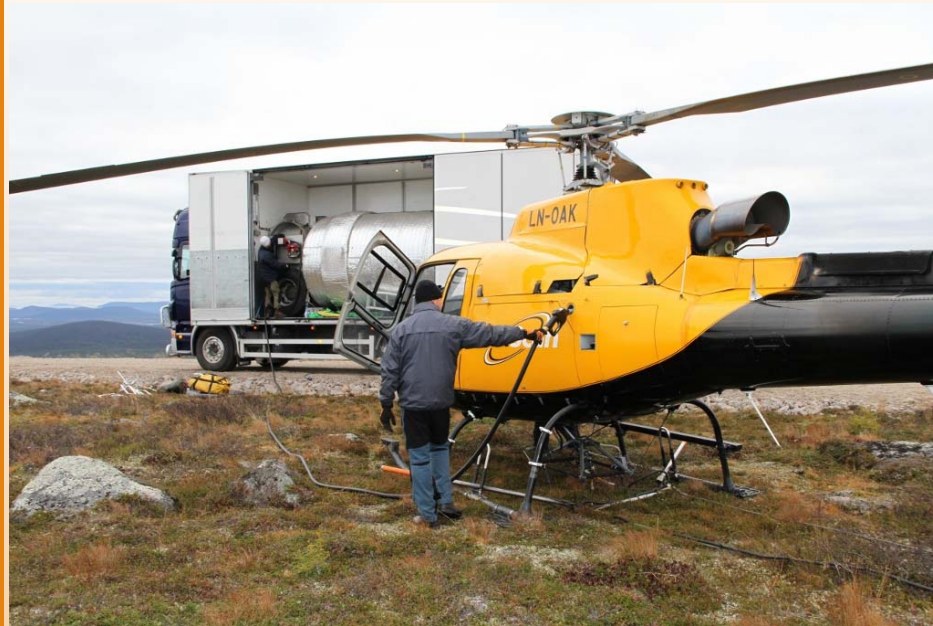
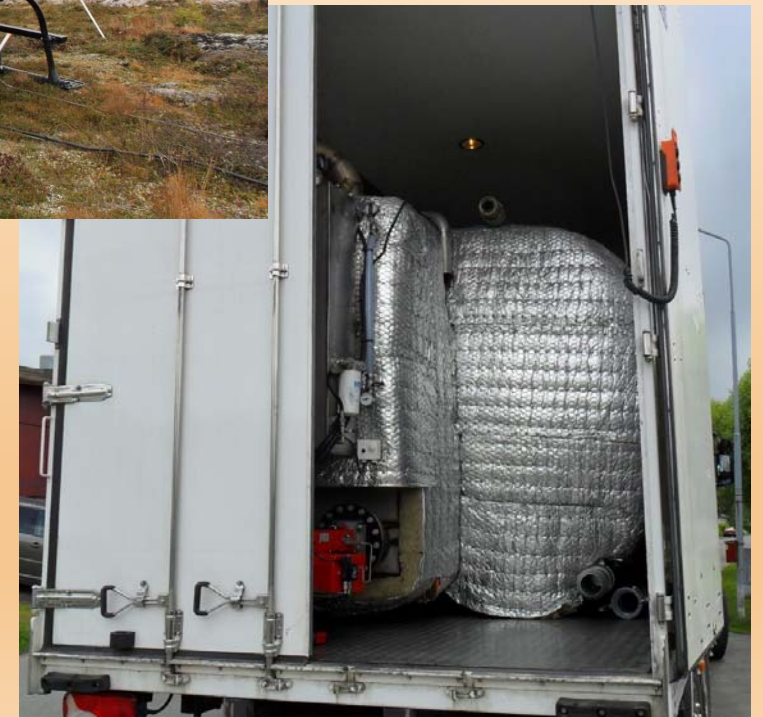
De-icing tank

long range of the water
jet (40 m)

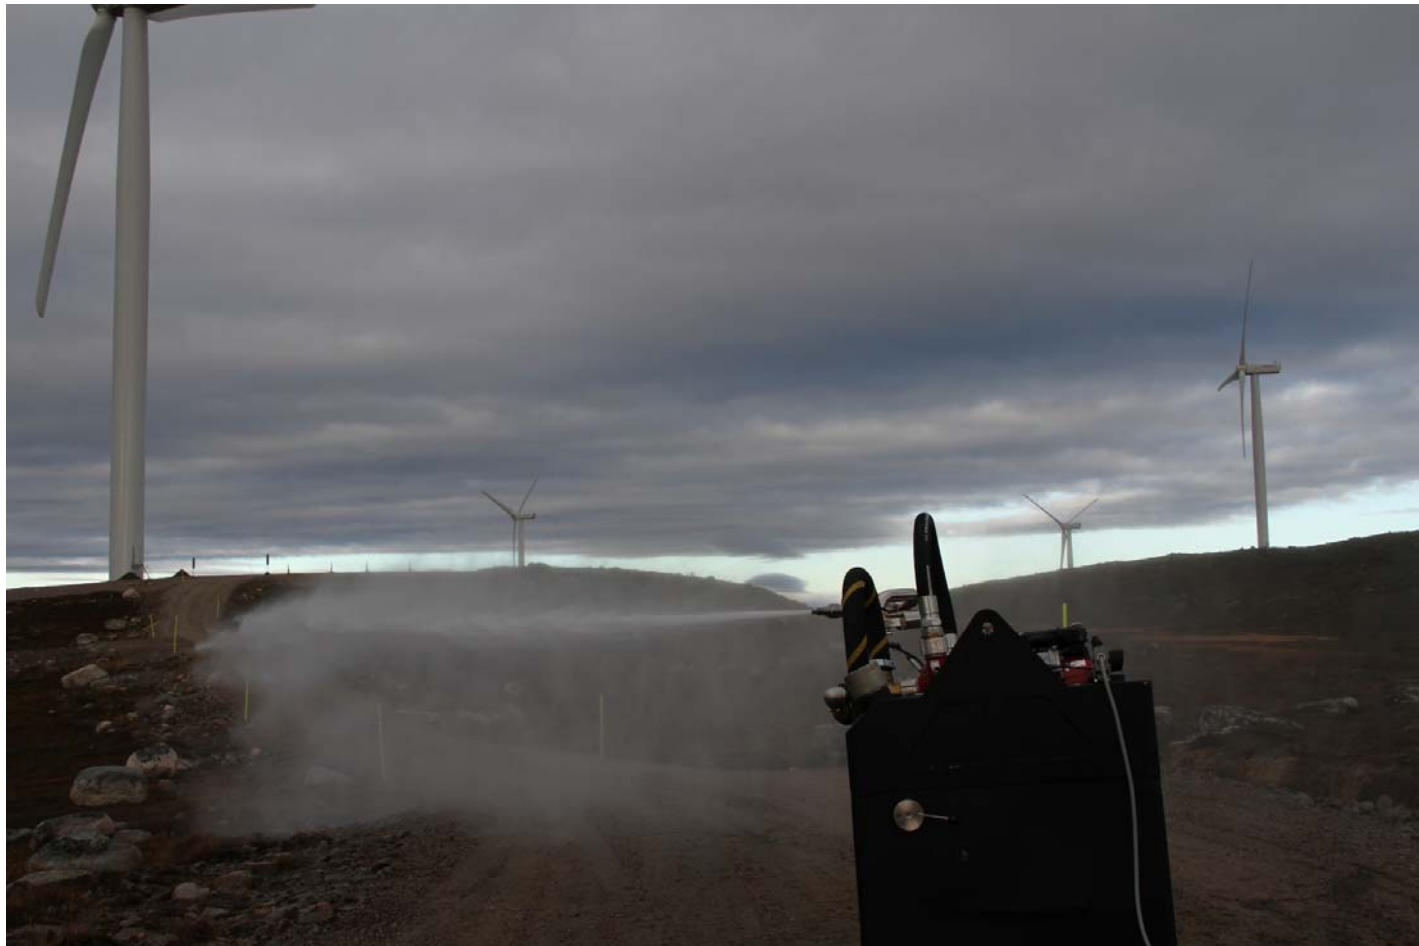
Helicopter test of de-icing equipment at Uljabuouda

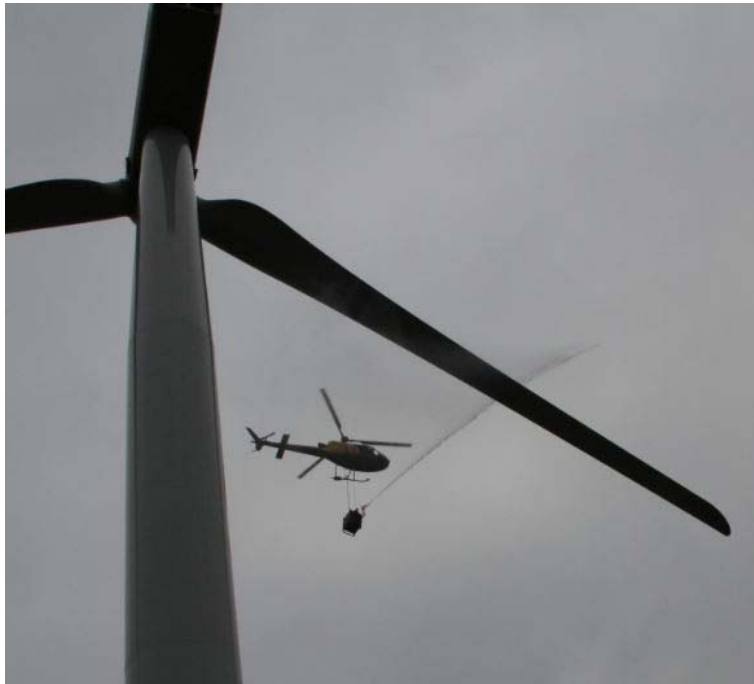
Helicopter and de-icing equipment

Tank capacity 900 l

Refilling of the tank takes 45 sec

Water jet is controlled with a joystick

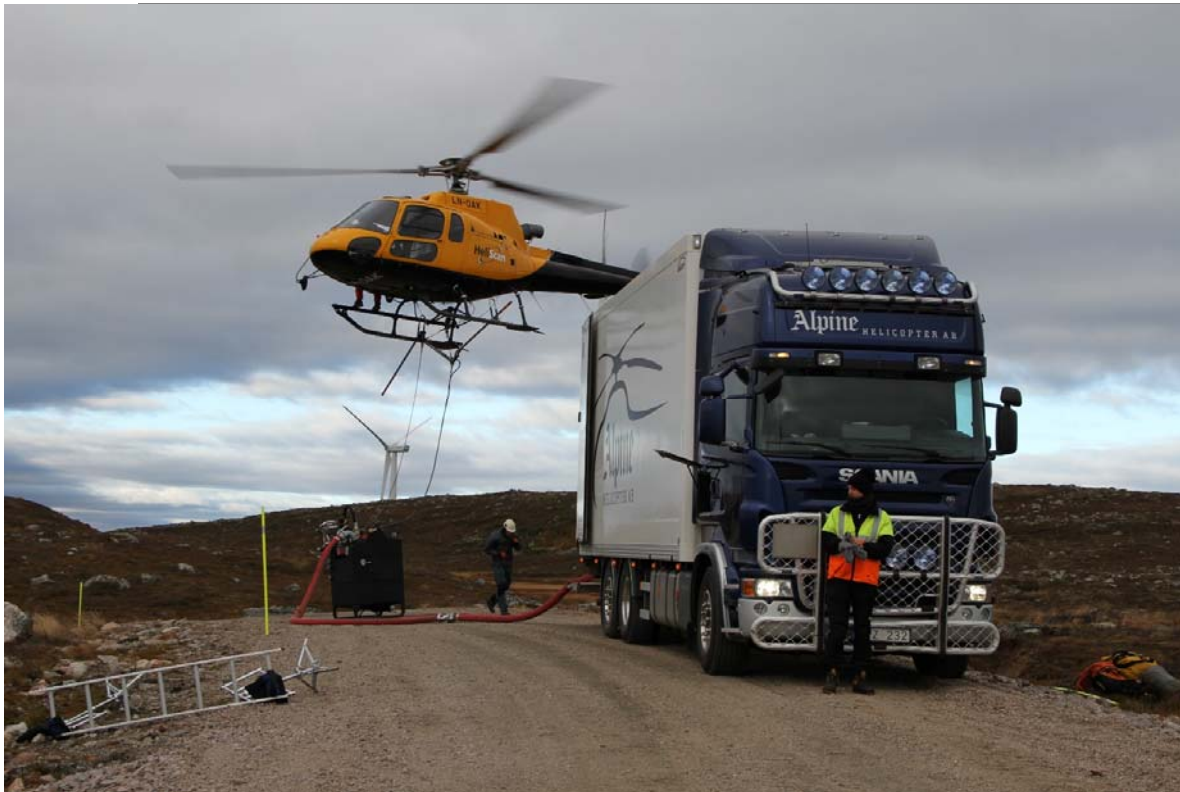
water filling is in progress
